# Housing New Zealand

Technical Report on the Results of Foundation Repair Trials  
Conducted following the Canterbury Earthquakes

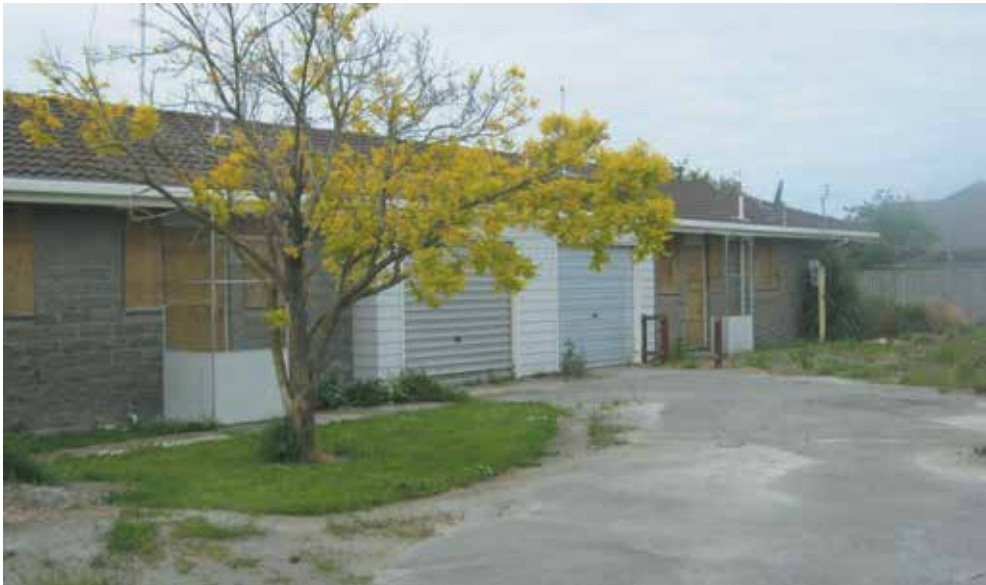
# 1/41 A & B Reginald Street, Burwood

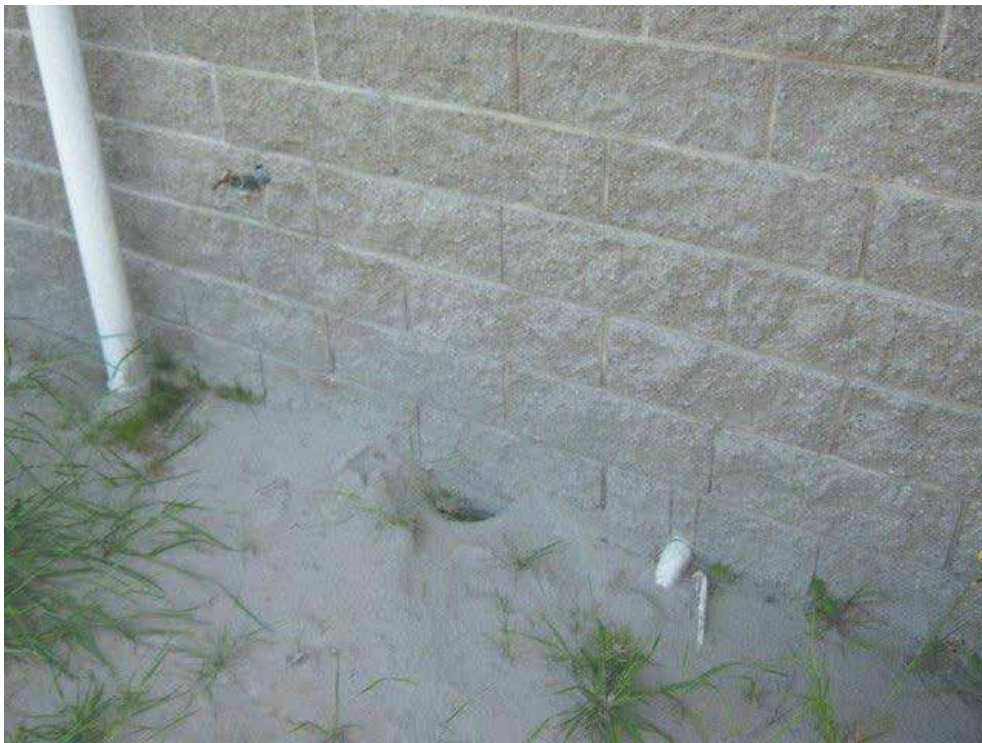
Image 1: Liquefaction ejecta potentially entered weep holes in veneer around perimeter

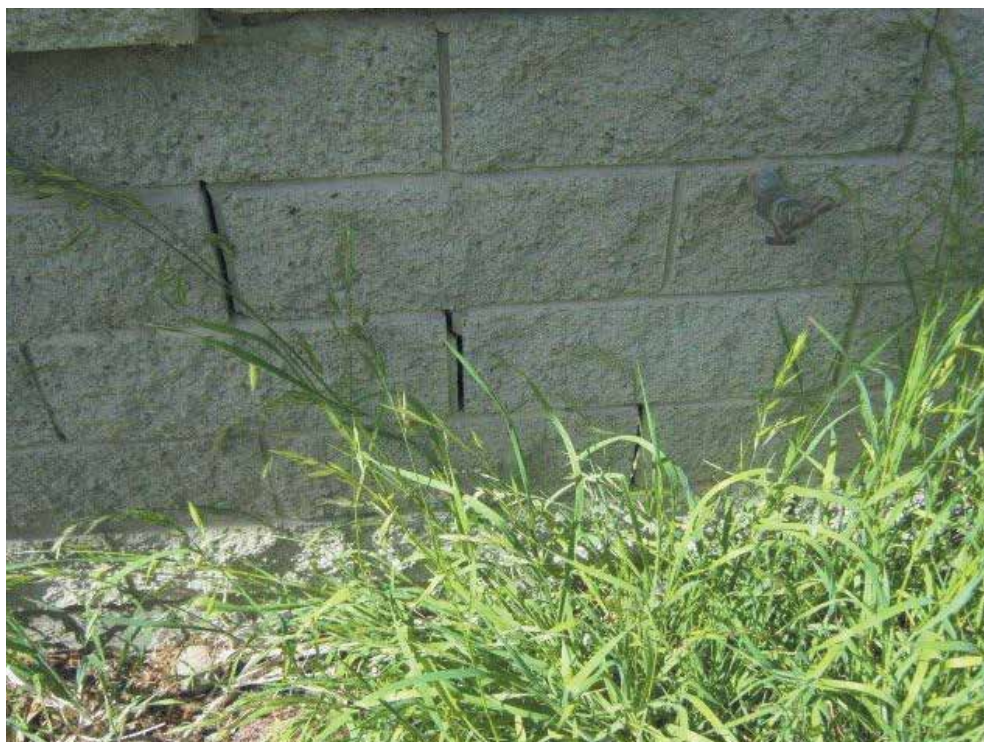
Image 3: Step cracks in mortar

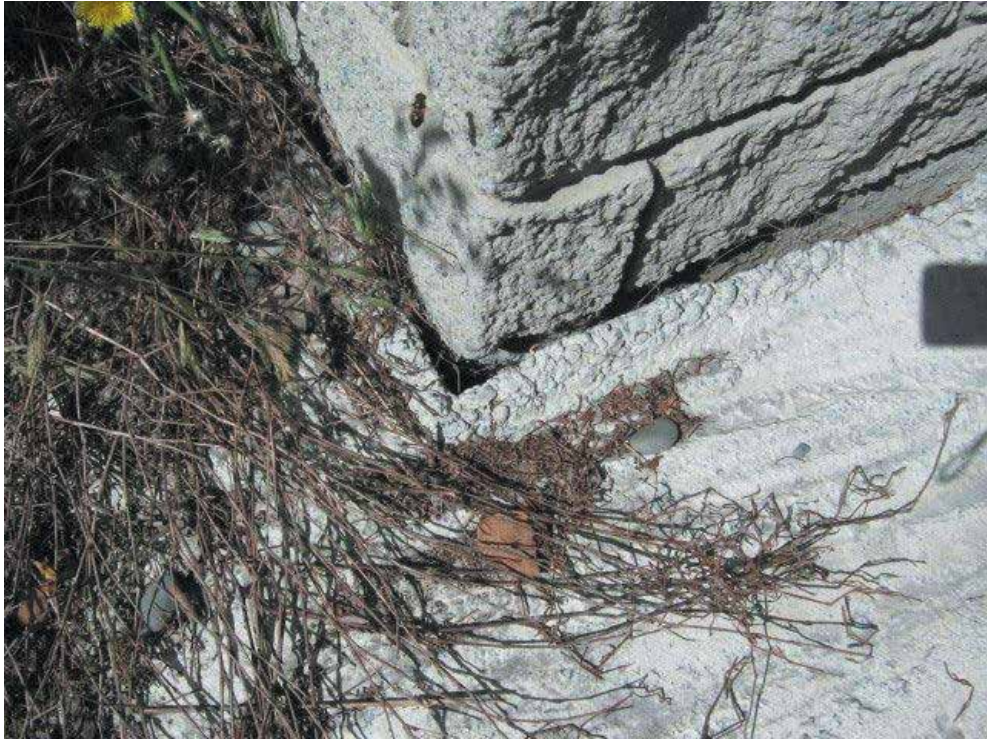
Image 4: Lateral spread of hard surfaces

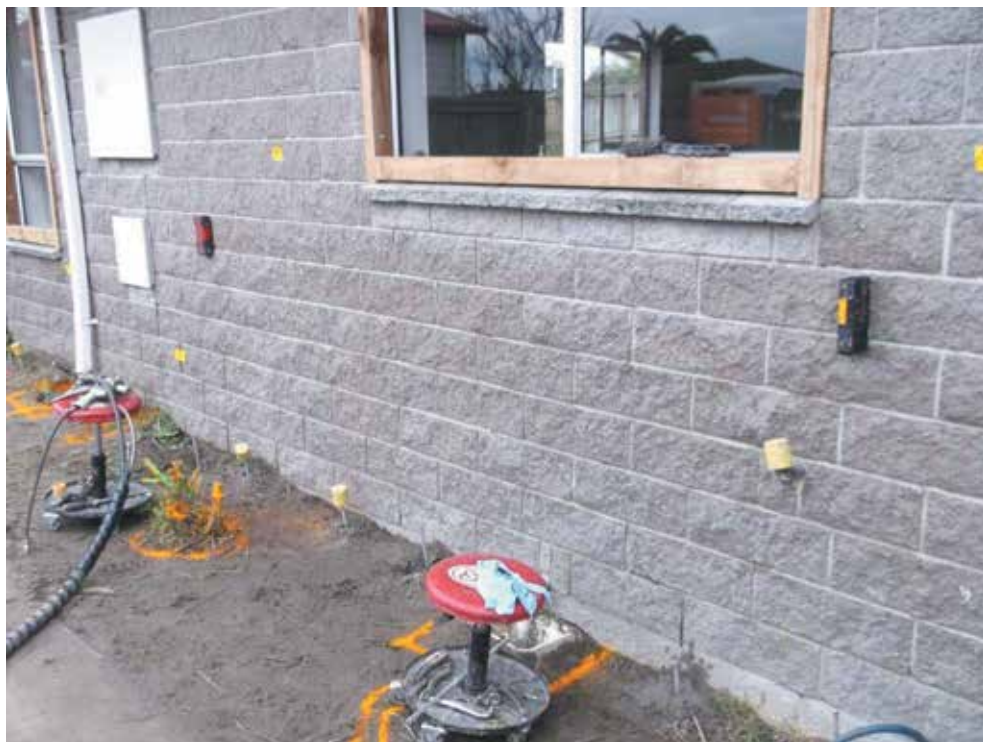
Image 6: Resin injection tubes inserted at specified centres

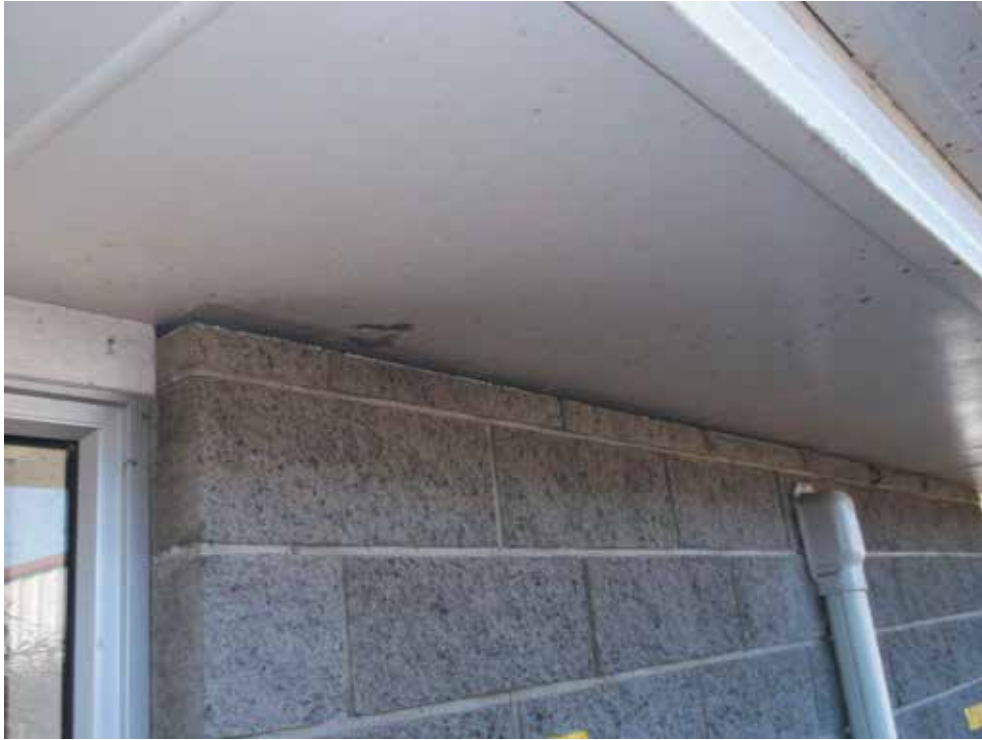
Image 10: Tapered gap between top of masonry veneer and soffit due to no structural connection between floor slab and foundation perimeter beam

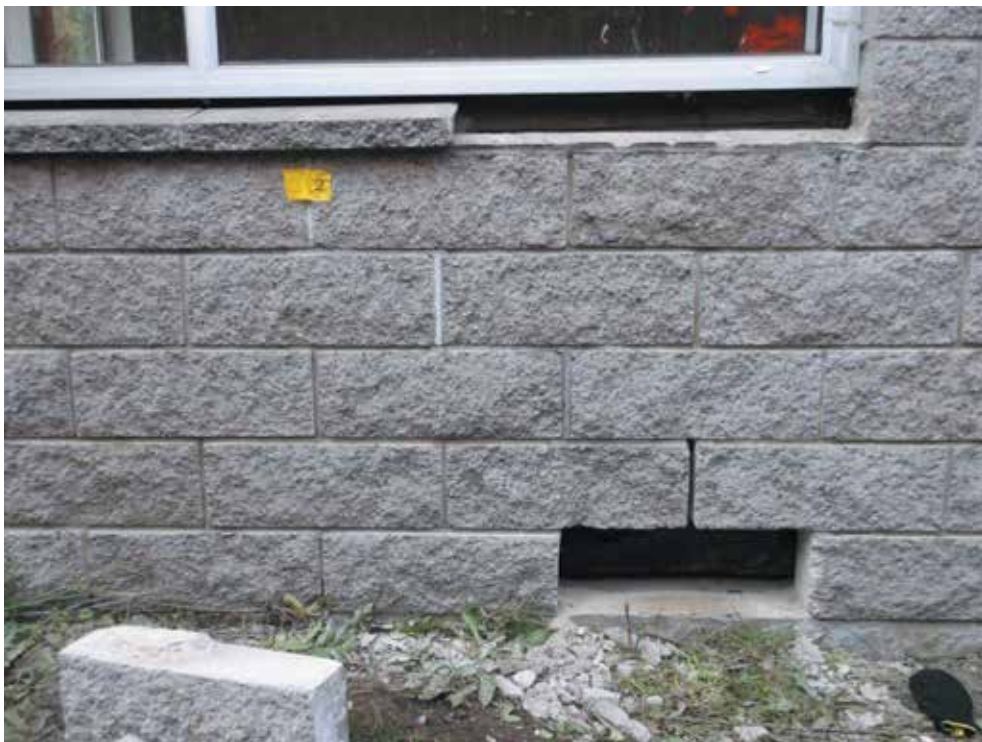
Image 11: Gap between sill block and window frame indicates separation between floor slab and foundation perimeter beam

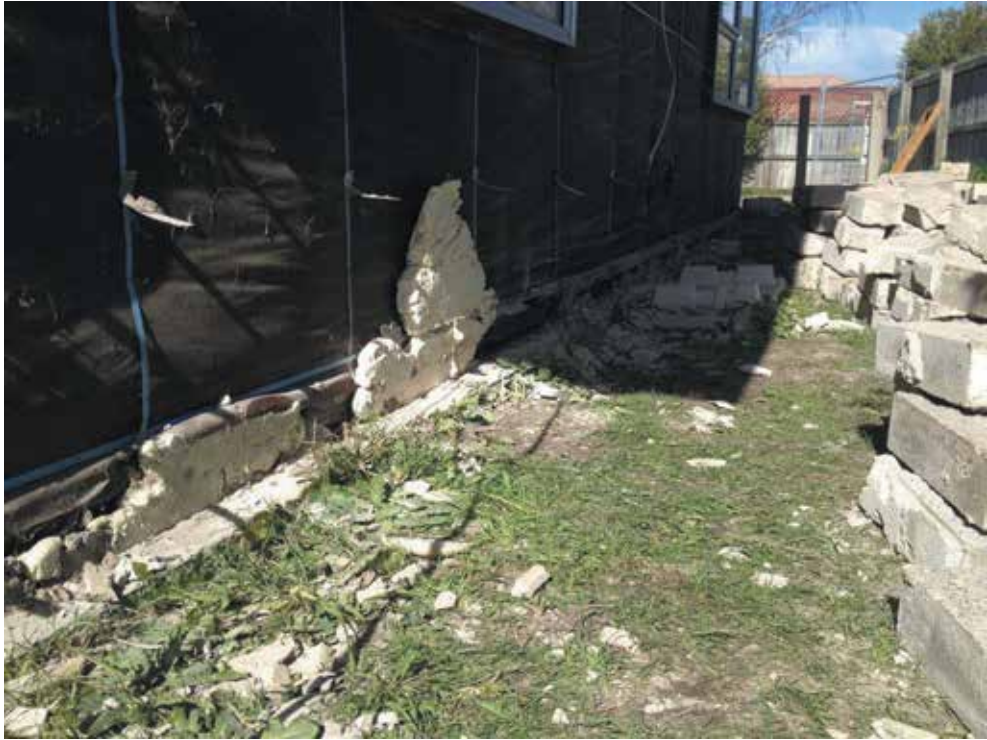
Image 12: Resin intrusion into cavity

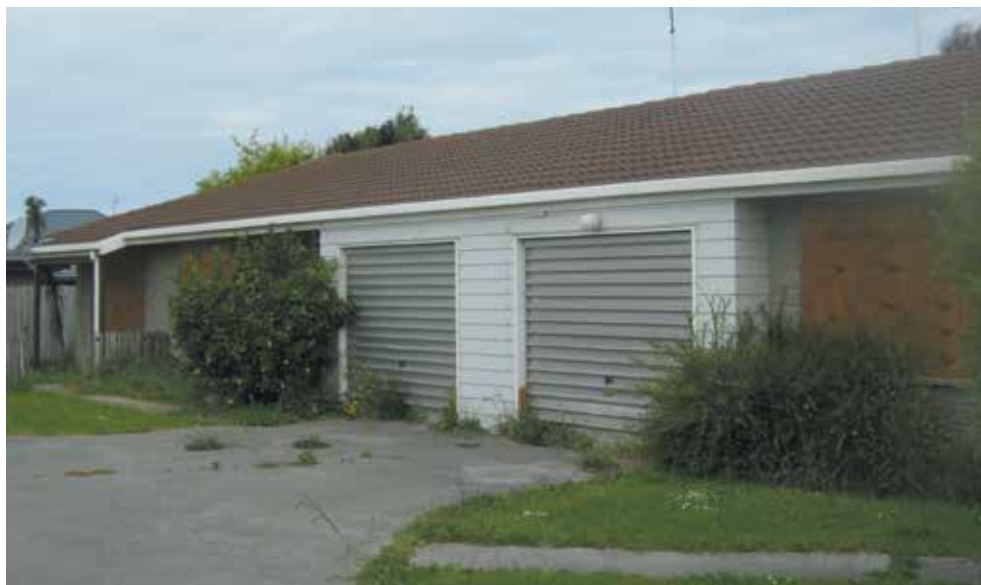
### Property Details

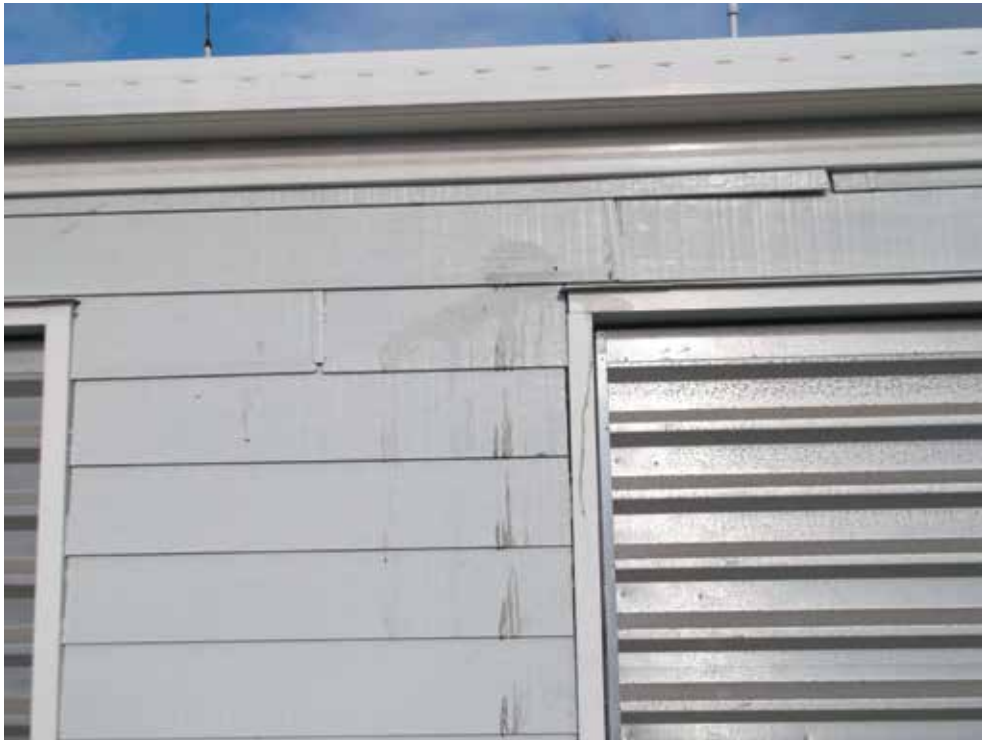
Image 1: Spreading of weatherboard cladding in the garage where foundation pulled in opposite directions

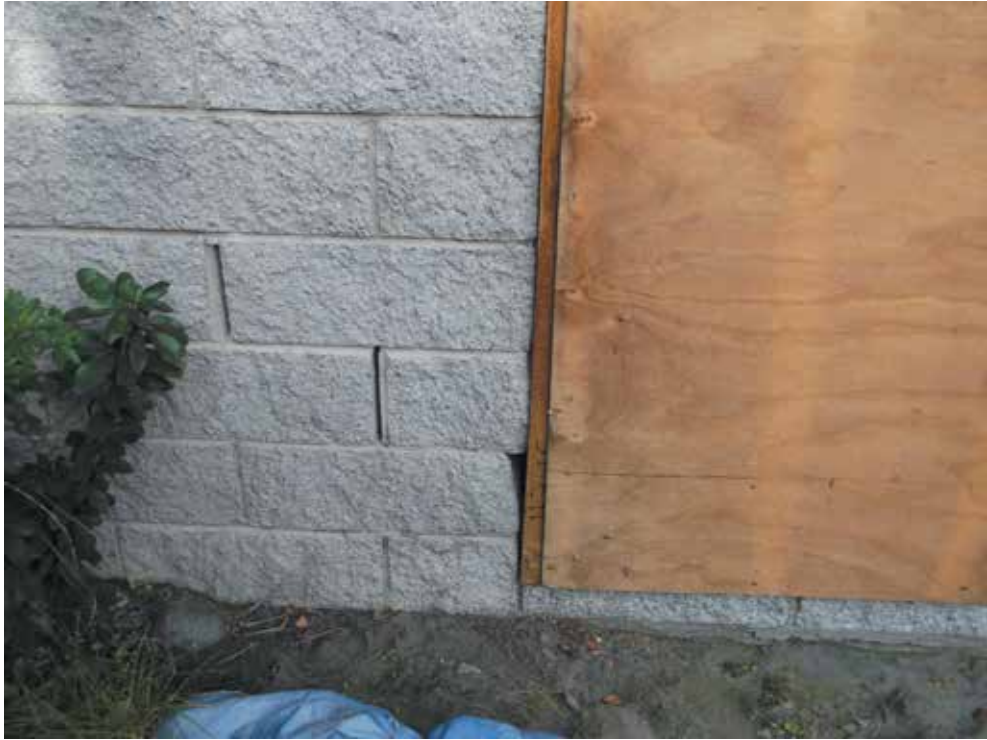
Image 2: Lateral spread of Summerhill Stone cladding caused by slippage on the foundation

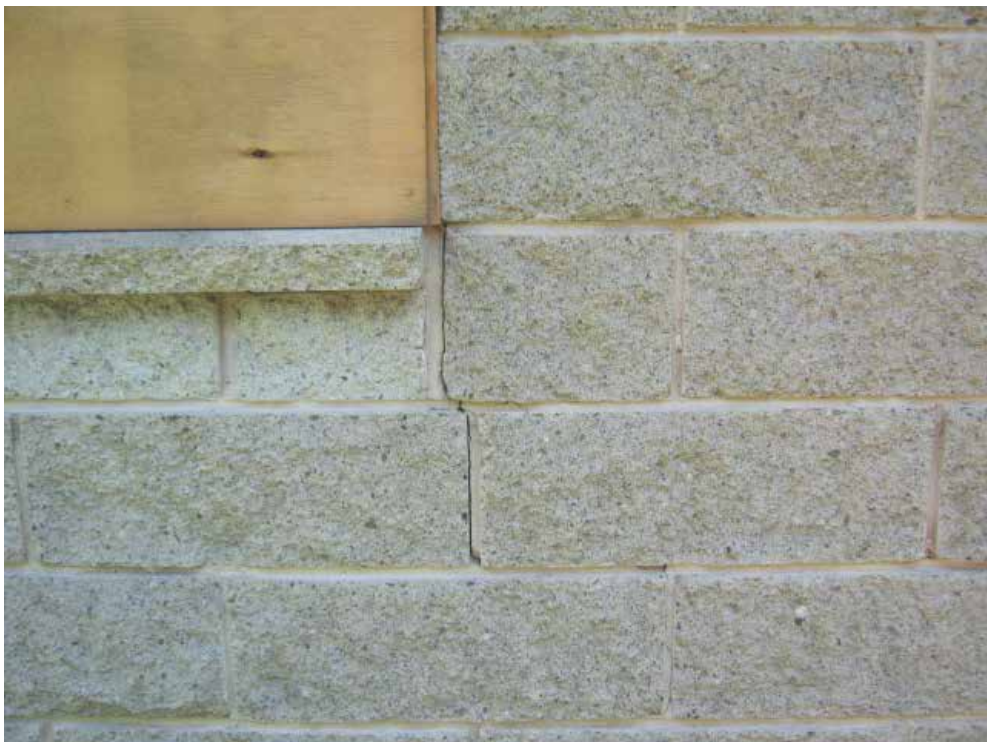
Image 3: Vertical cracks in veneer

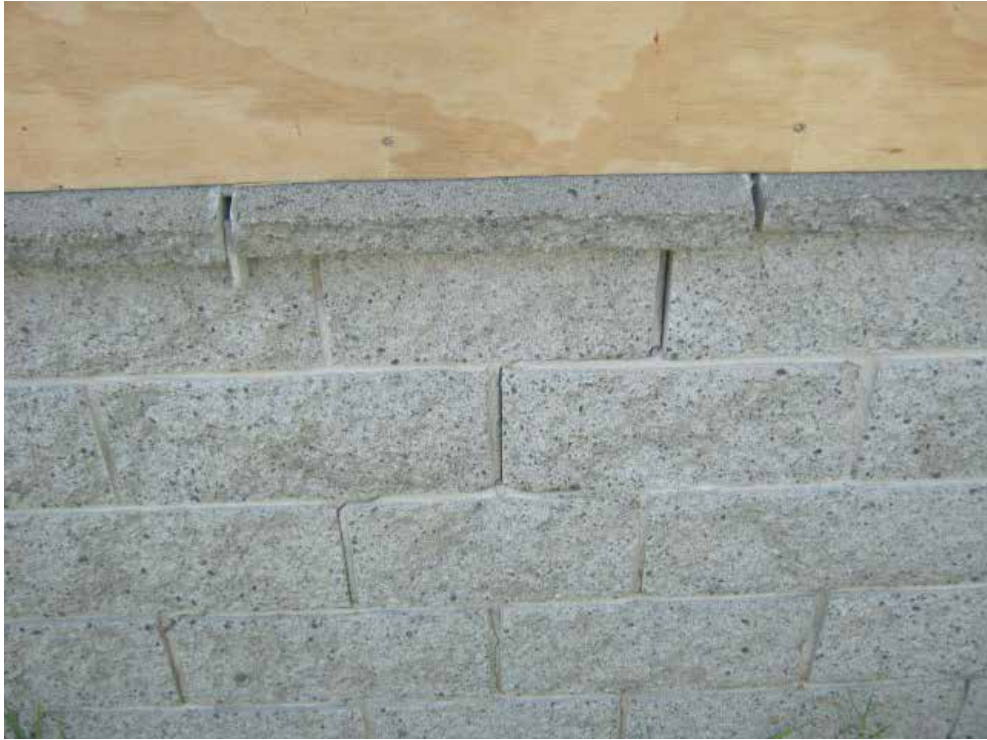
Image 4: Step cracking in mortar

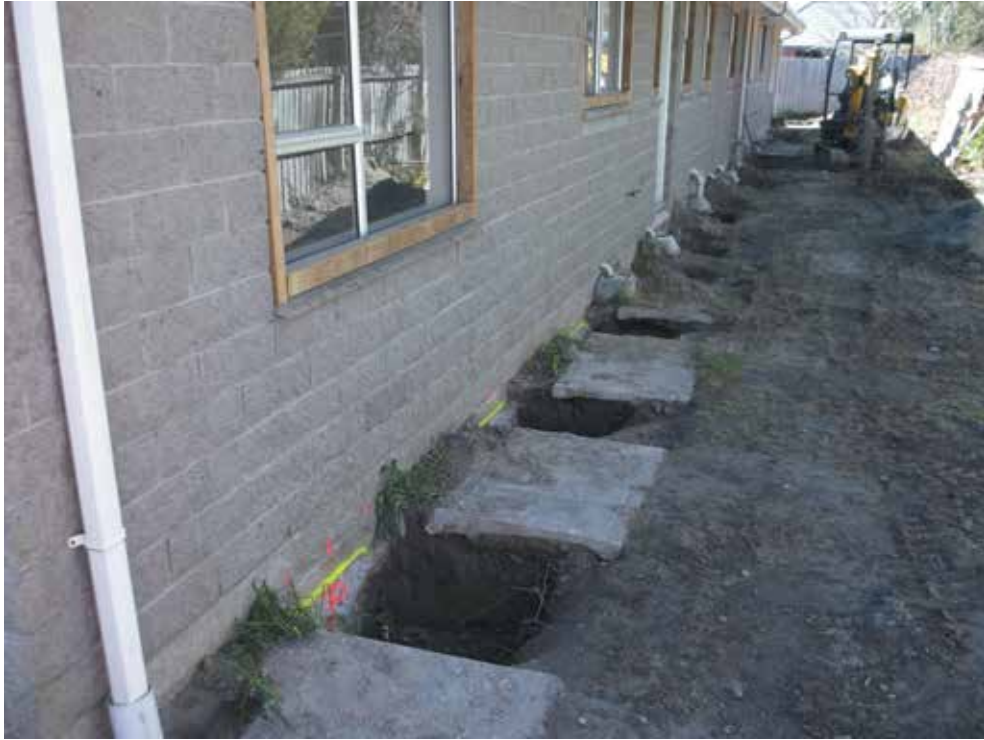
Image 5: Jacking points excavated at centres determined by structural engineer

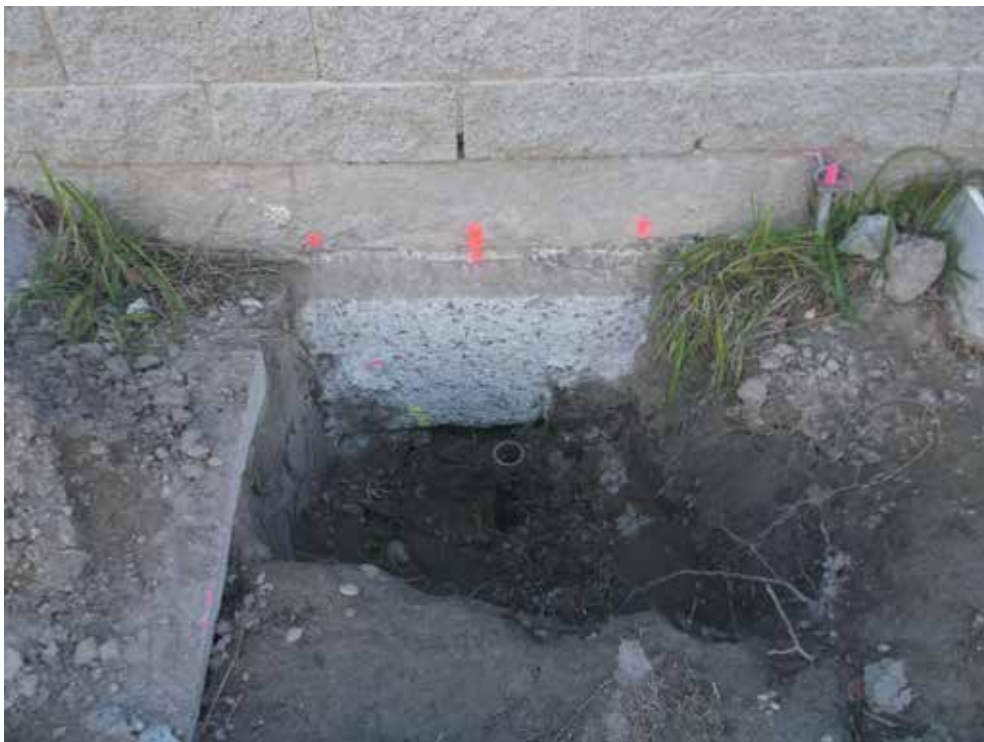
Image 6: Screw piles installed at depths determined by geotechnical ground conditions

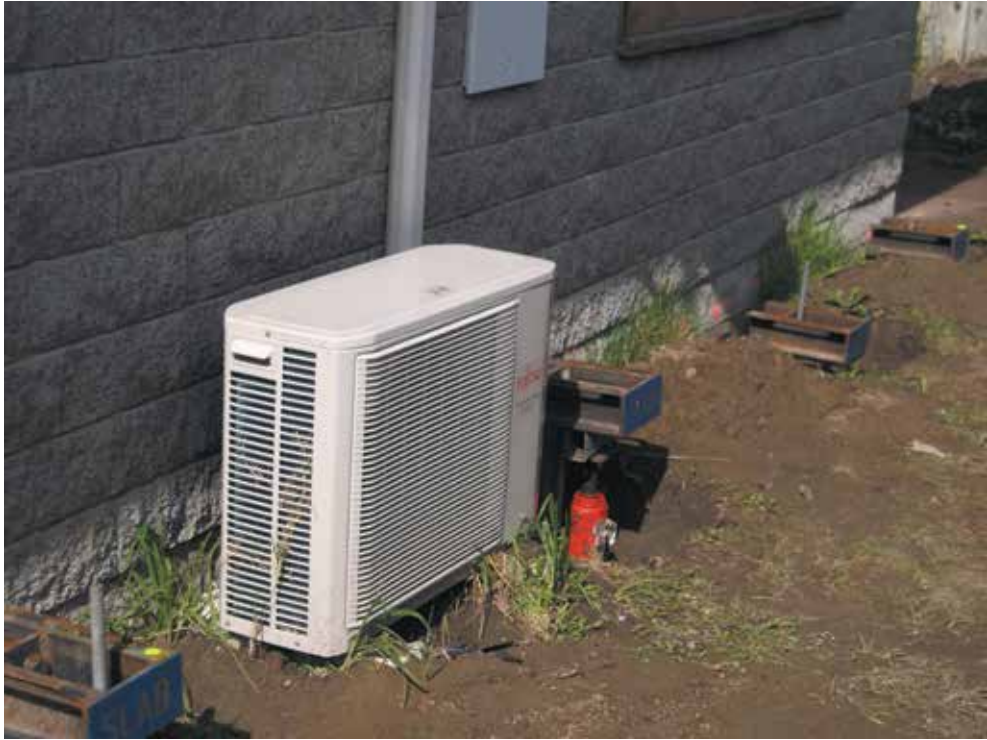
Image 7: Lifting brackets and jacks installed for foundation lift

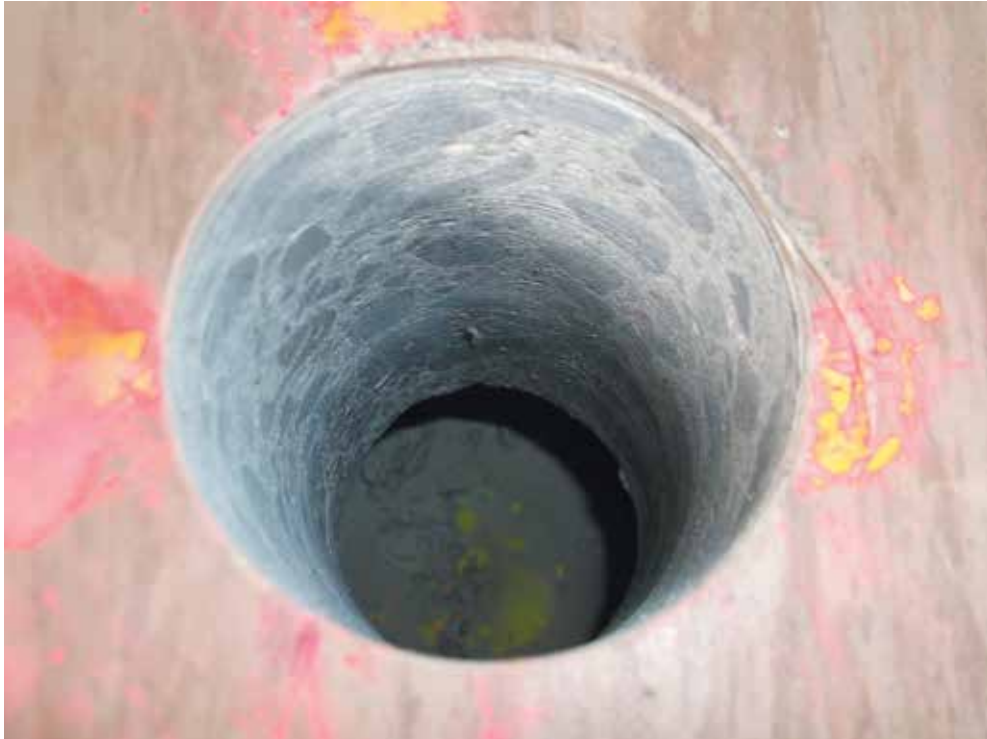
Image 8: Internal core holes drilled in slab for void fill injection points and internal mechanical lifting points

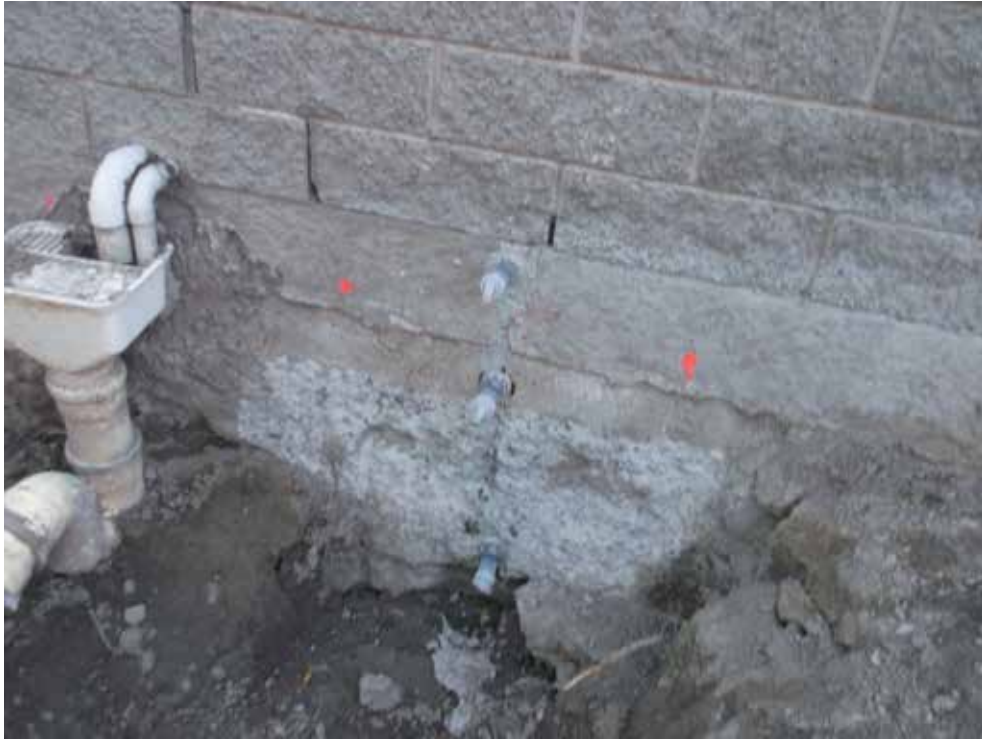
Image 9: Void fill under perimeter foundation beam and beneath concrete slab. New and existing cracks in foundation repaired with epoxy compound injection

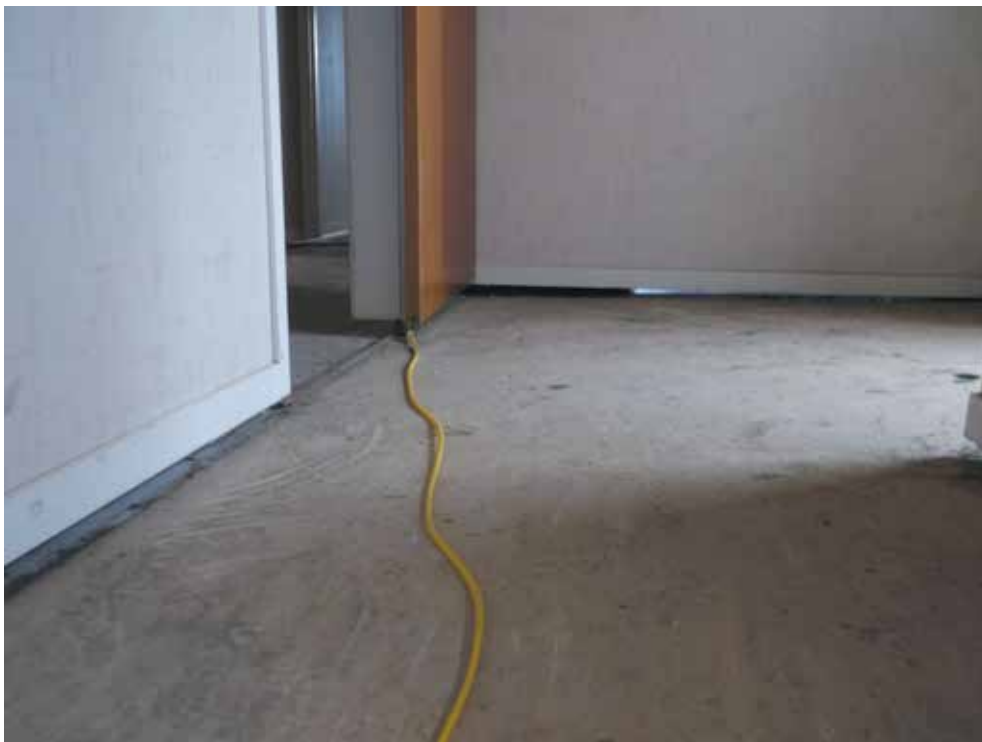
Image 10: Separation between slab and bottom plate was rectified by mechanically lifting centre of slab at several points. The slab then had the void filled

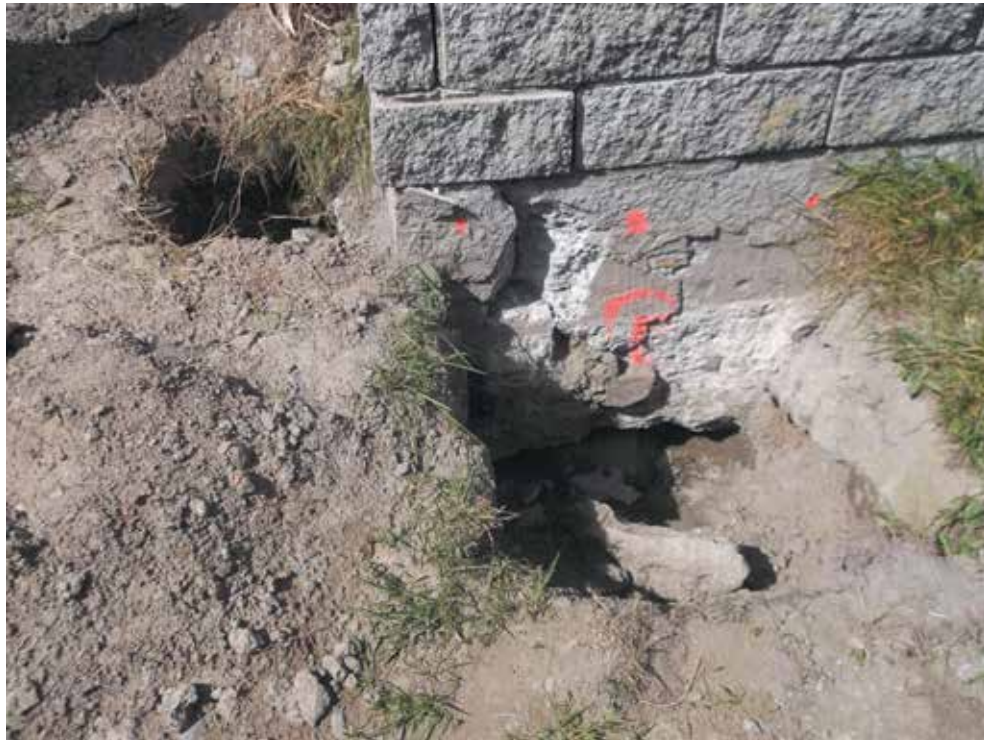
Image 11: Damage to foundation beam caused by bracket being installed too close to the corner. Foundation repairs were necessary to remedy

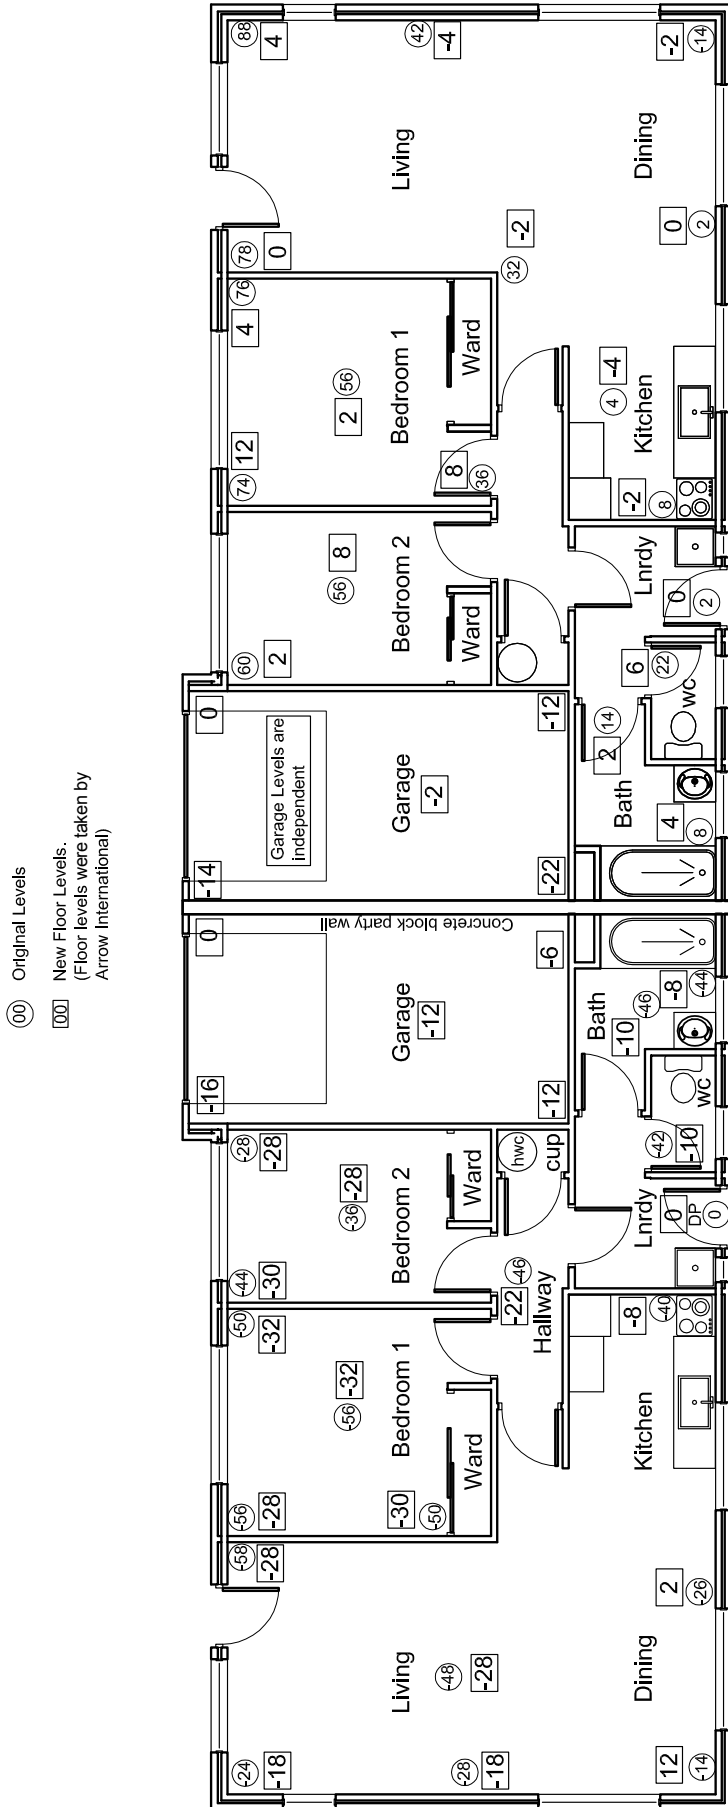
Unit 2, 41a Reginald Street

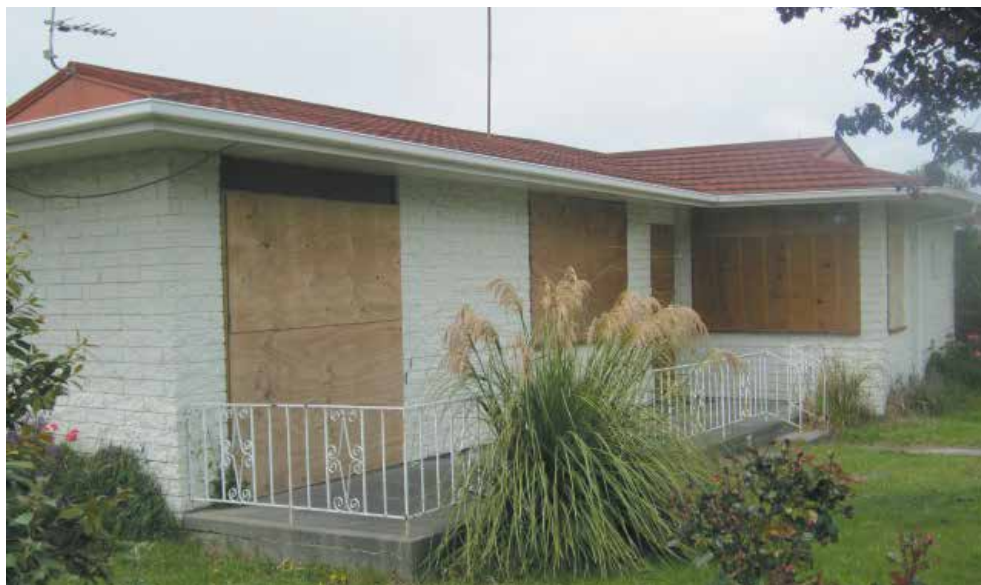
### Property Details

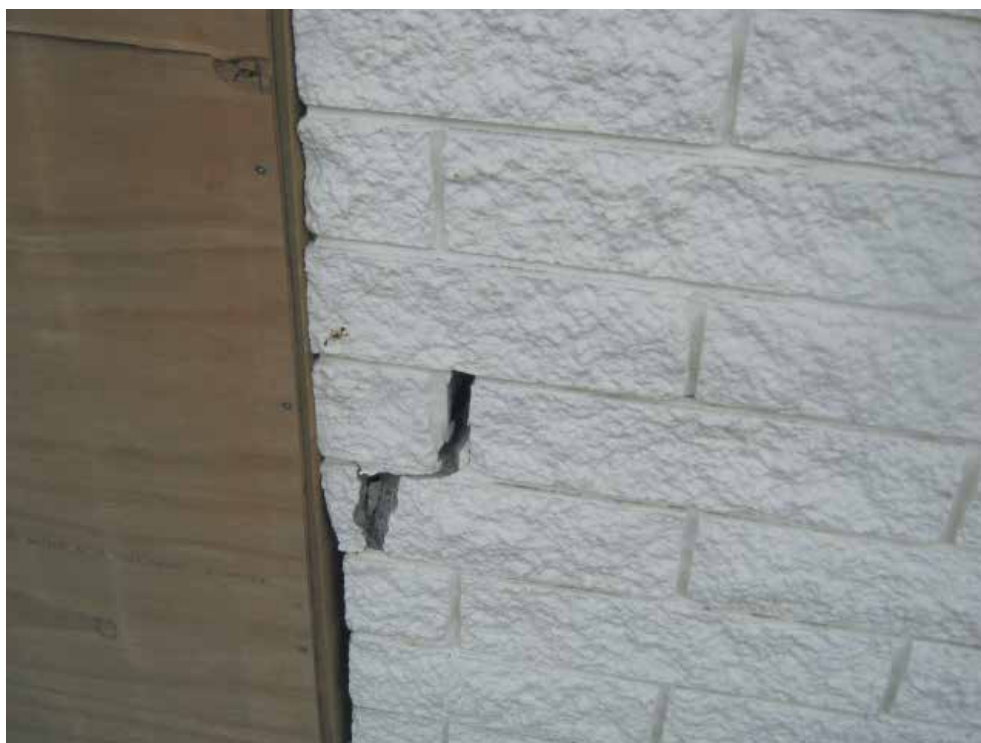
Image 1: Moderate brick veneer damage

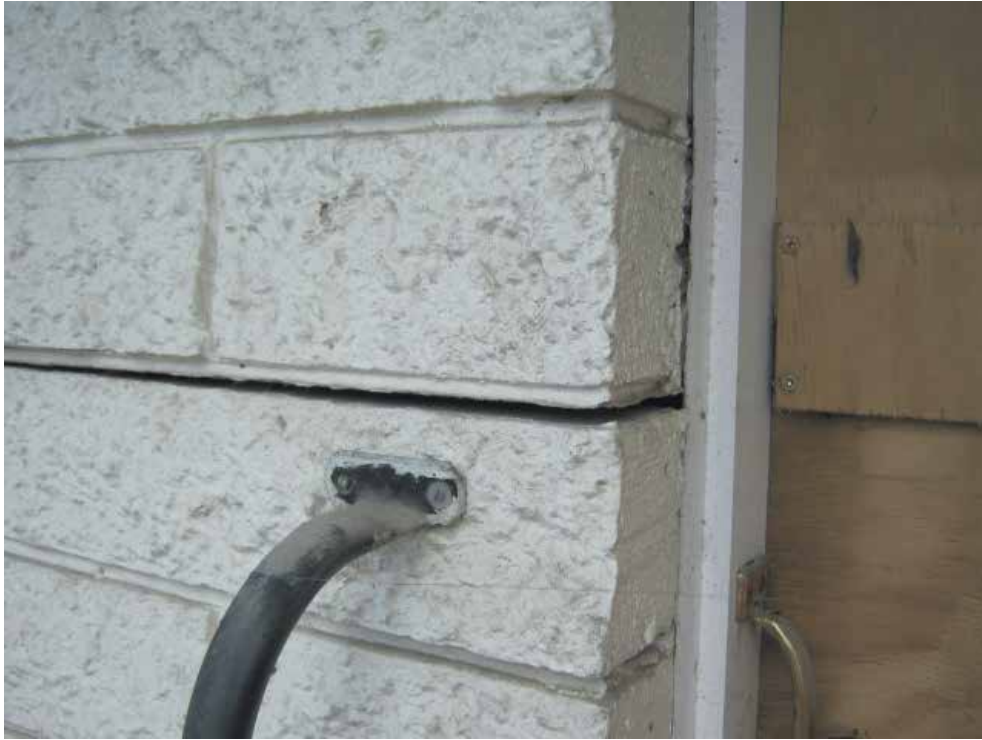
Image 2: Bond failure of the mortar allowing separation of brick courses under differential settlement of the foundation beneath

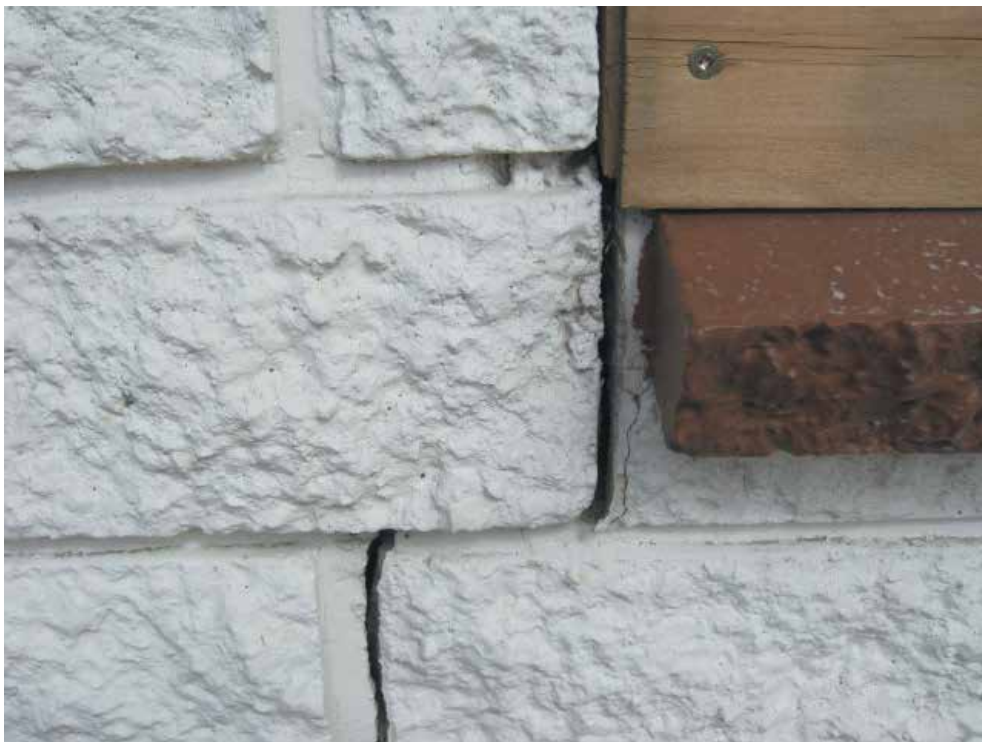
Image 3: Step cracking from openings caused by differential settlement of the foundation

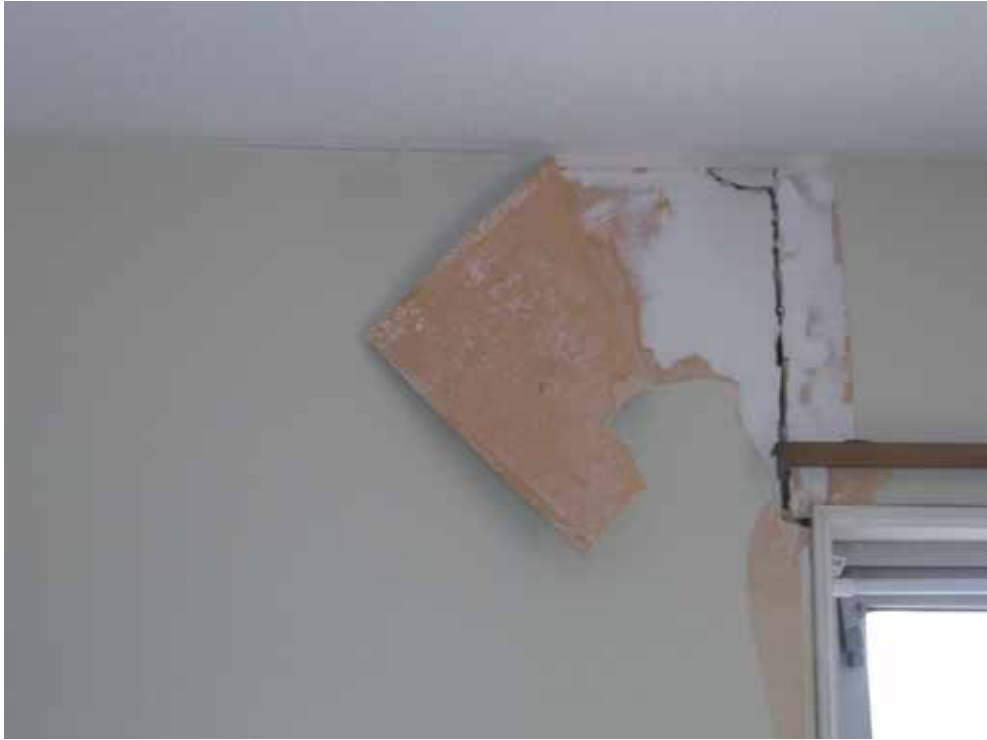
Image 4: Cracks at joints between plasterboard sheets from the corner of the opening

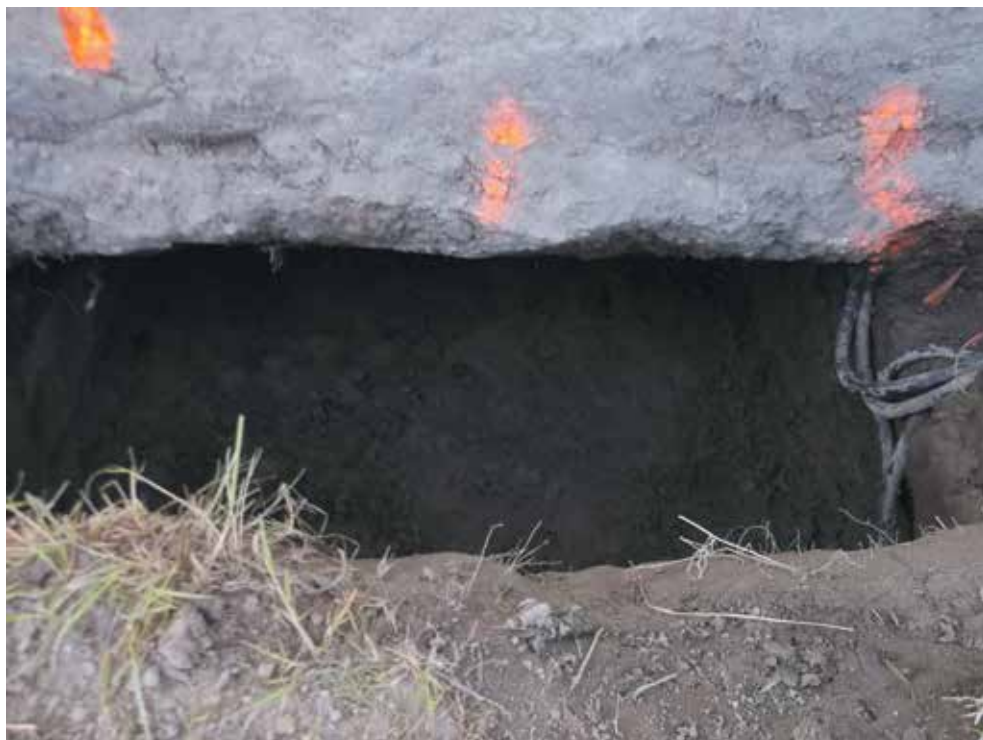
Image 5: Excavated jacking points as per engineer's specifications

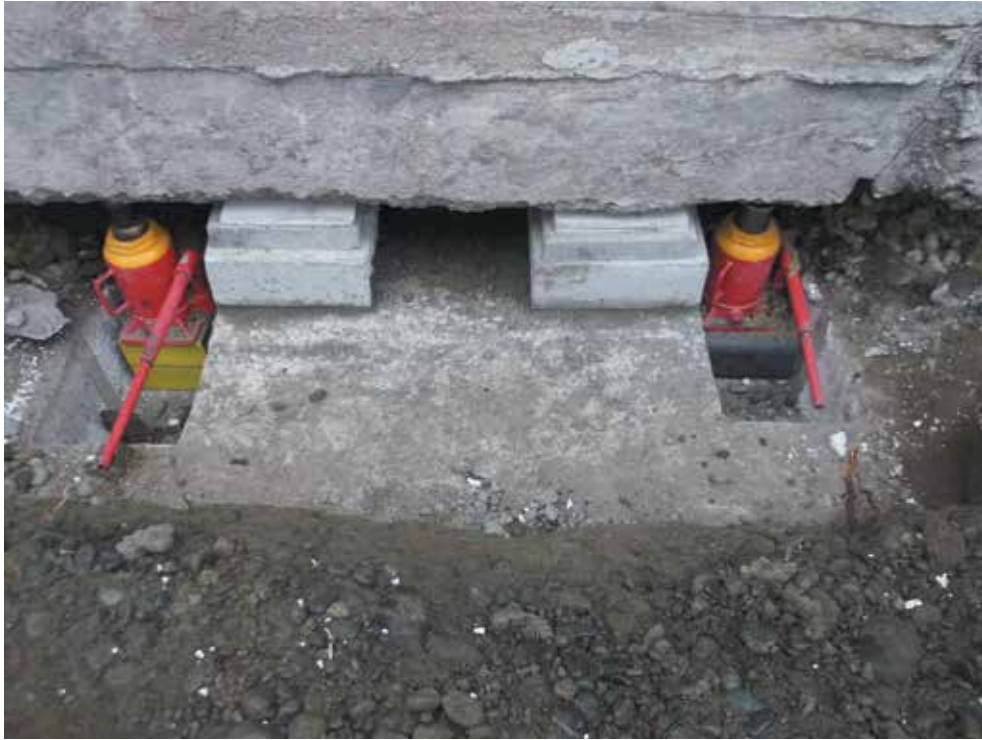
Image 7: Jacked and supported foundation

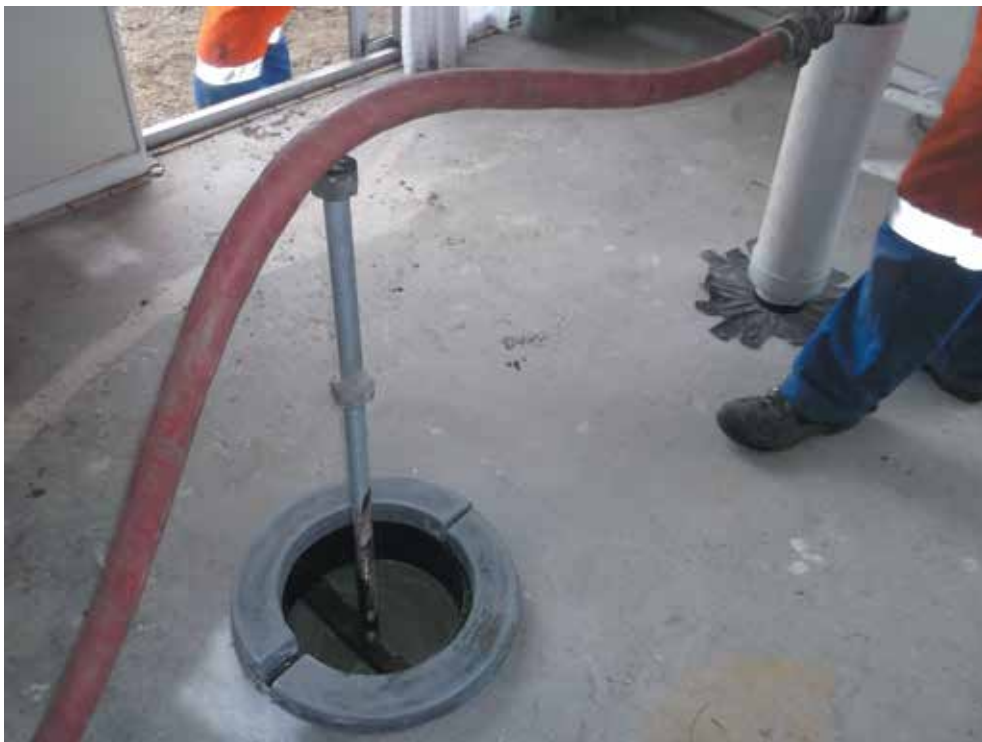
Image 8: Concrete slab lifted at same time as foundation. Void fill poured

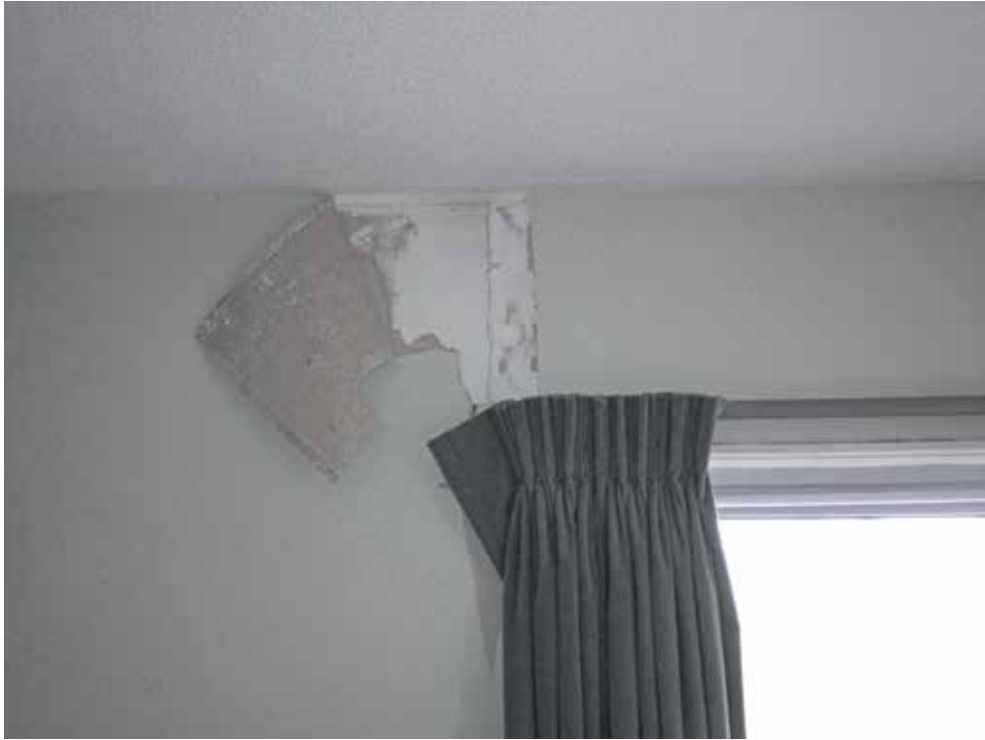
Image 9: Vertical cracks in plasterboard closed up after foundation relevel

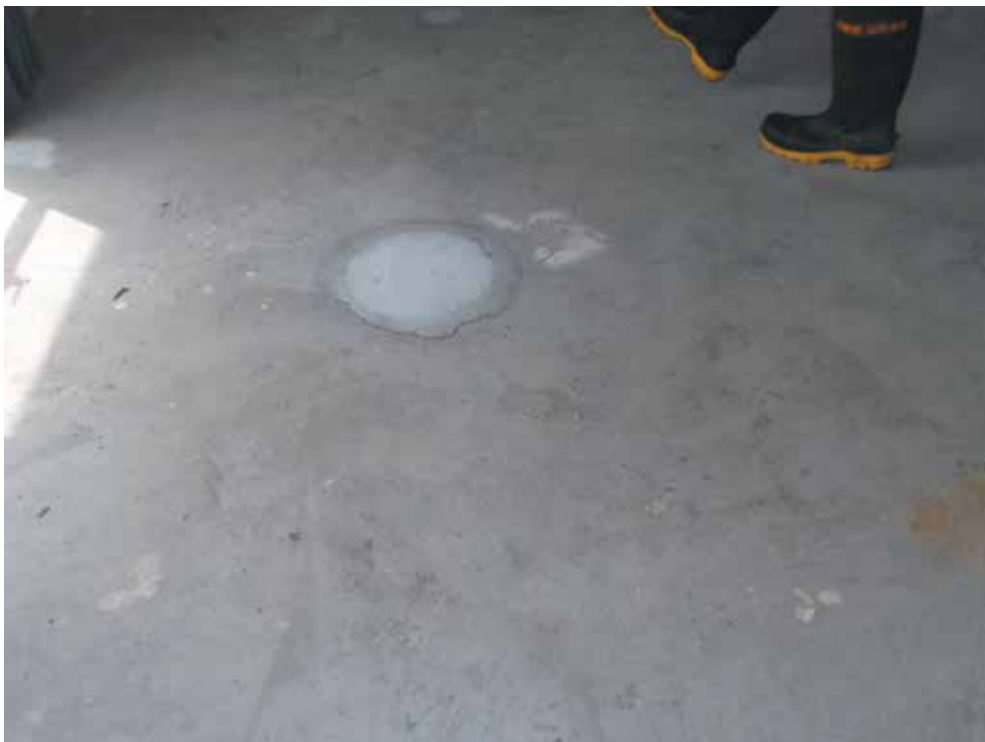
Image 10: DPM reinstated and concrete slab core holes sealed
