# Housing New Zealand

Technical Report on the Results of Foundation Repair Trials  
Conducted following the Canterbury Earthquakes

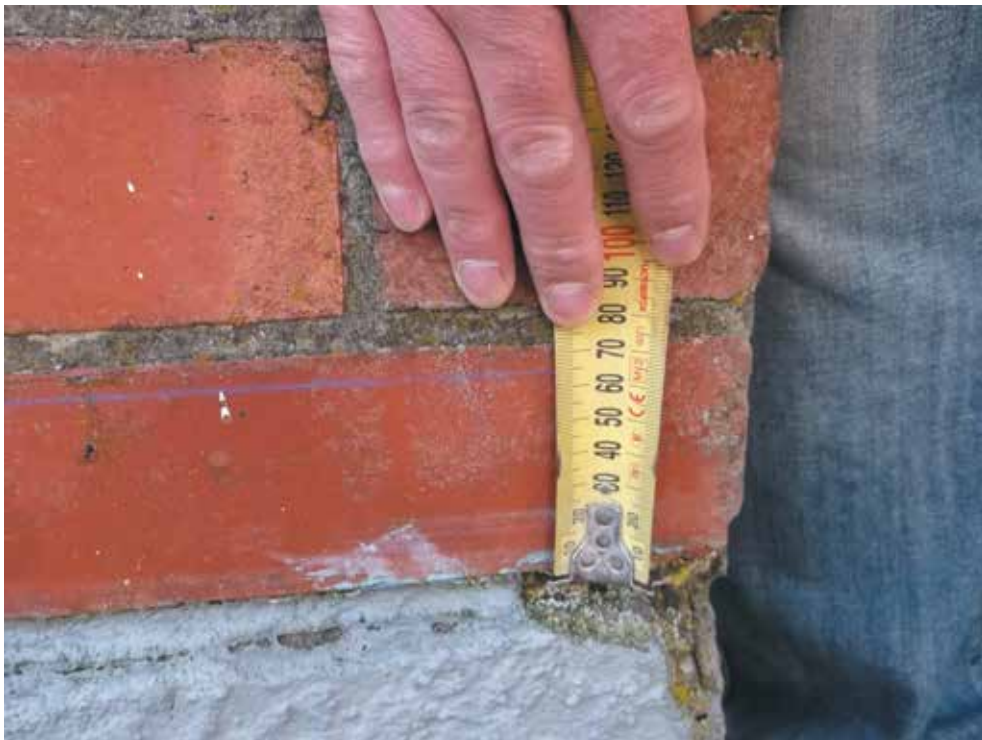
Image 1: 65mm vertical settlement at this corner

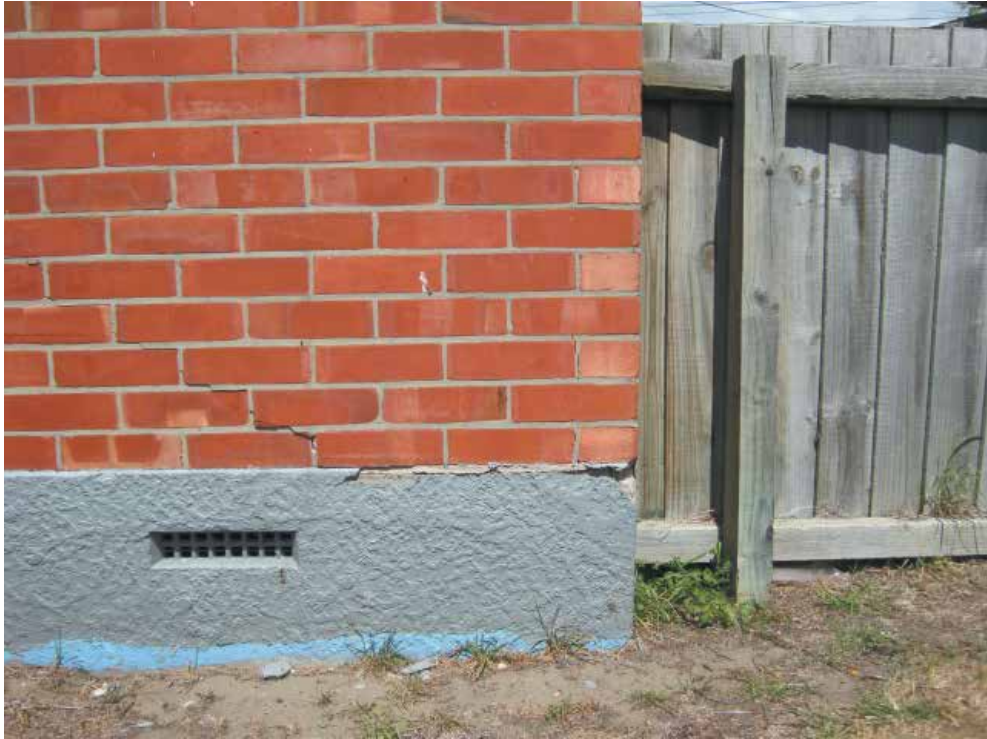
Image 3: Veneer damage and movement on foundation

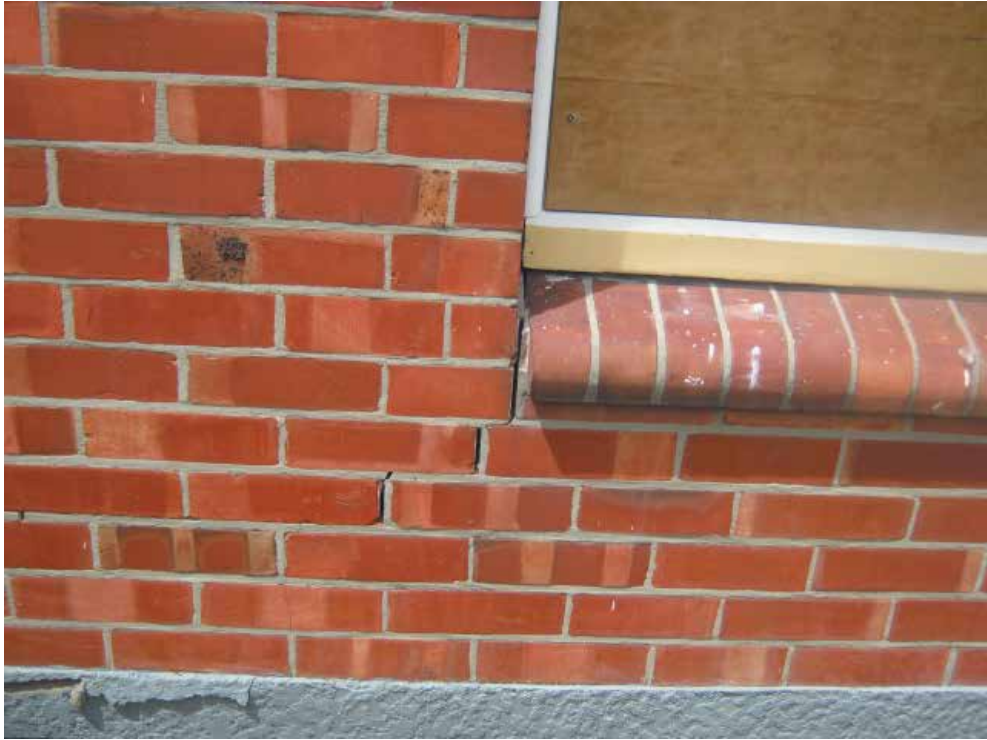
Image 4: Veneer damage

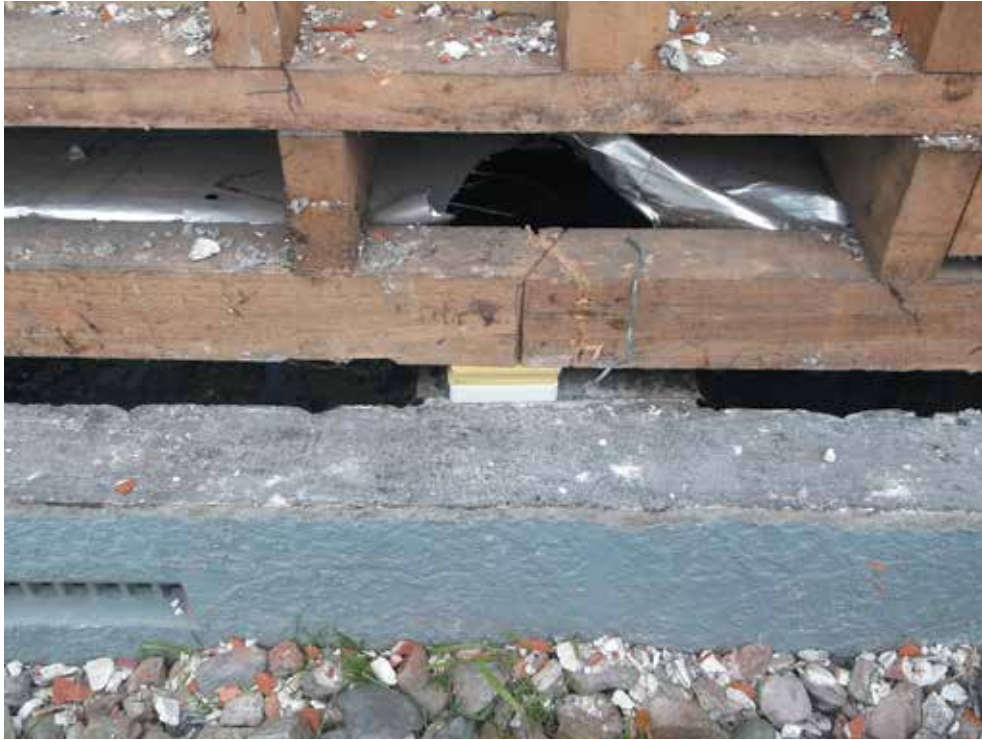
Image 5: New bearer packed for superstructure releveling (still to be wired down)

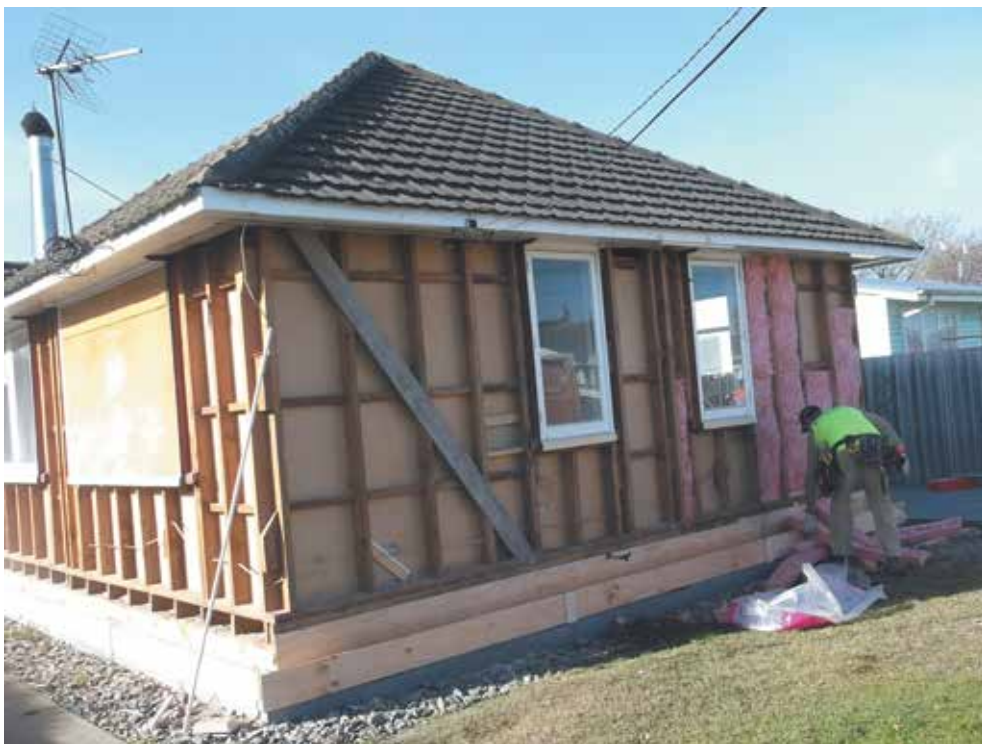
Image 6: Foundation formwork ready for topping. Insulation being installed

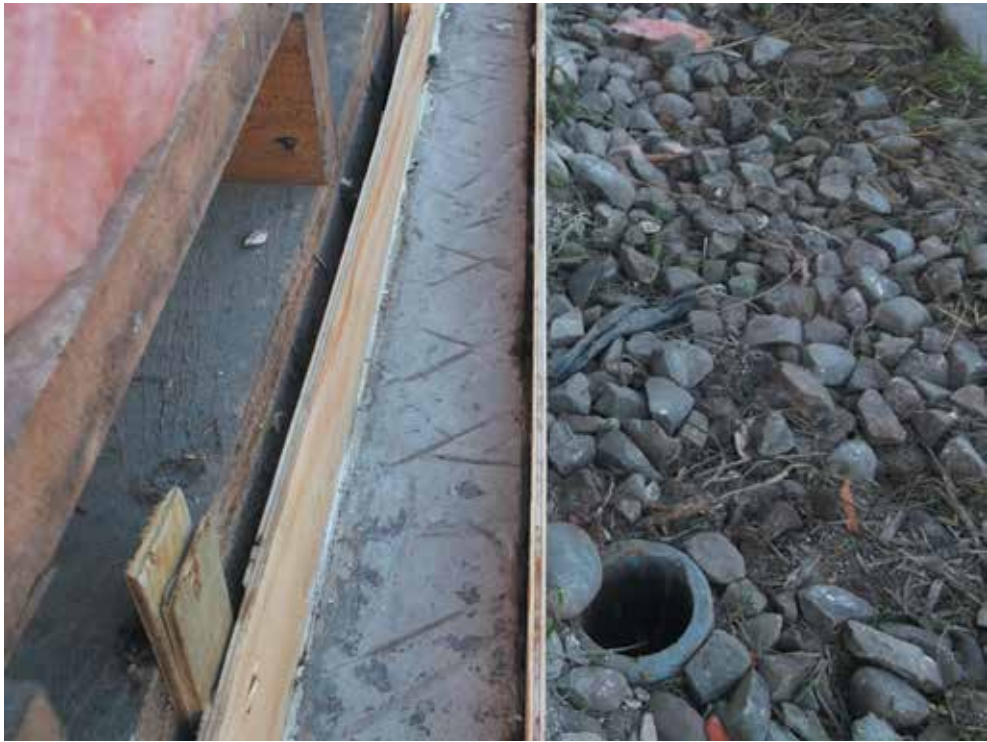
Image 7: Foundation scabbled and formwork ready for topping

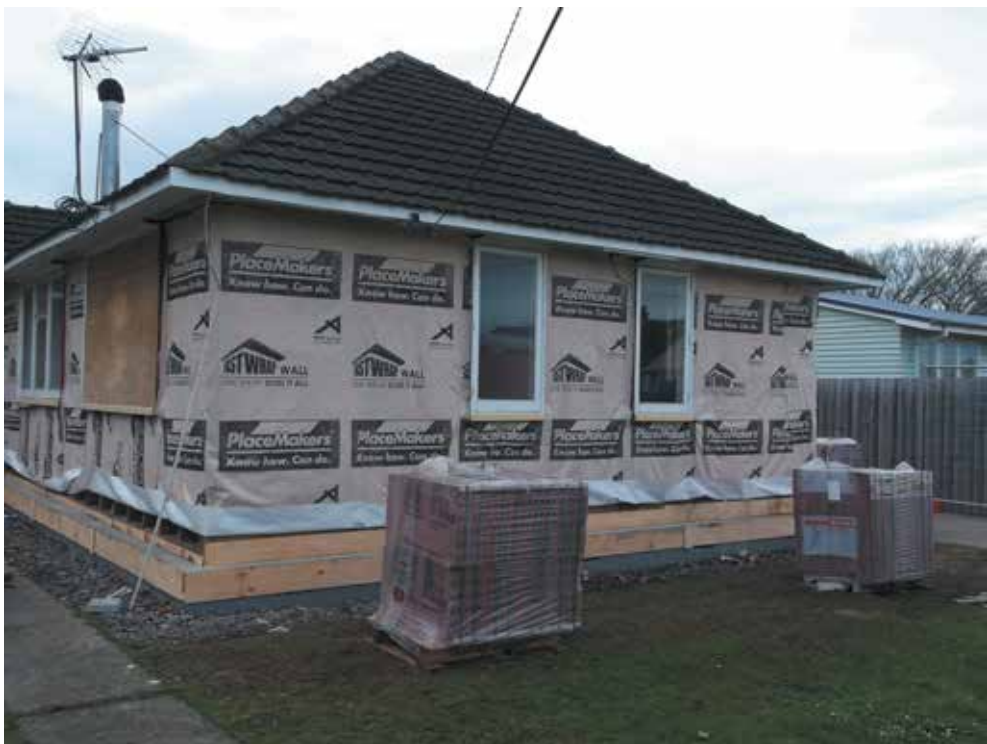
Image 8: Insulation and wrap in place

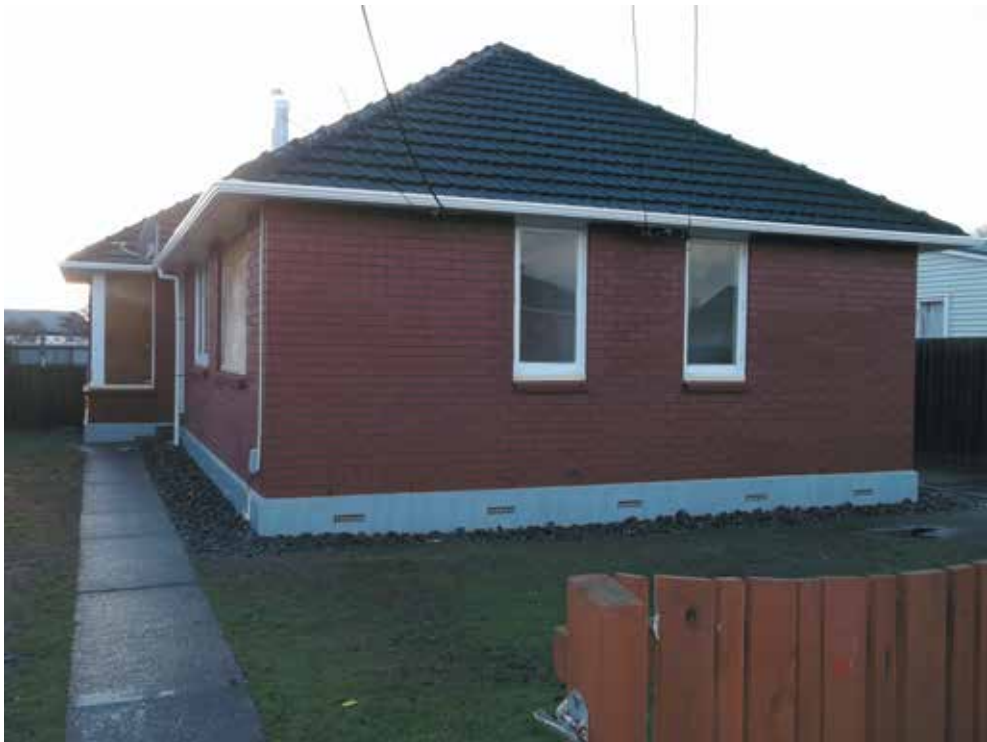
Image 10: Repairs complete. New veneer cladding with replastered foundation

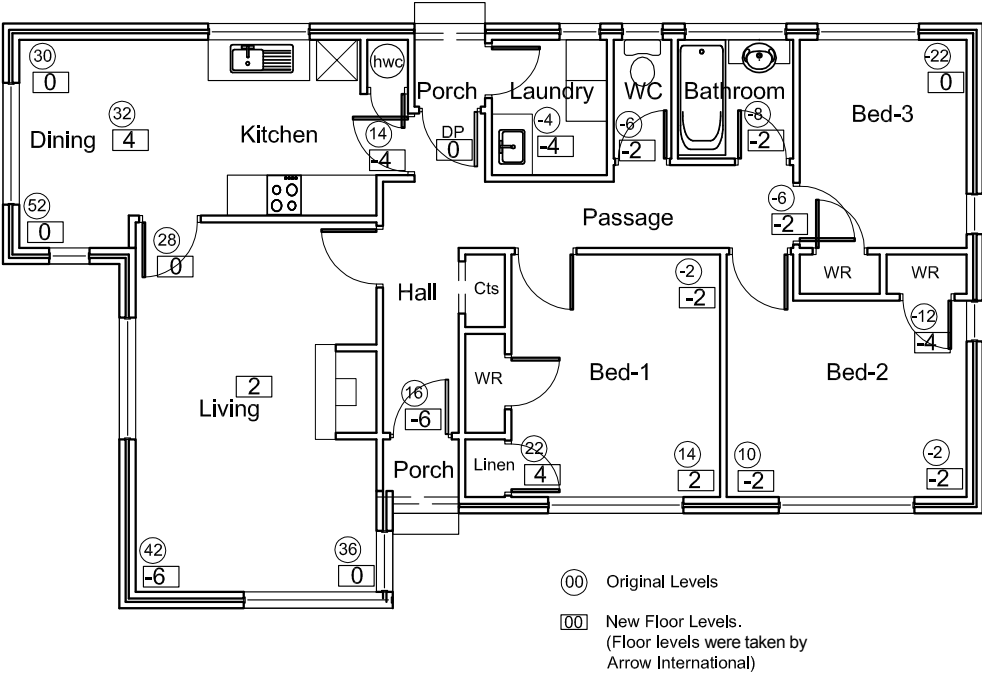
## 41 Aldershot Street, Aranui

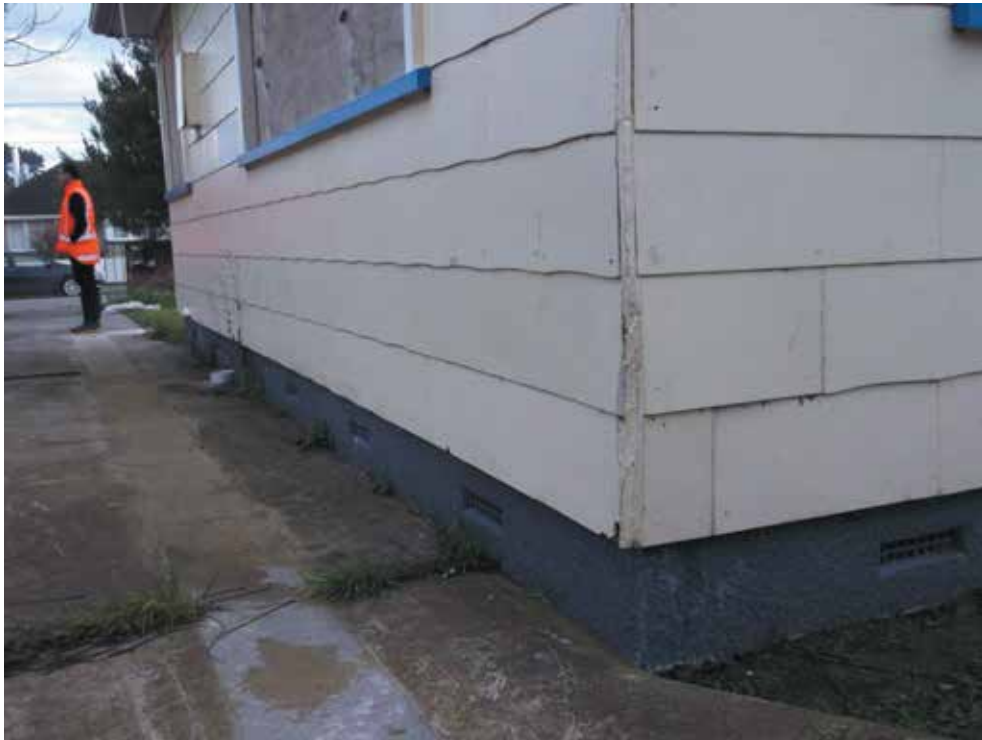
Image 1: No earthquake damage to exterior cladding

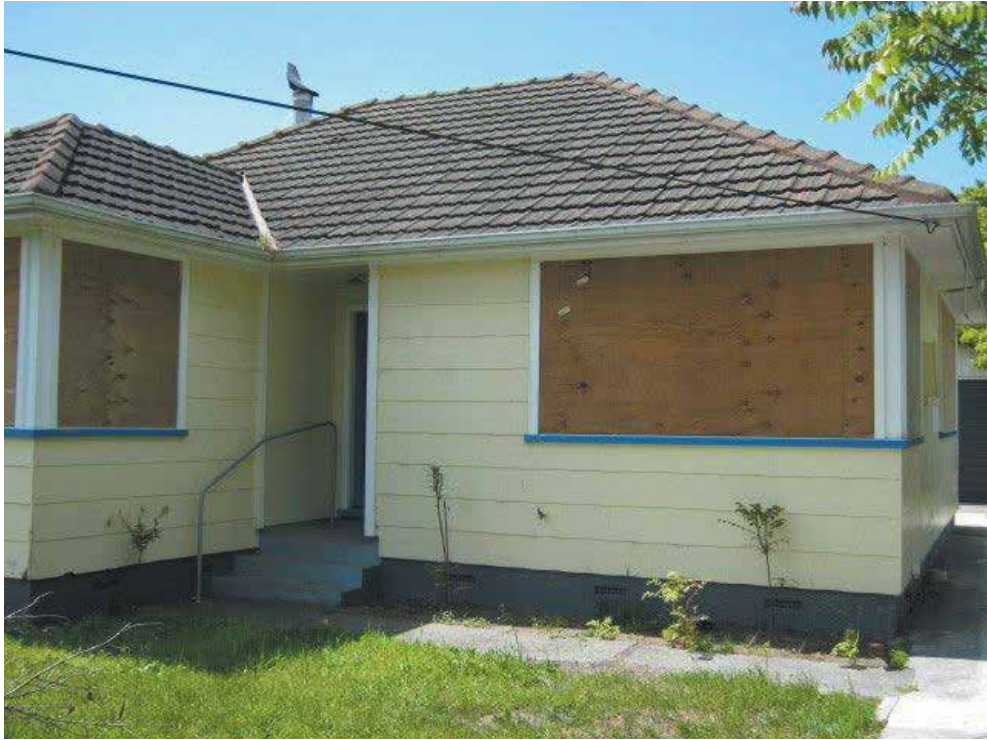
Image 2: No earthquake damage to exterior cladding

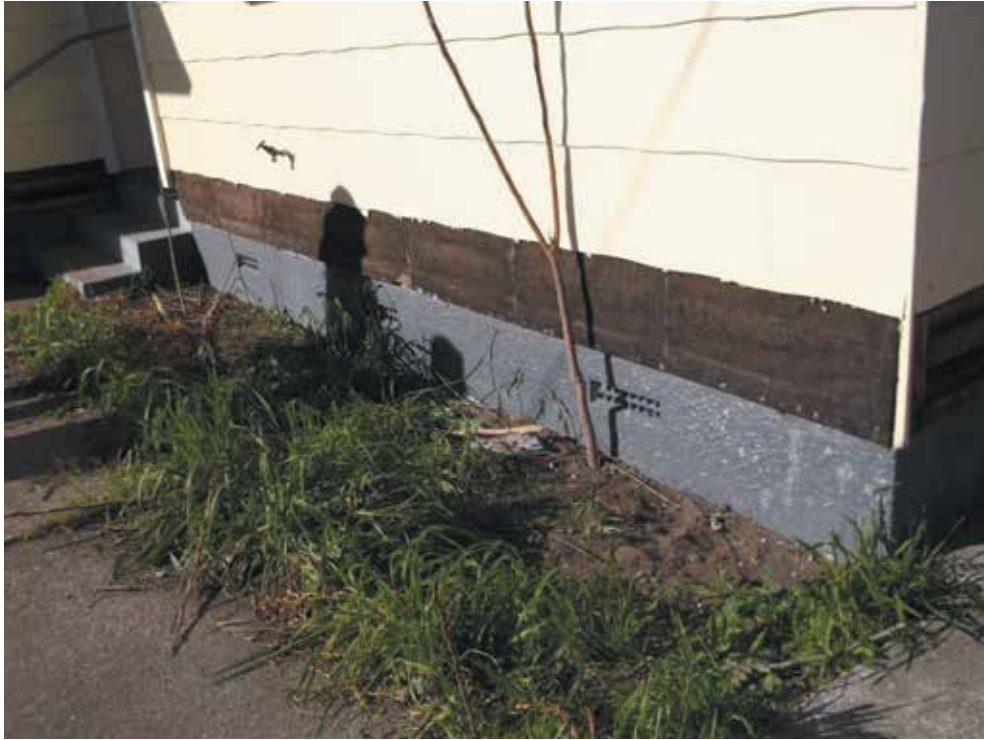
Image 4: Bottom row of weatherboards removed. Existing building wrap kept intact where possible

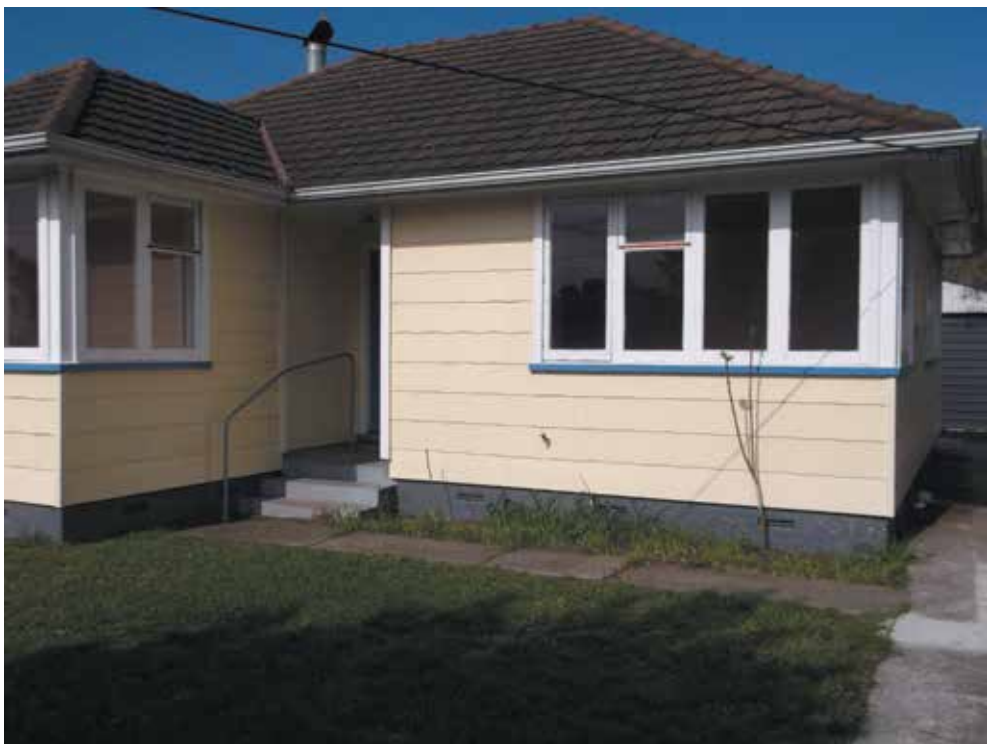
Image 7: Fibre cement sheet replaced bottom row of asbestos weathersiding

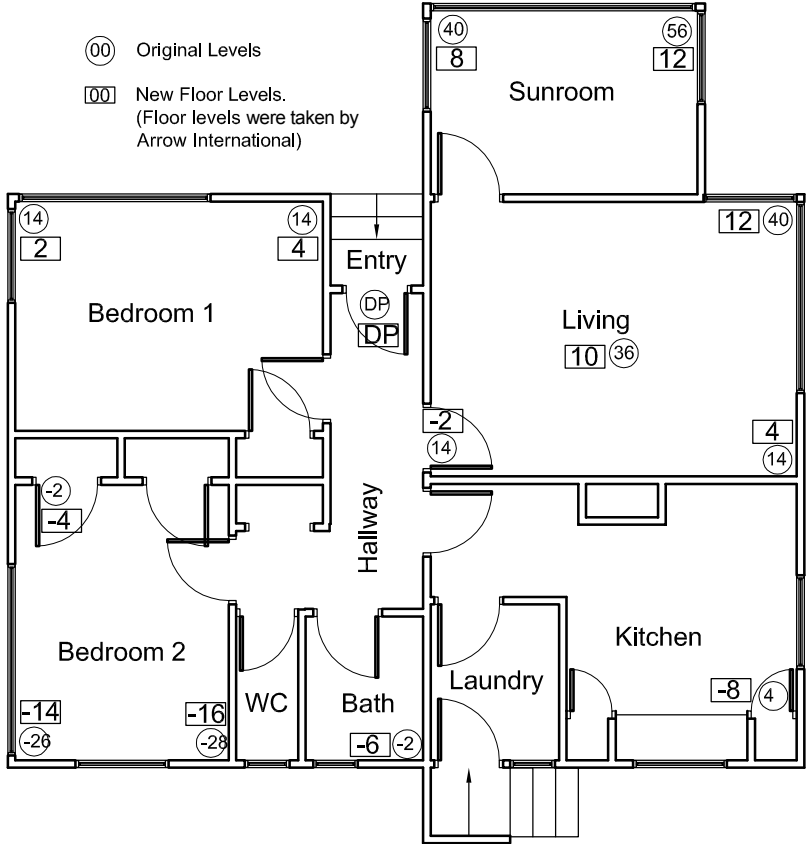
## 6 Aldershot Street, Aranui

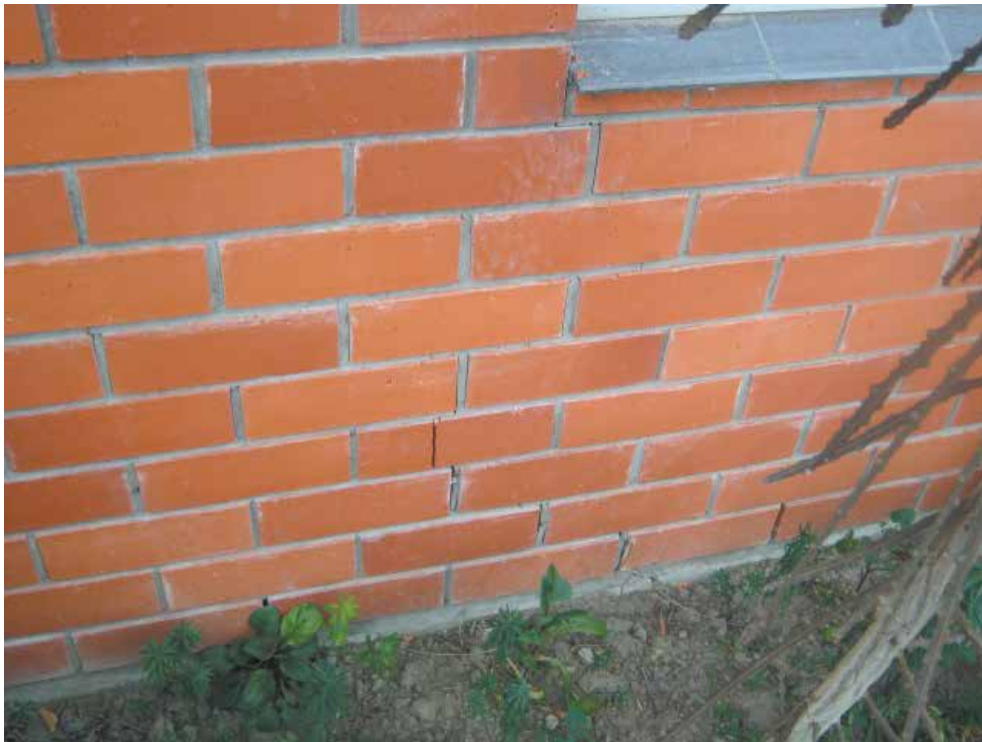
Image 1: Minor veneer damage, step cracking

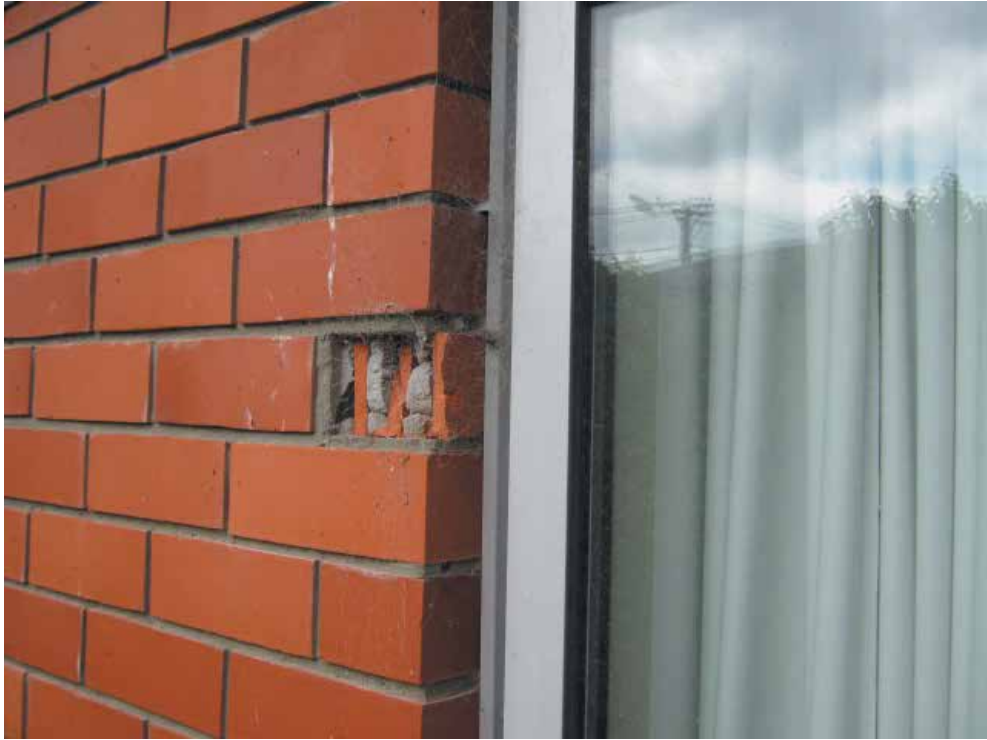
Image 2: Loose bricks, lost connection with brick ties

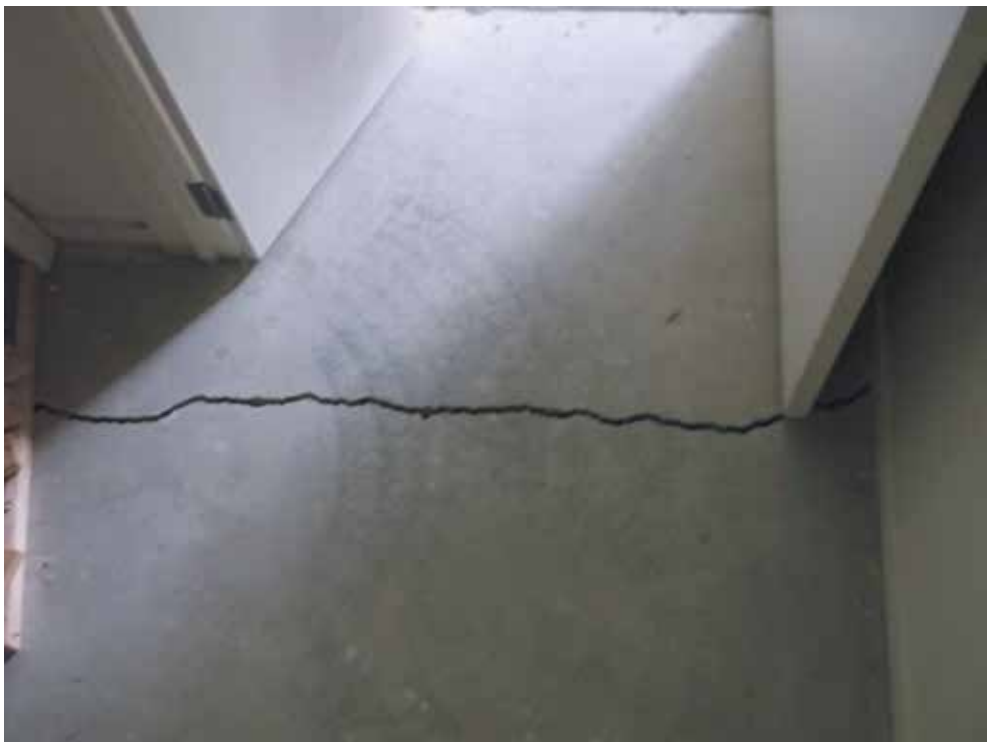
Image 3: Moderate slab crack of 8-15mm through width of floor

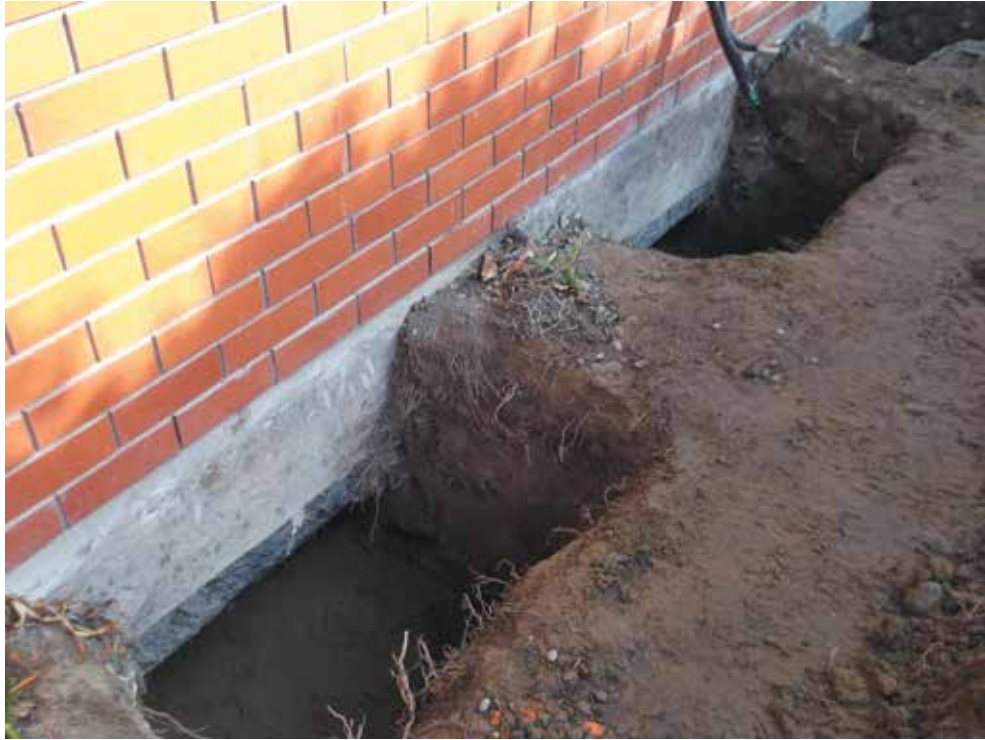
Image 4: Jacking points excavated as per engineer's design

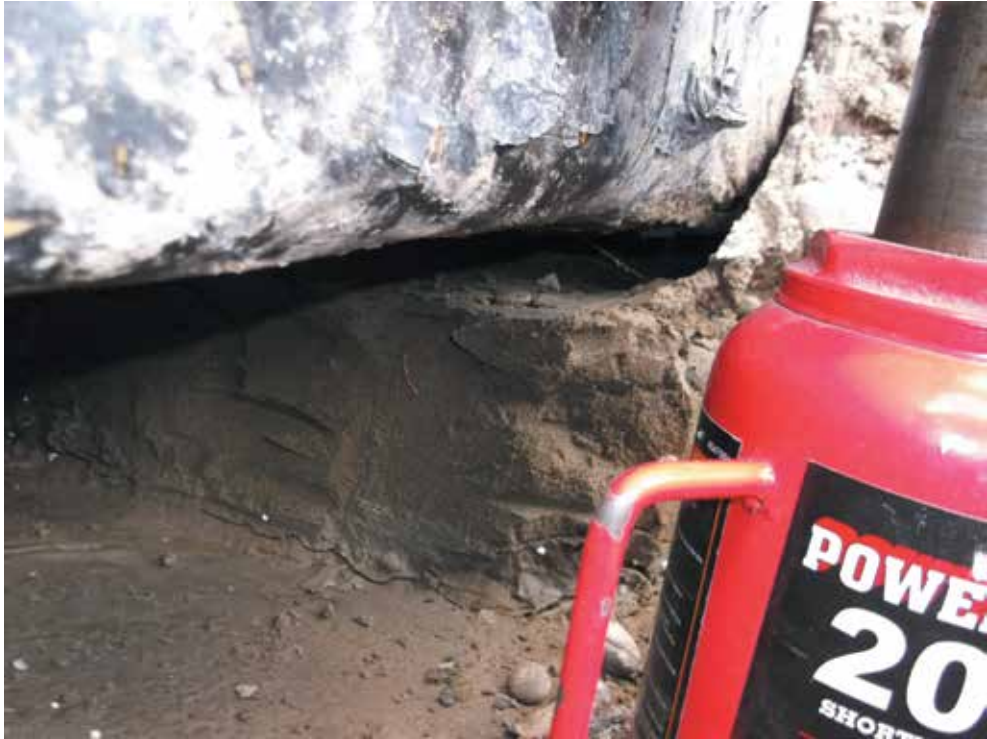
Image 7: Exterior foundation jacked to required level

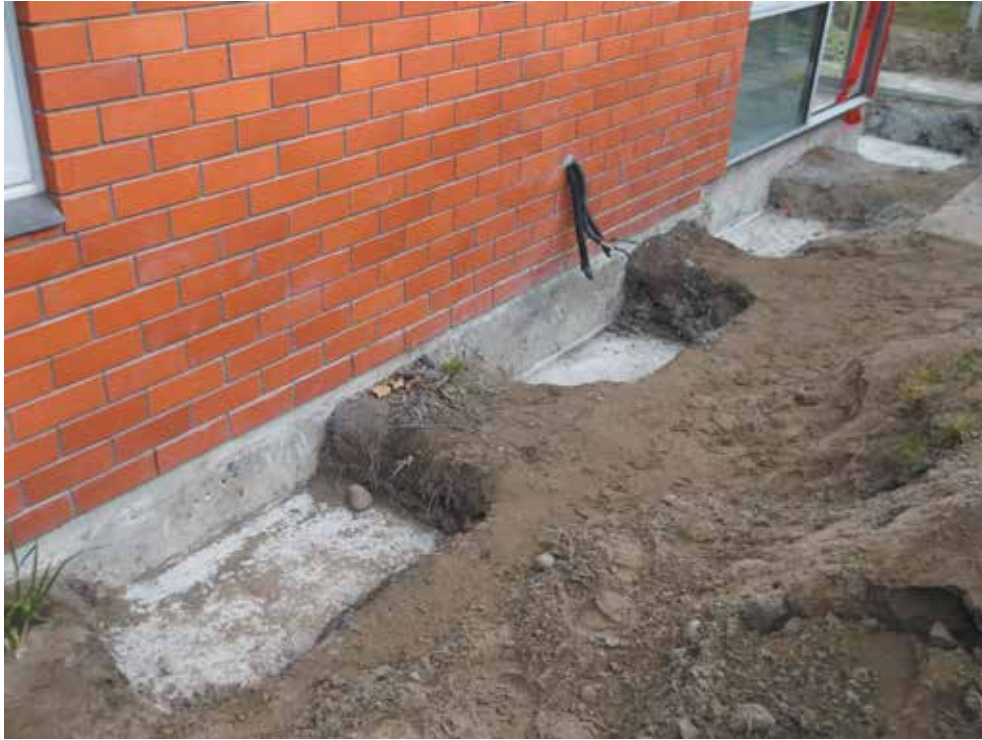
Image 8: Void filled under footing

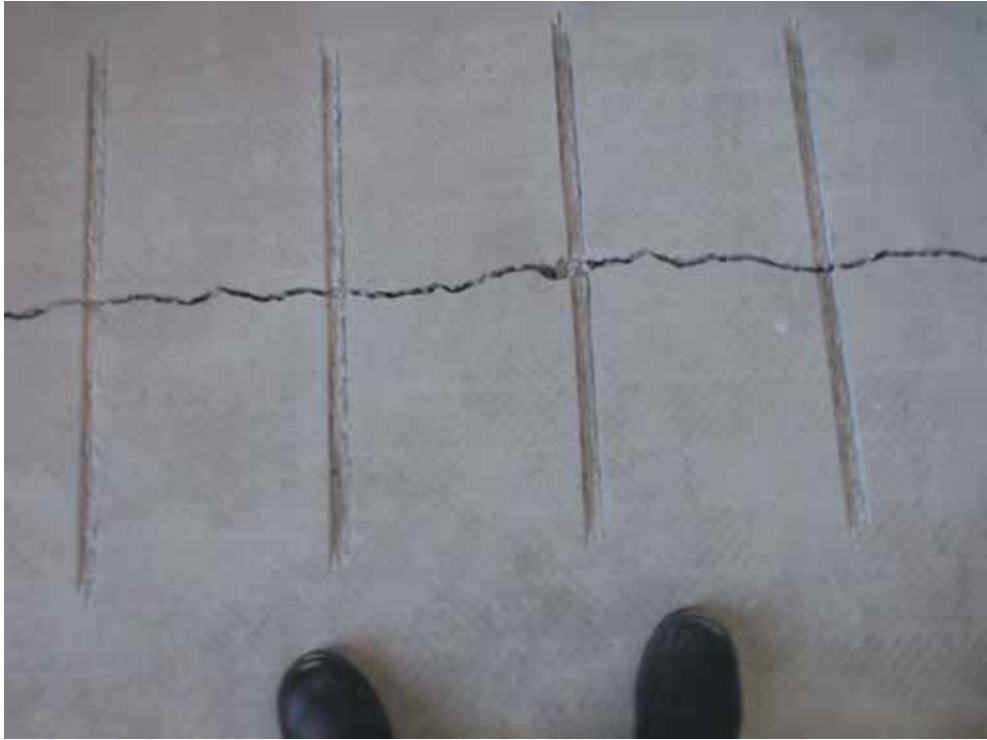
Image 10: Channels cut into slab perpendicular to crack

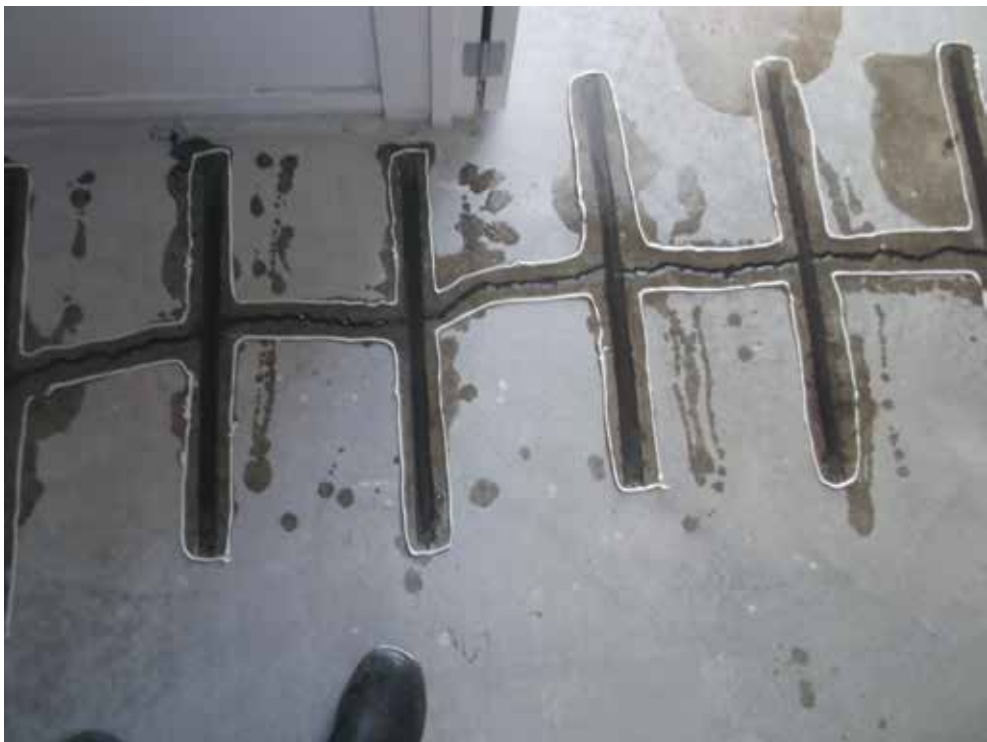
Image 11: Reinforcing bars inserted and epoxy compound put in place (see Figure 1)

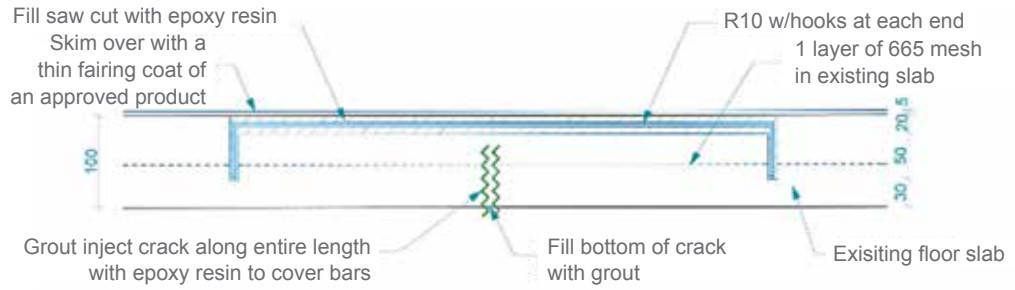
## Floor Plan Showing Floor Levels

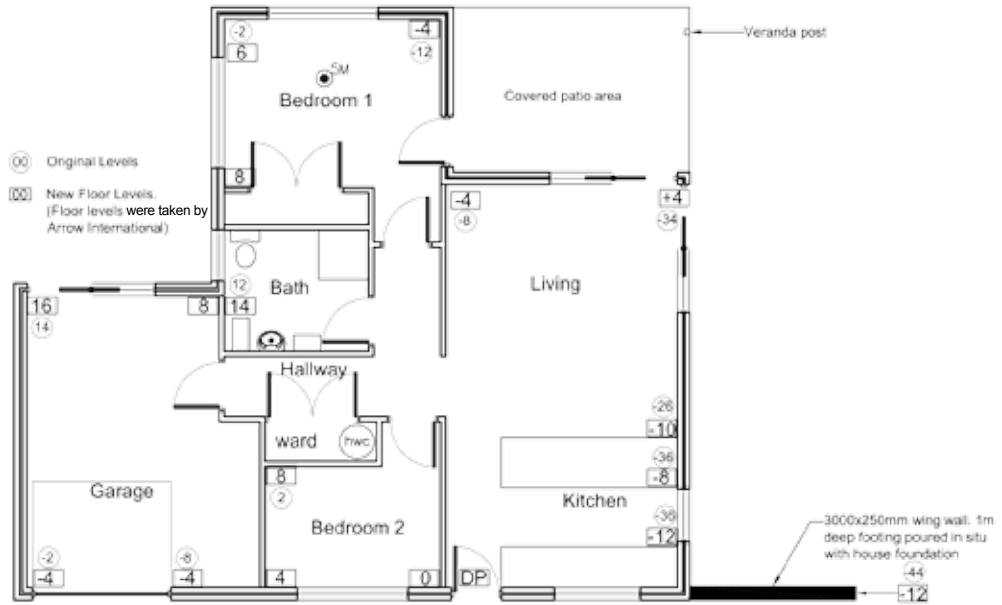
## Crack In Slab and Relevelled Area

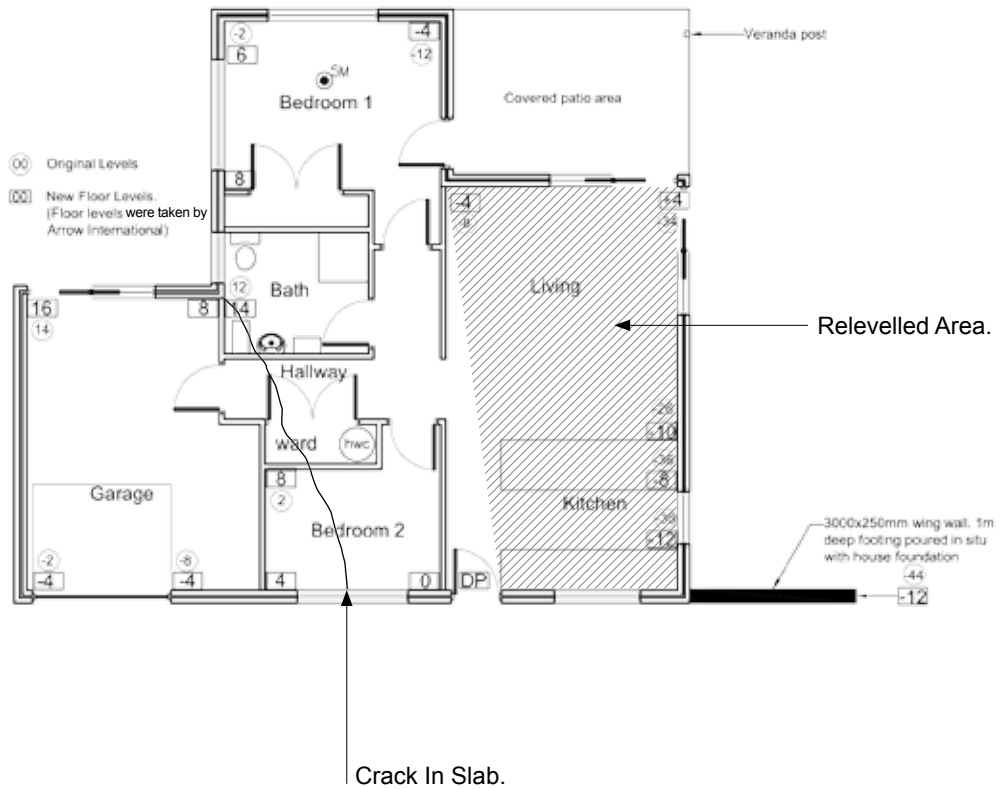
## 53 Eureka Street, Aranui

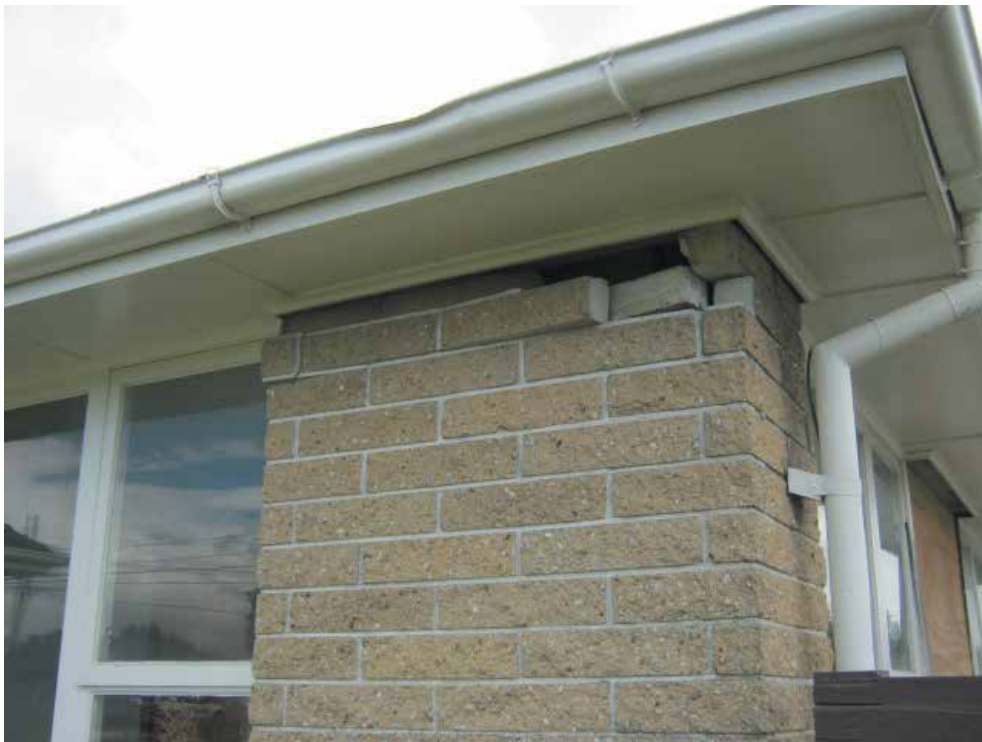
Image 1: Damage to brick veneer at soffit

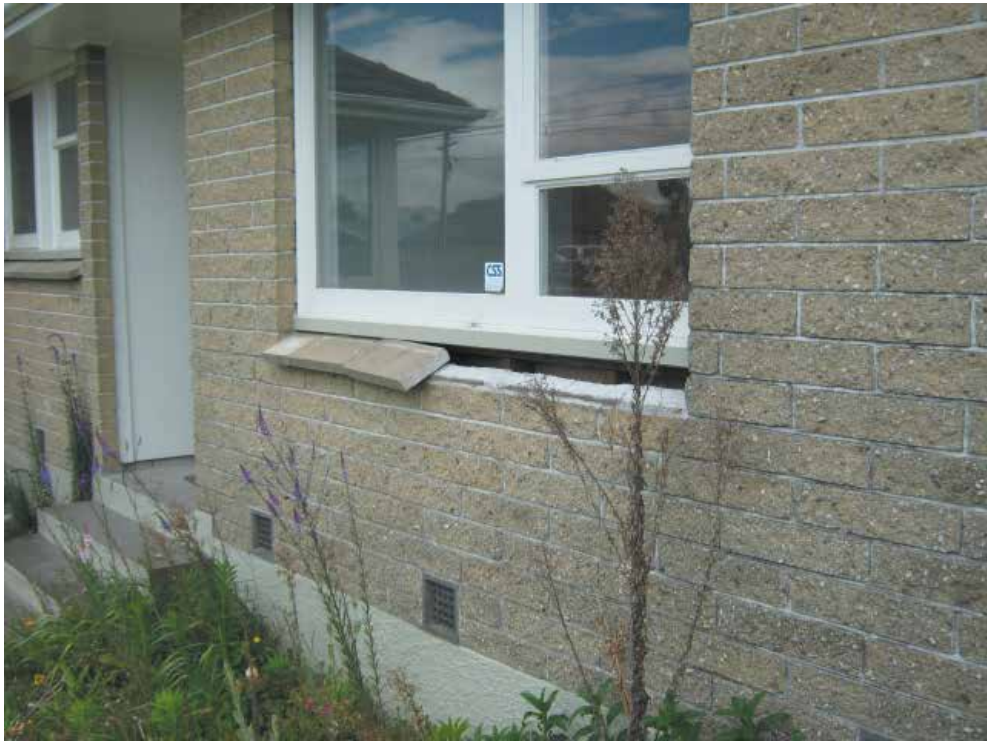
Image 2: Damage to brick veneer at windows

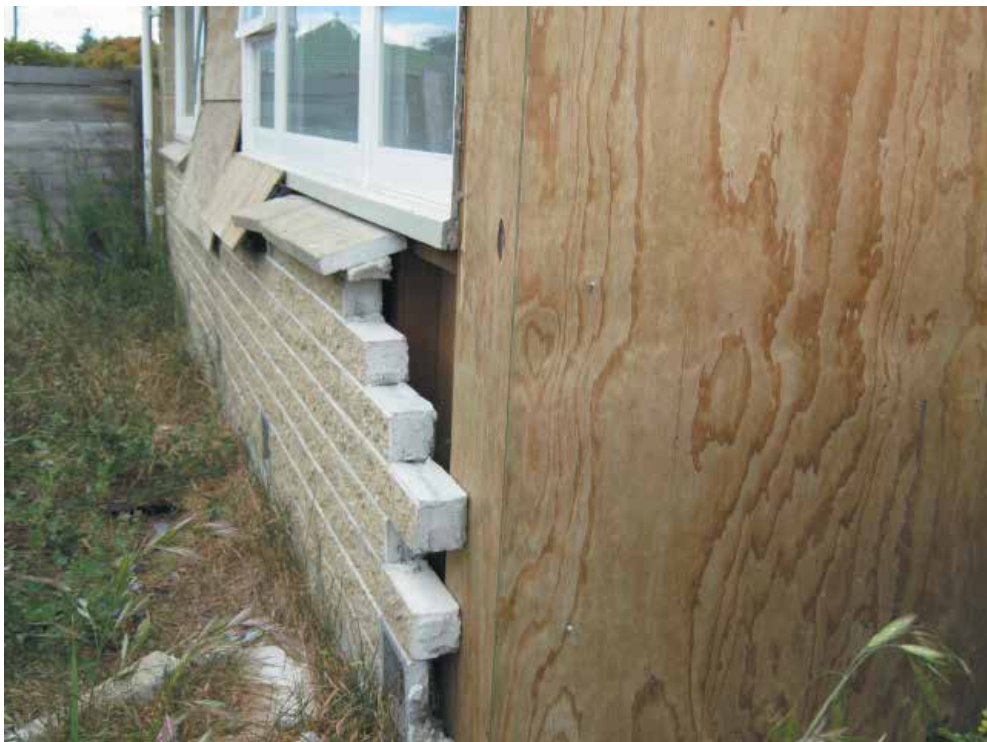
Image 3: Masonry veneer separated from structure

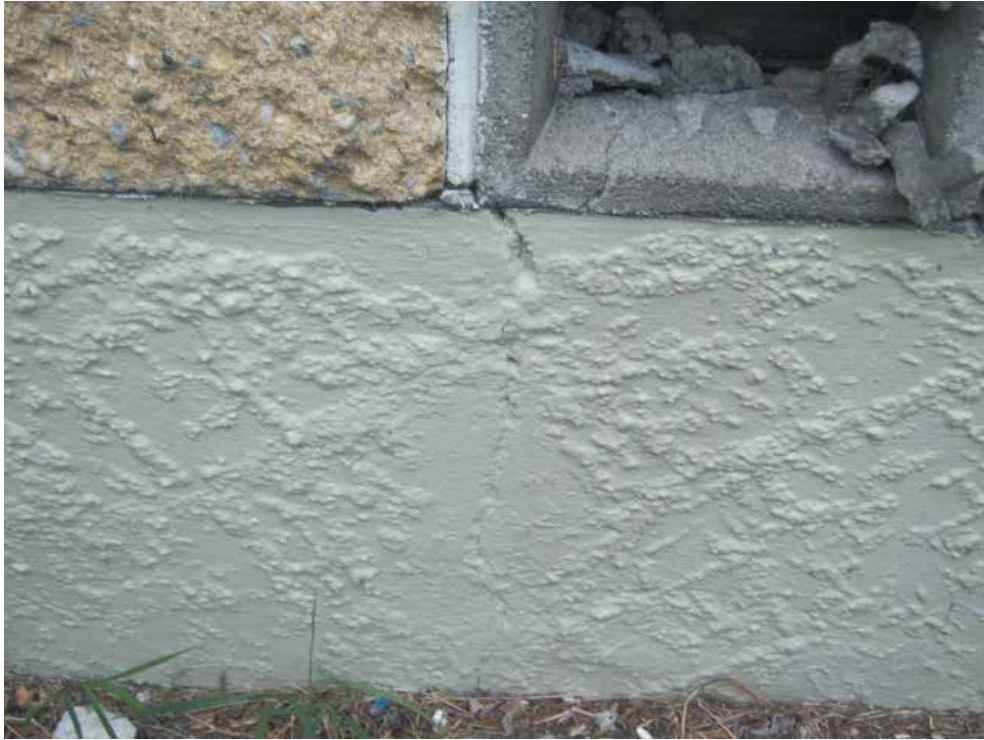
Image 4: Pre-existing foundation crack that appeared to have been repaired before the earthquakes

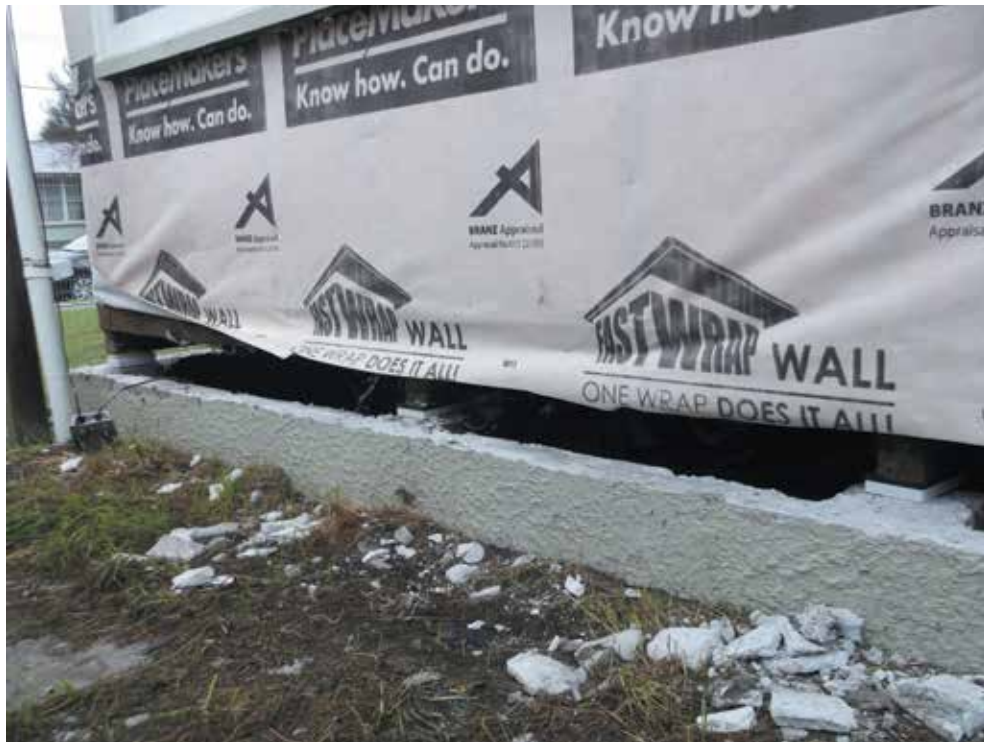
Image 5: Cladding removed, new insulation and wrap installed. Bearers packed

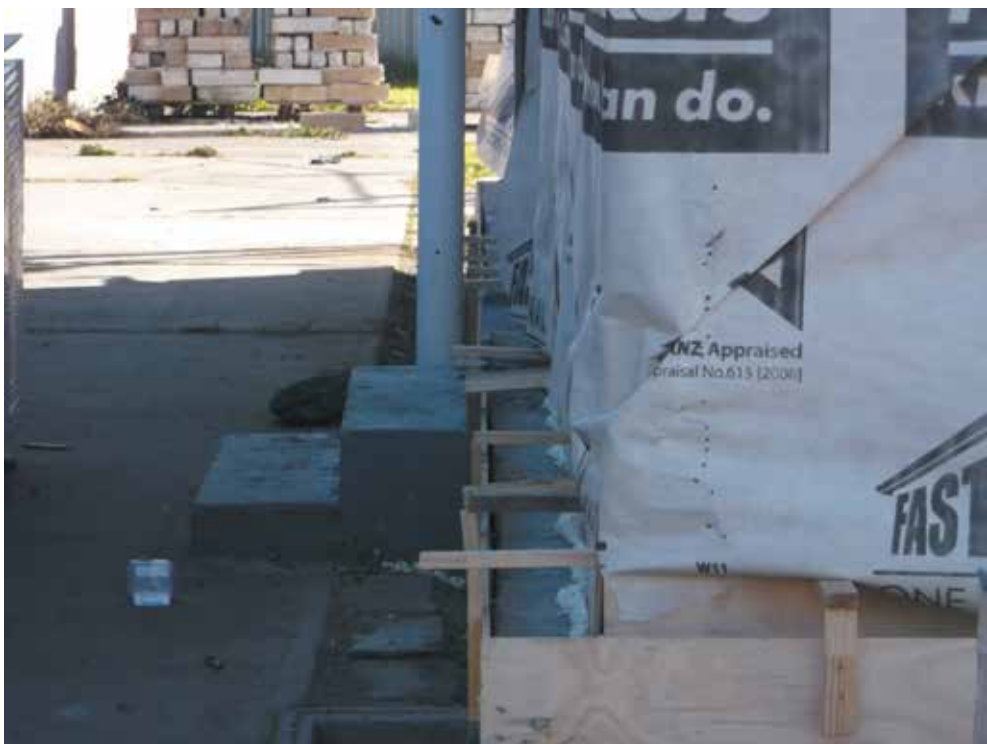
Image 8: Foundation formwork in place

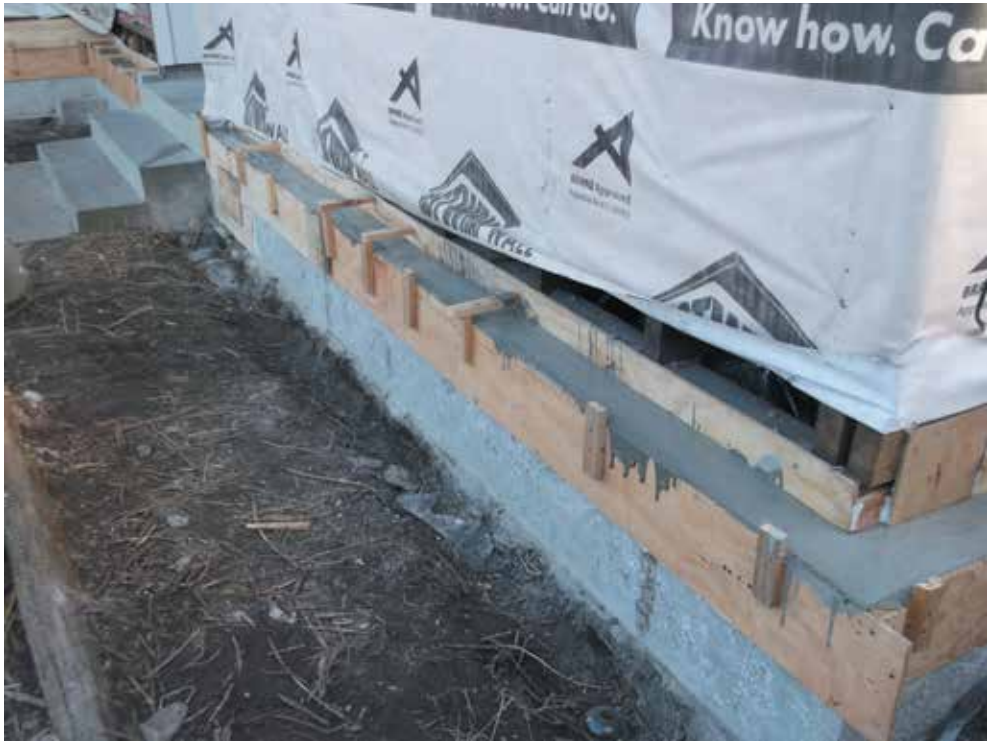
Image 9: Cementitious grout poured into formwork that was preset to correct level
