# Housing New Zealand

Technical Report on the Results of Foundation Repair Trials  
Conducted following the Canterbury Earthquakes

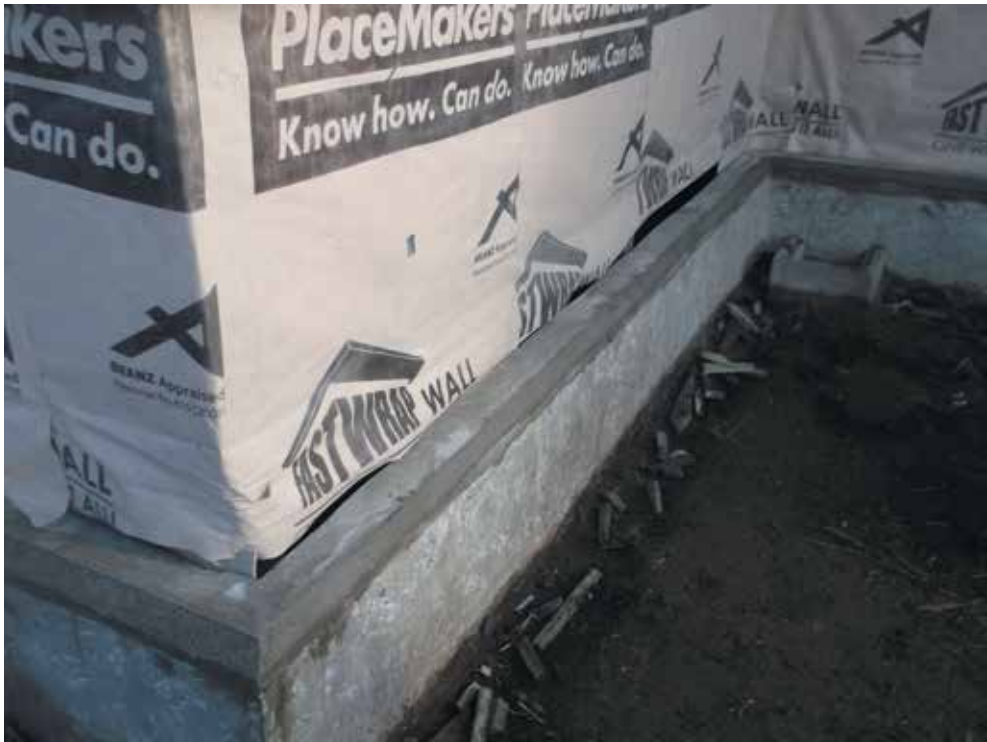
Image 10: Chamfer ground on top of foundation

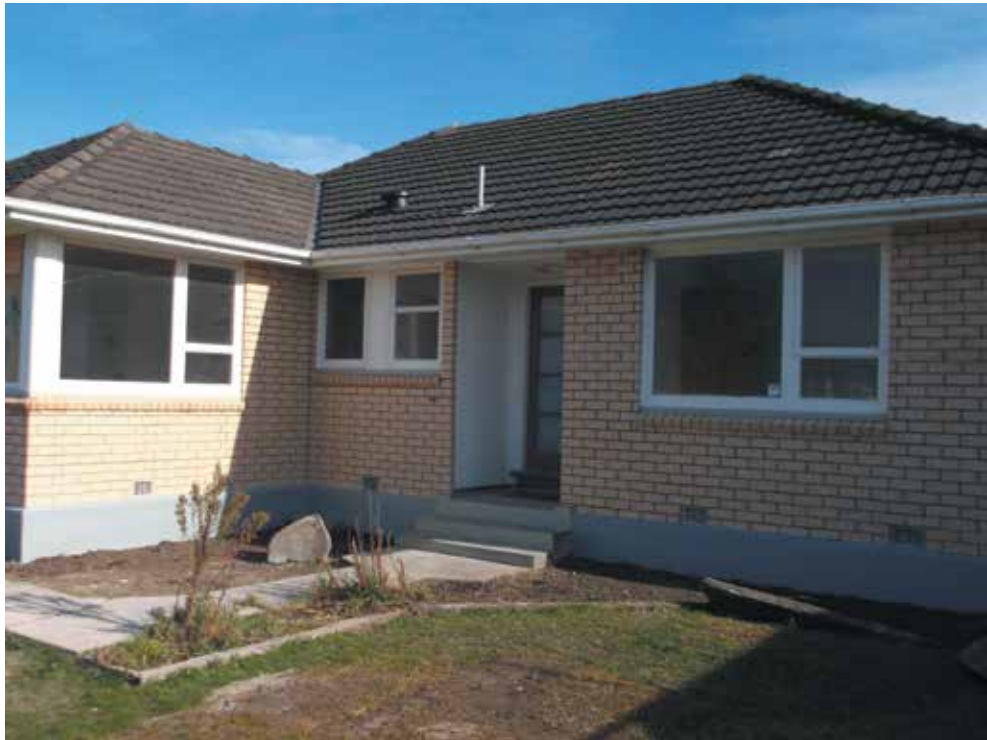
Image 11: Reclad with lighter weight brick veneer

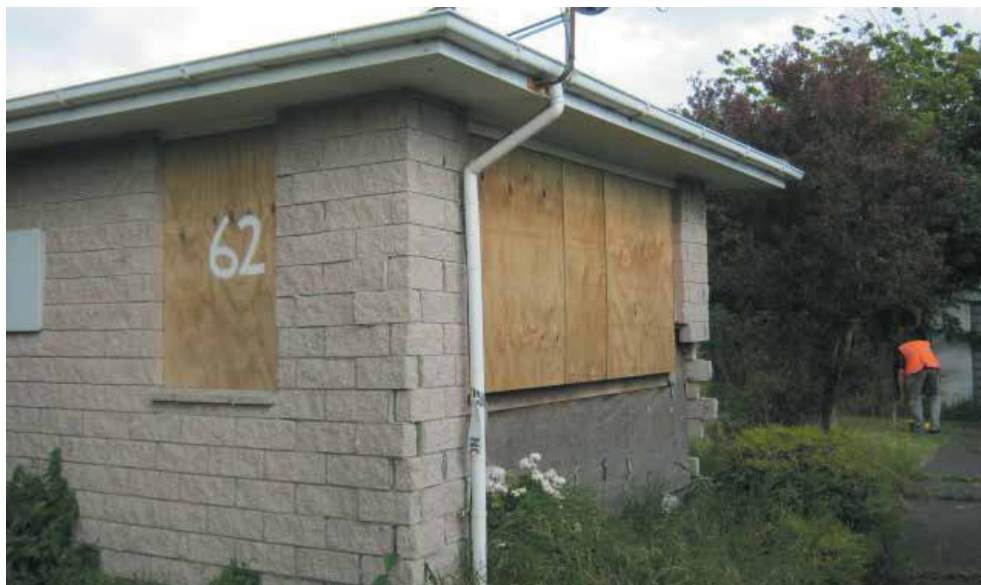
### Property Details

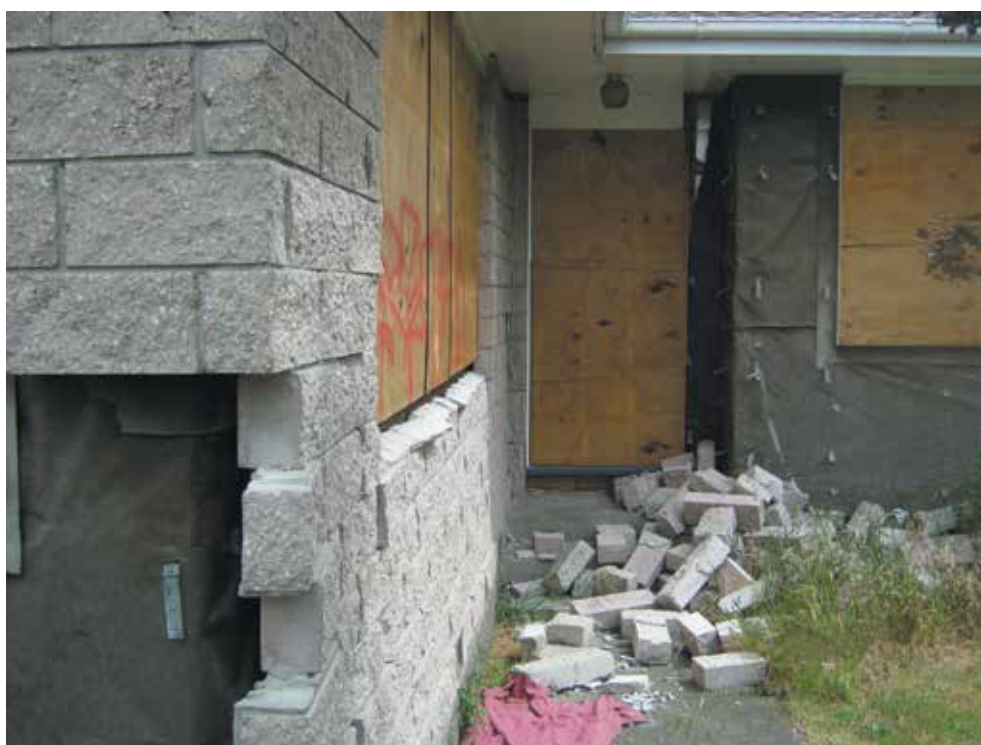
Image 1: Major veneer damage

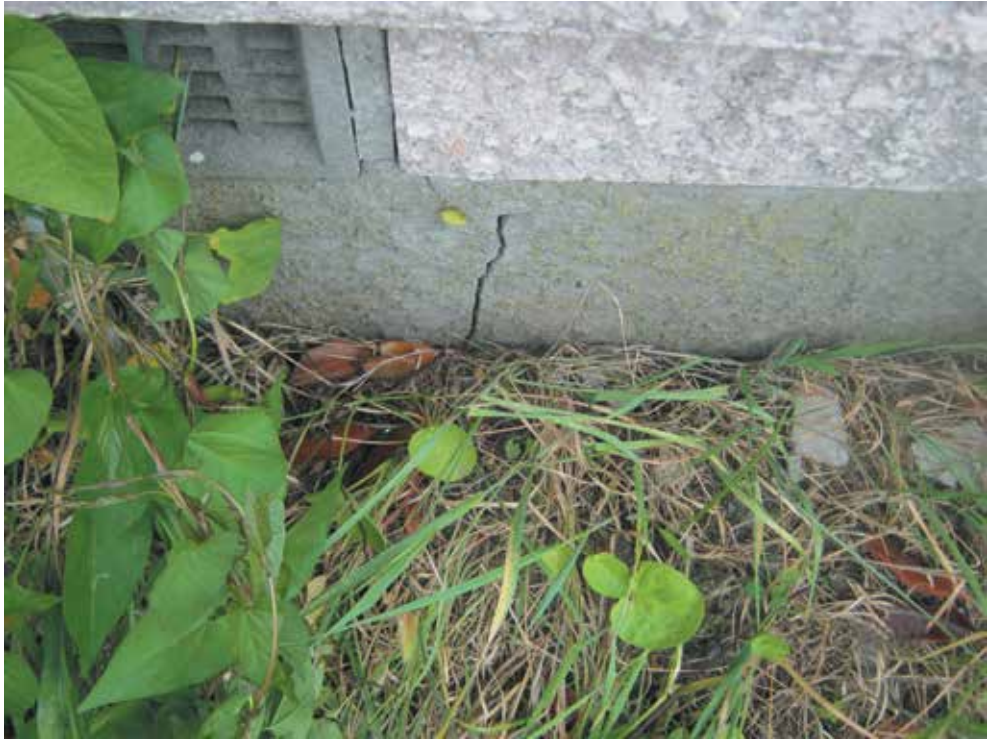
Image 2: Cracked foundation

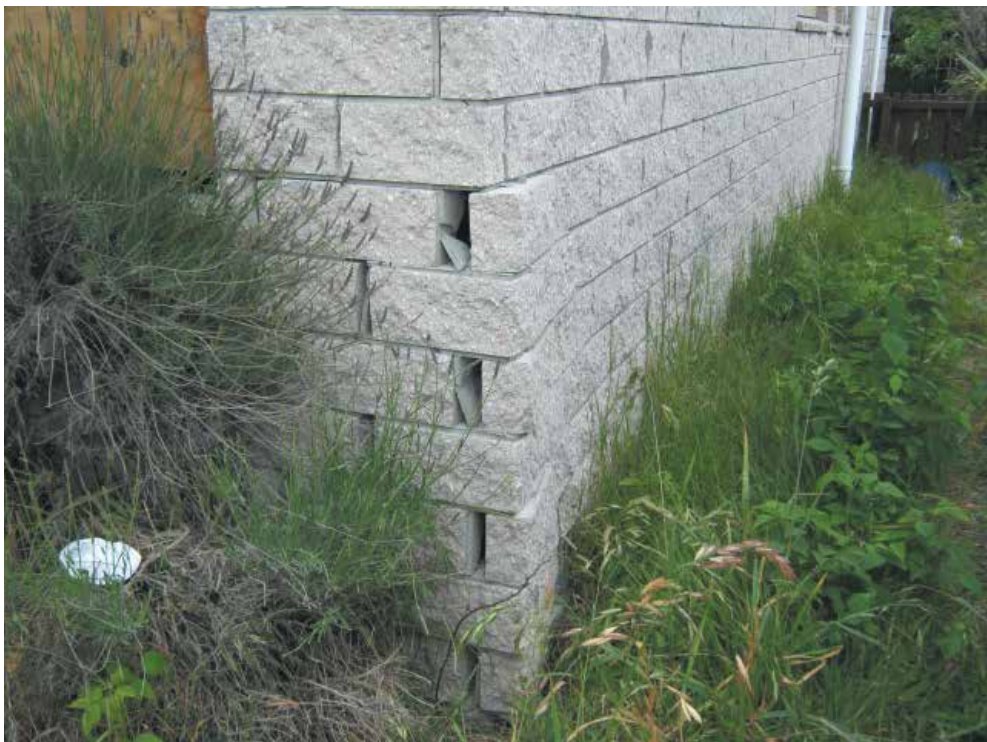
Image 3: Bricks dislodged, failed connection to framing

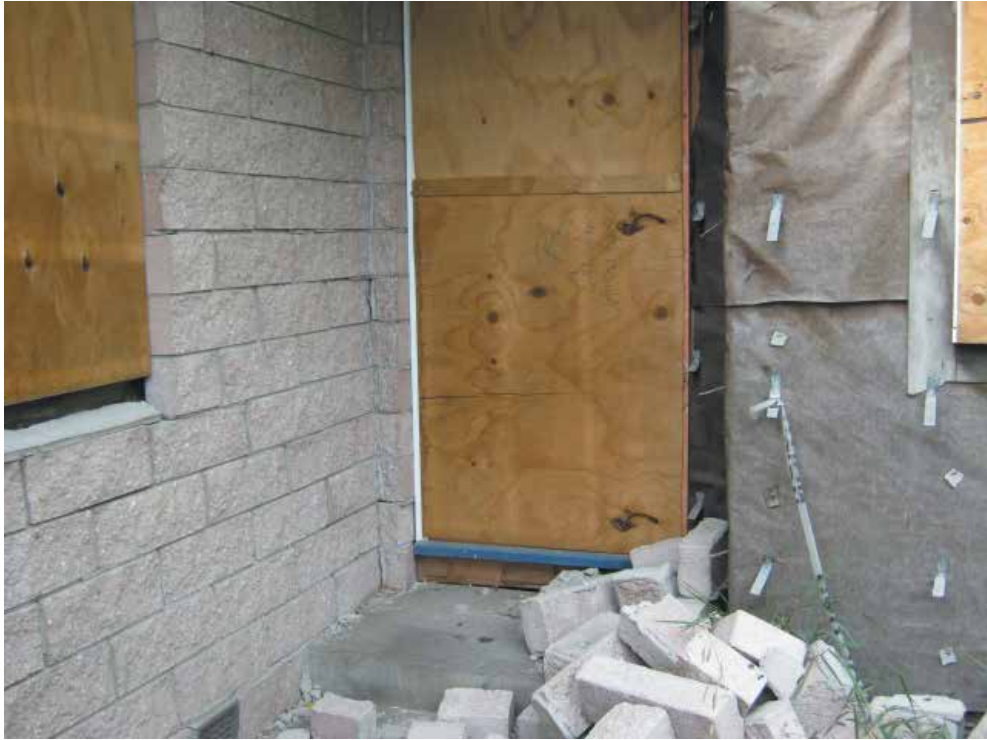
Image 4: Failed brick ties

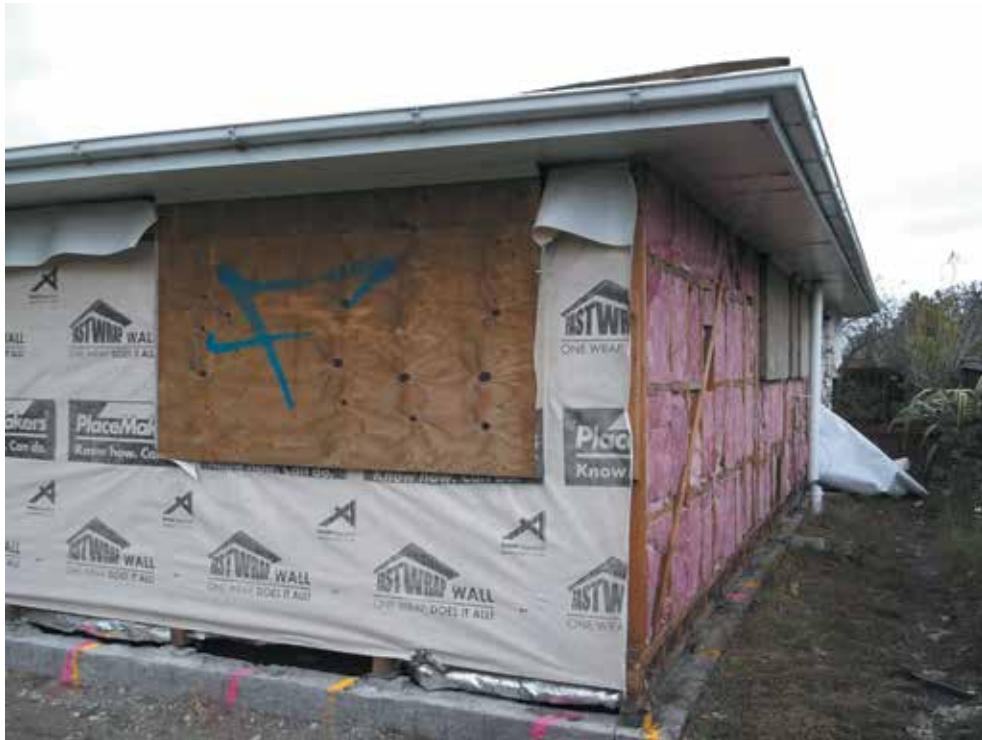
Image 5: Opportunity taken to insulate and wrap

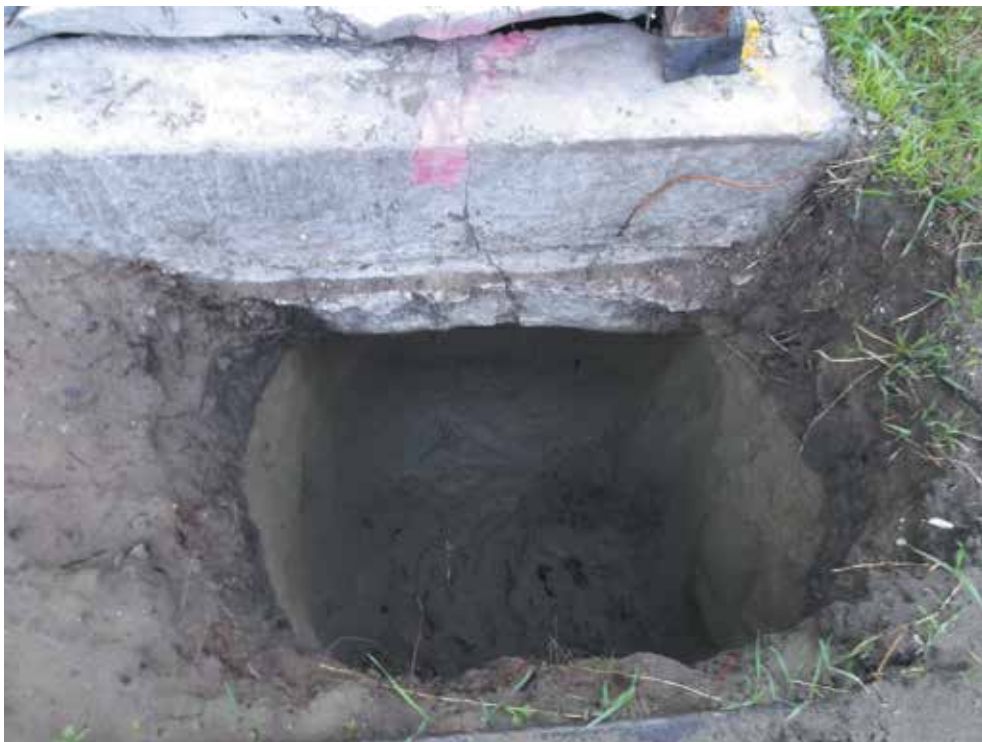
Image 6: Jacking points excavated under foundation cracks as specified by engineer

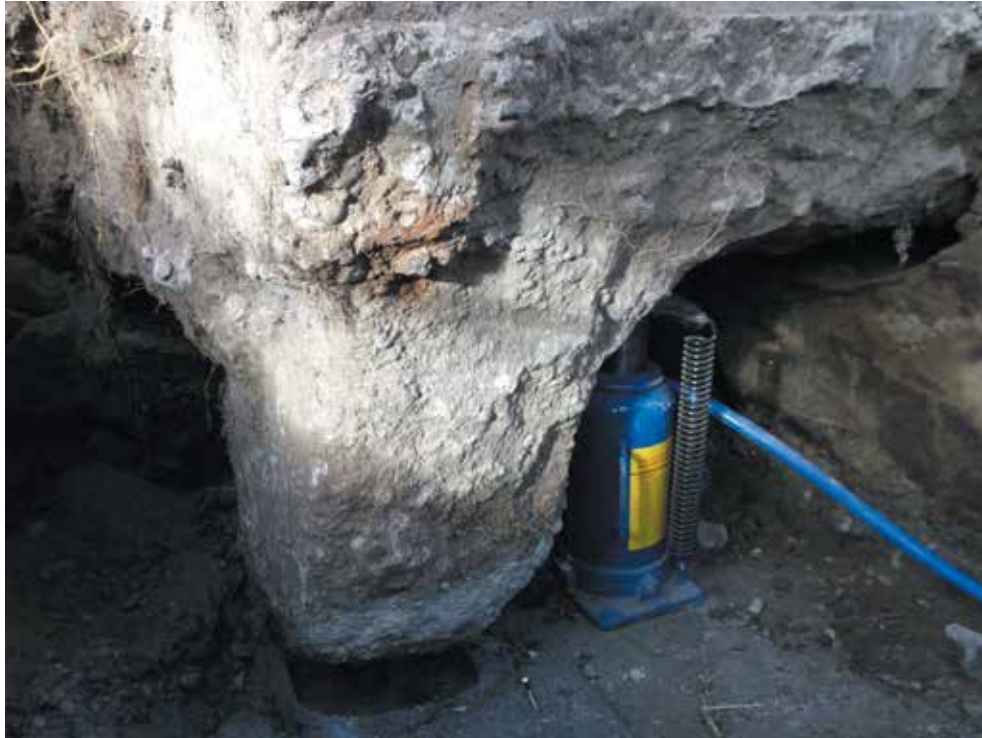
Image 7: Jacks in place. All points of foundation lifted simultaneously

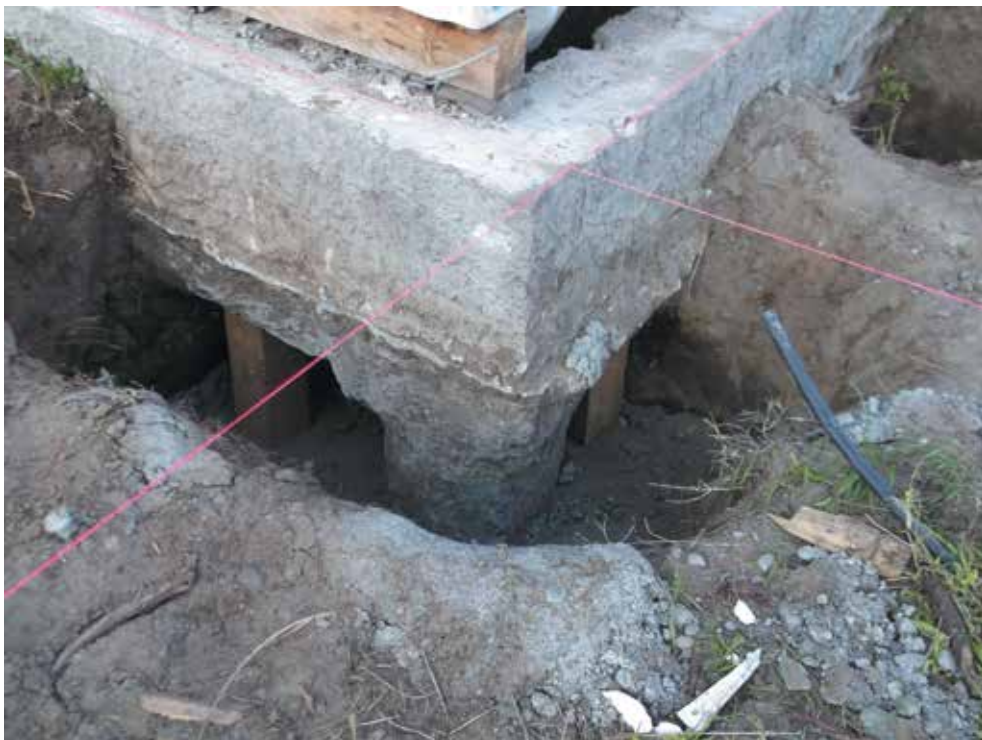
Image 8: H5 timber packers installed before jacks removed

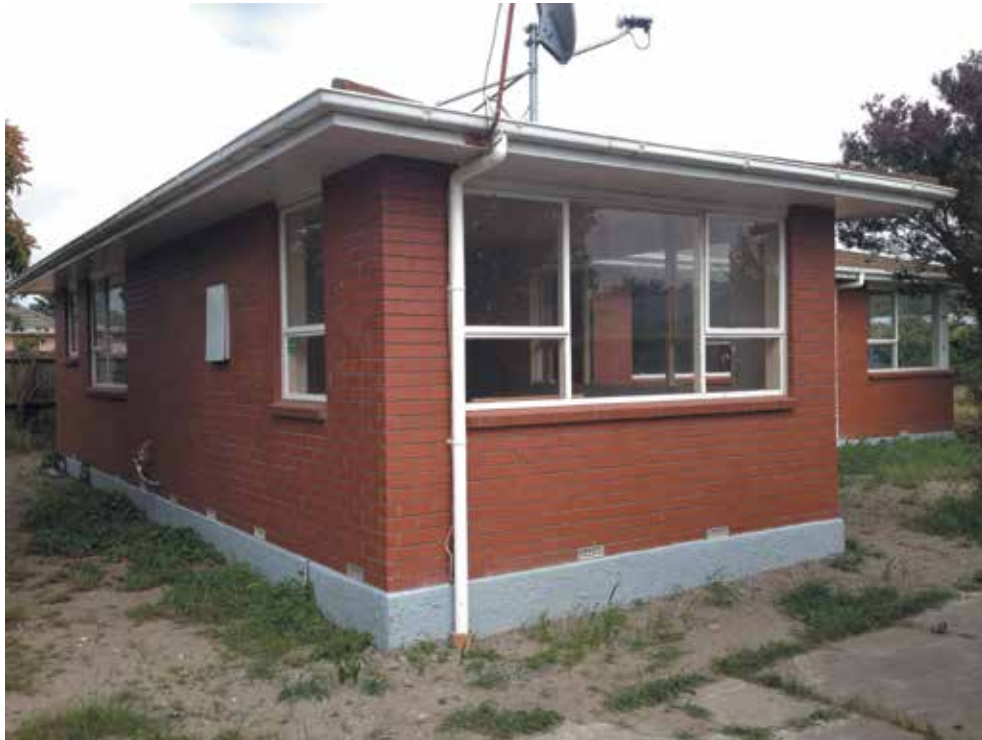
Image 11: Foundaton repaired and house reclad

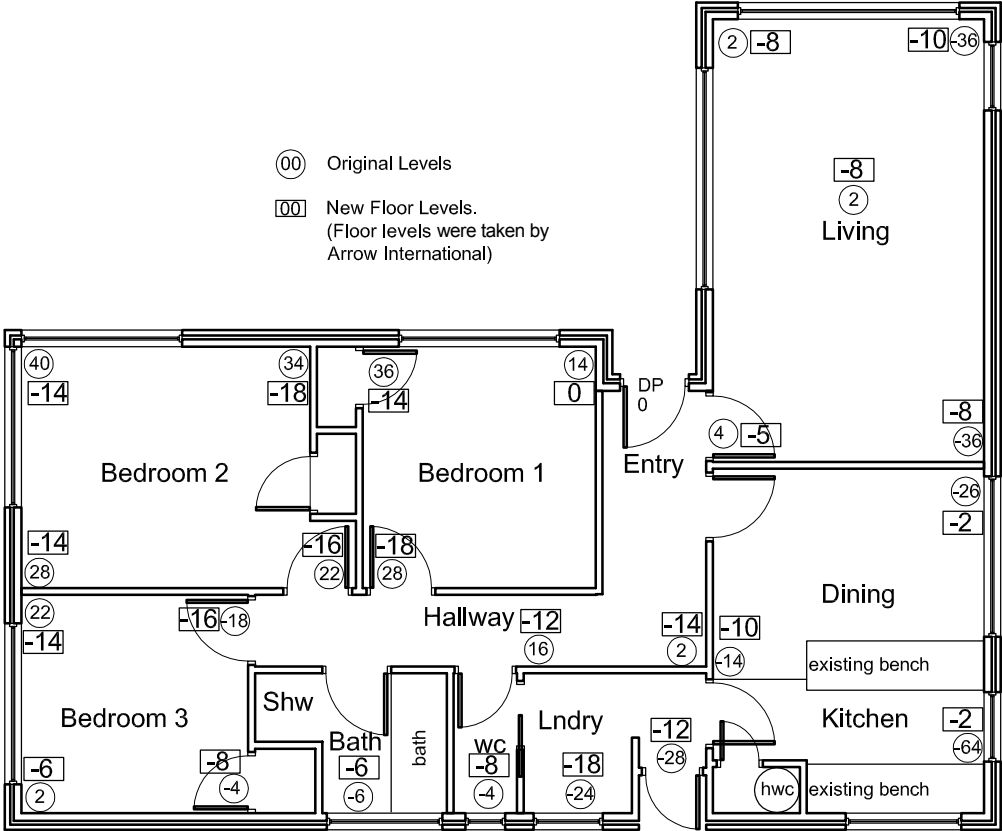
# 1 Seafield Place, South New Brighton

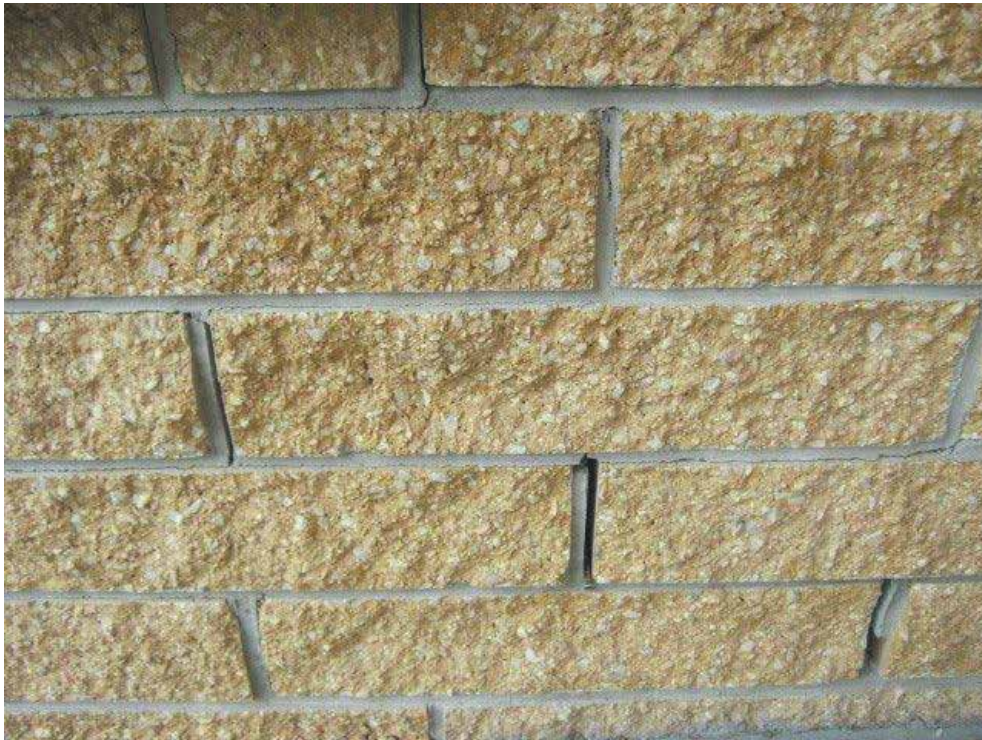
Image 1: Minor step cracking in veneer

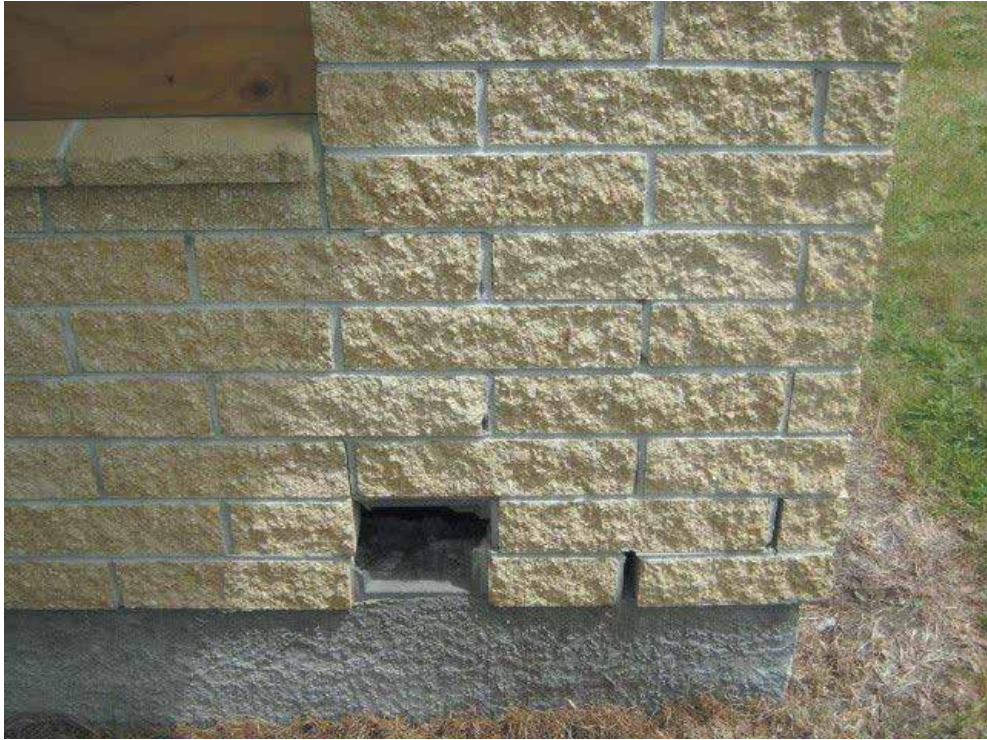
Image 2: Minor damage to brick veneer

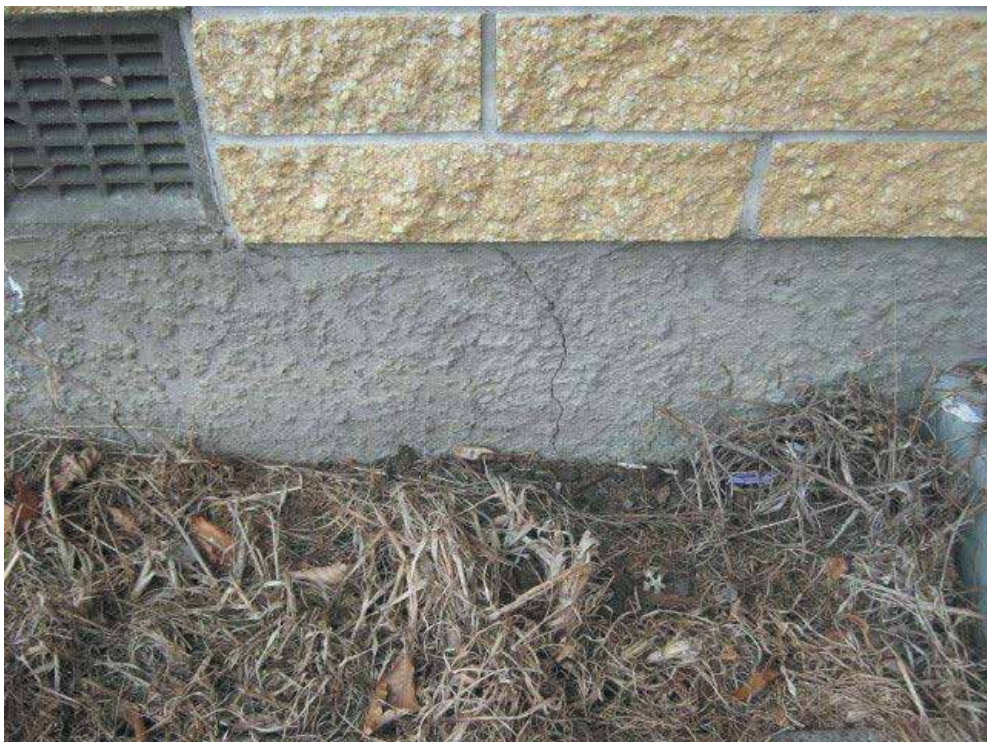
Image 3: Minor damage to foundation

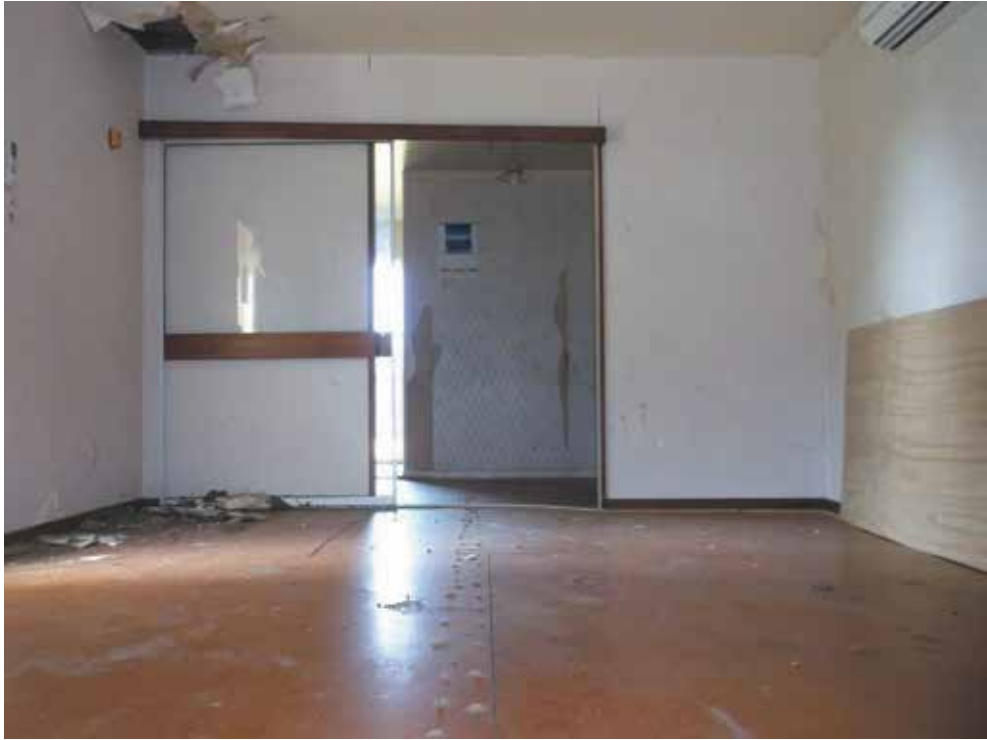
Image 4: Uneven floor settlement

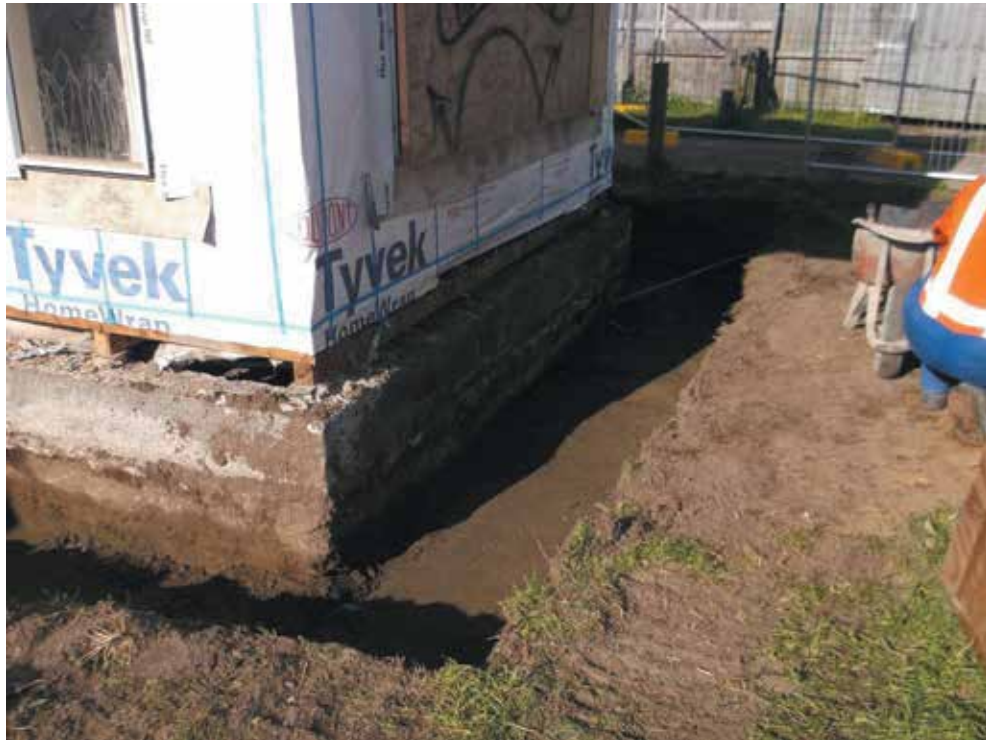
Image 5: With cladding removed, opportunity taken to insulate and wrap. Trench excavated around foundation perimeter for access to footing

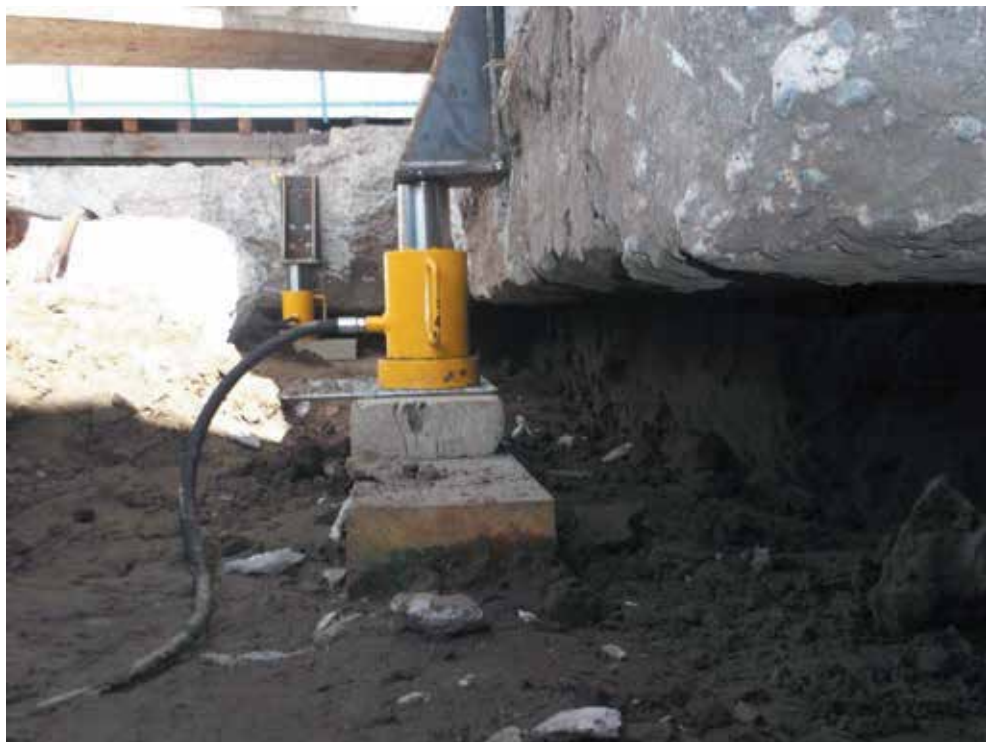
Image 6: Foundations mechanically jacked to required height

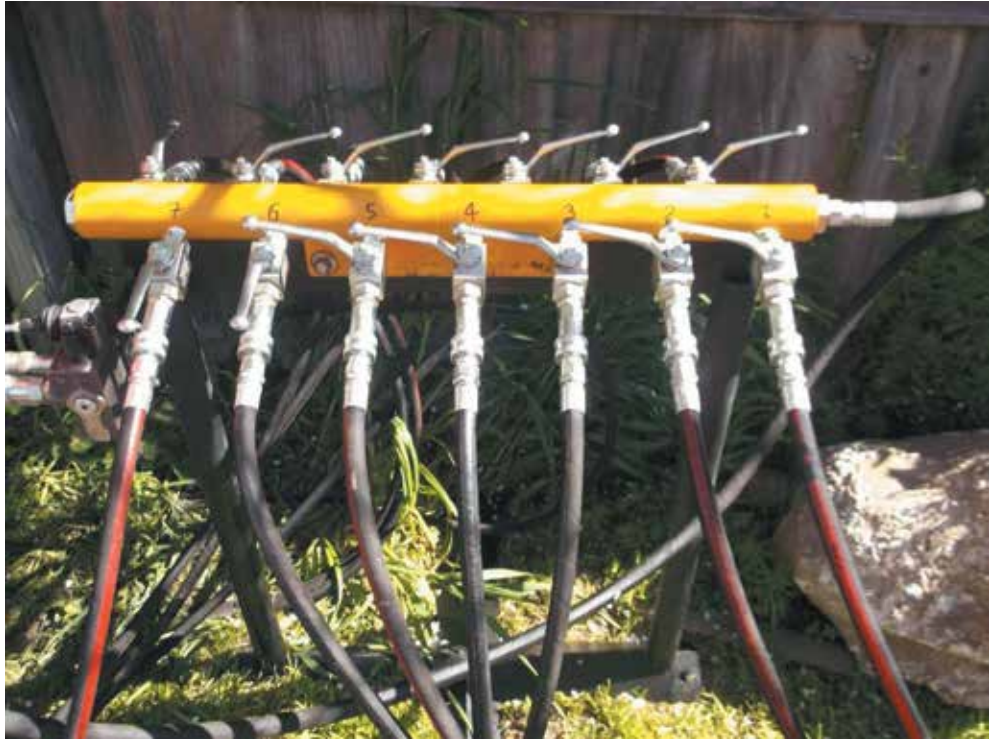
Image 7: Mechanical jacking manifold system

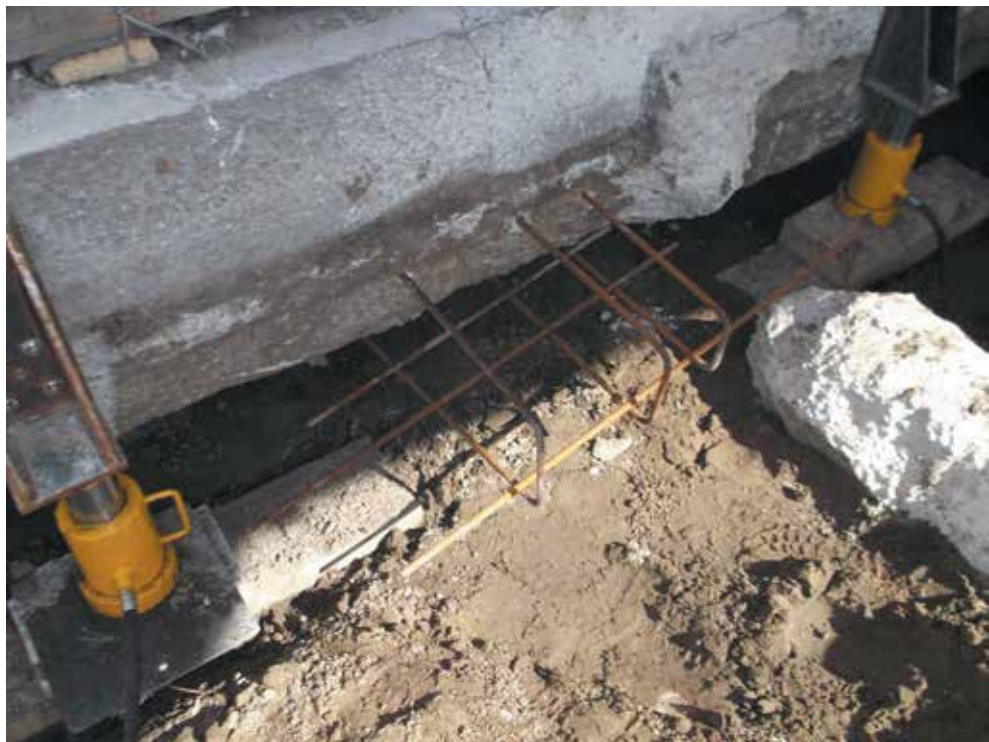
Image 8: Reinforcing installed under foundation cracks as per engineer's specification

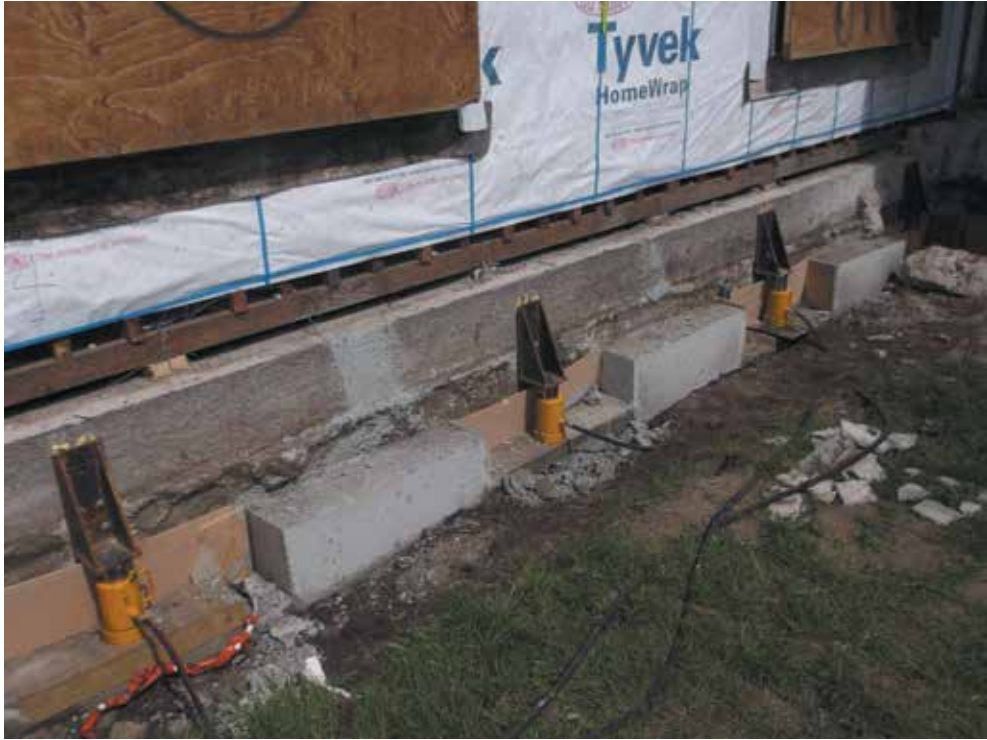
Image 9: Voids under relevelled footing filled with poured concrete

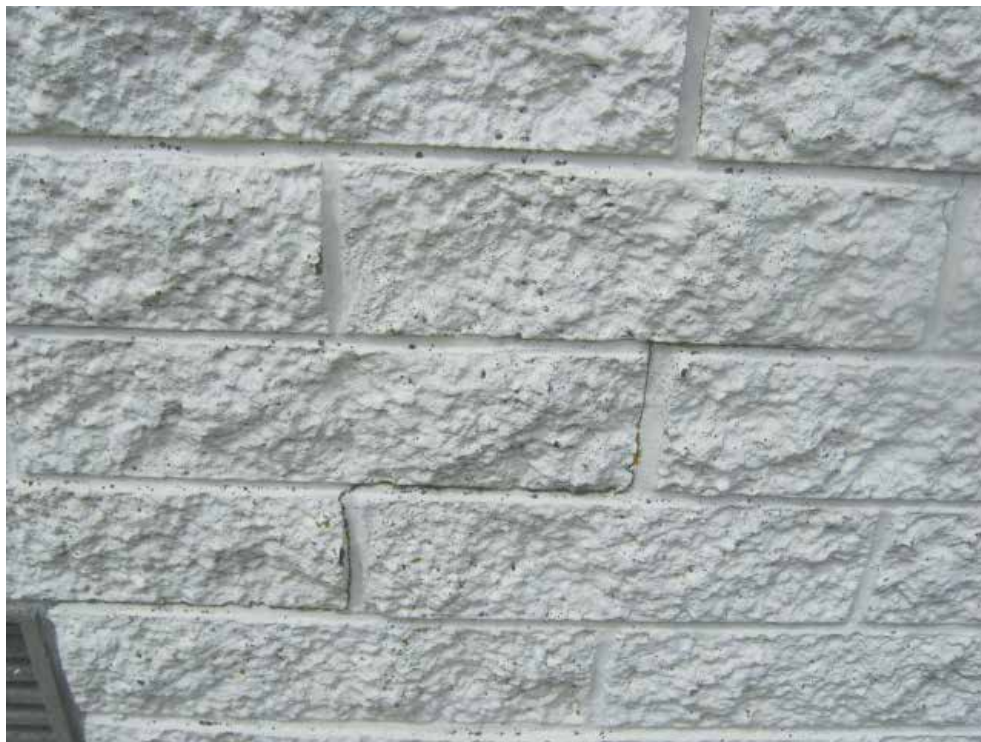
Image 1: Minor step cracking in veneer

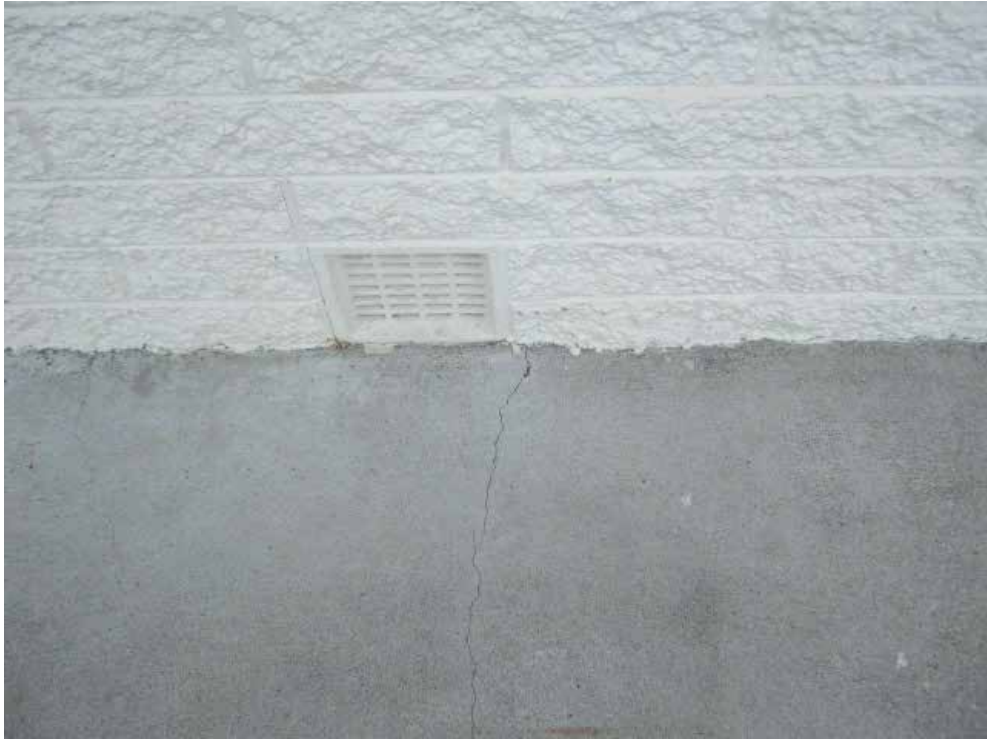
Image 2: Hairline crack in foundation

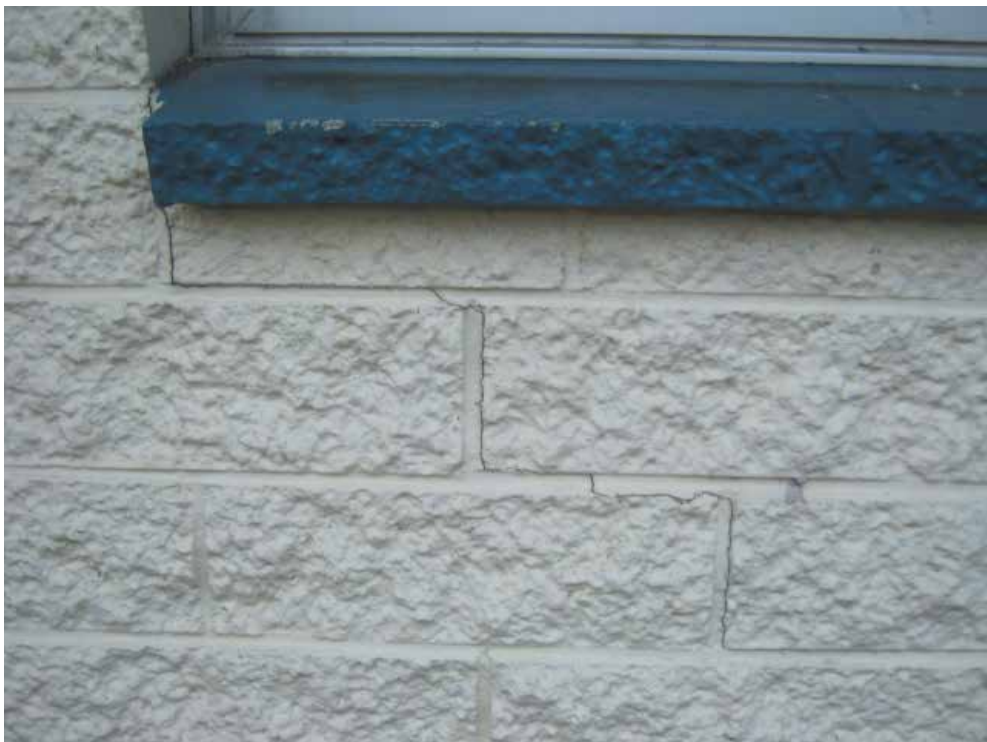
Image 3: Minor step cracking from window corners

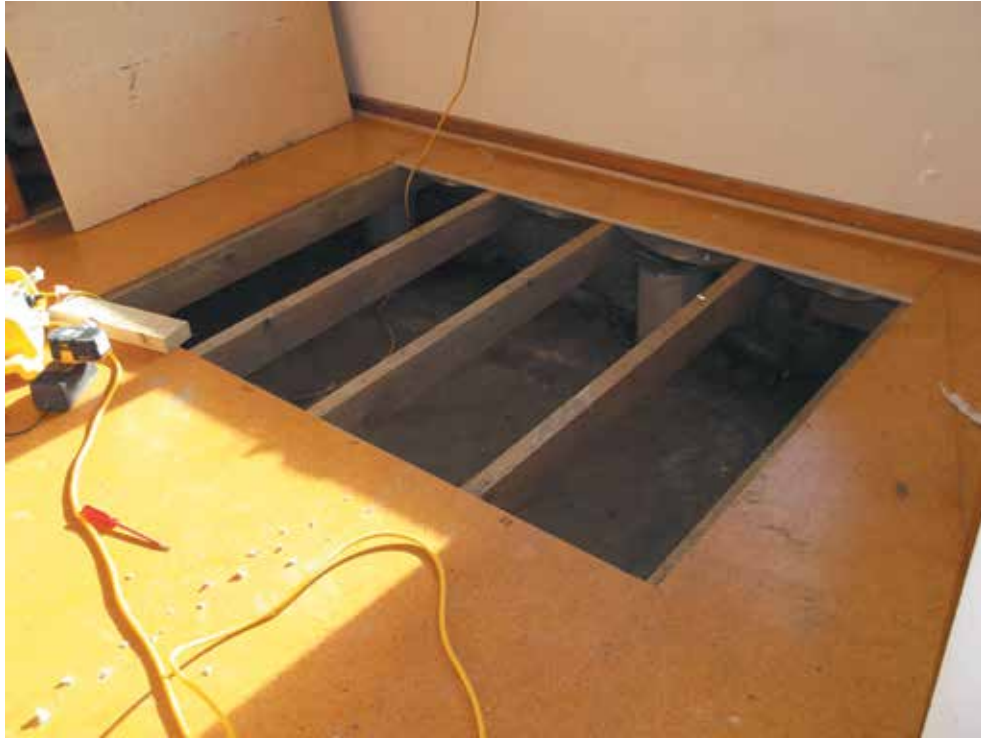
Image 4: Flooring removed to access subfloor

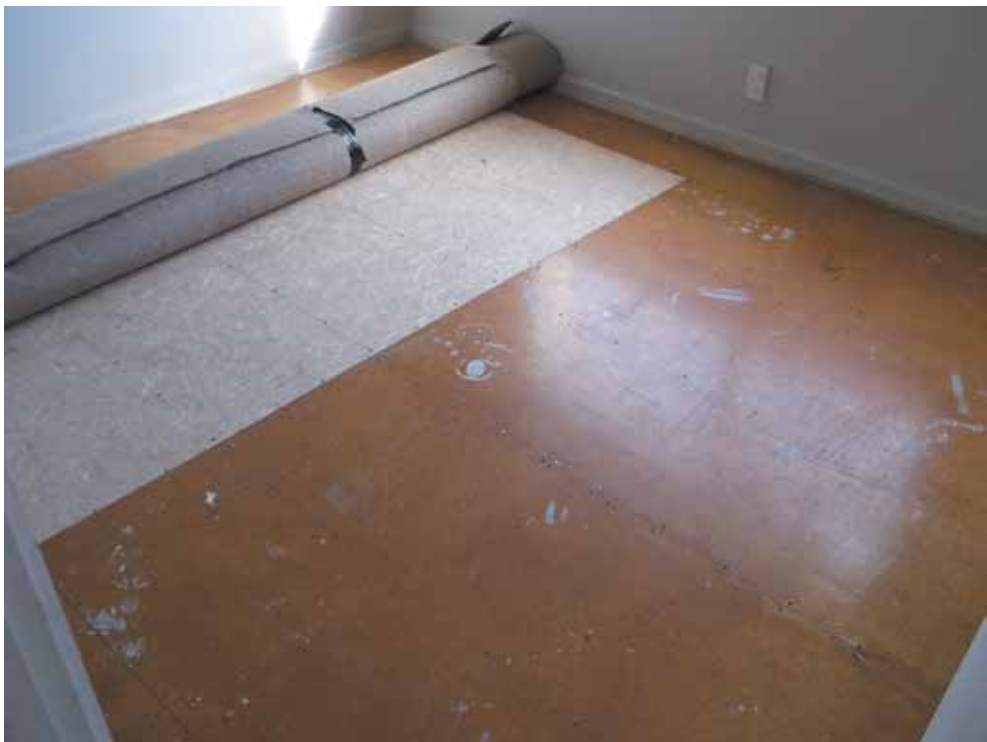
Image 7: Internal flooring replaced with original materials if available and fixed down using glue and screws

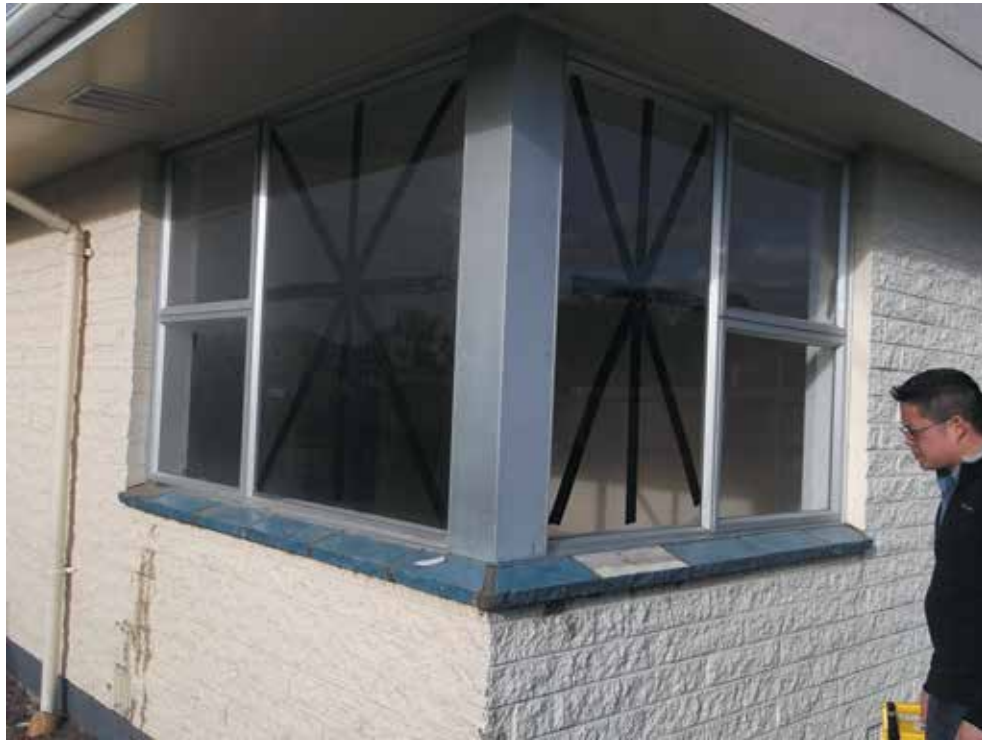
Image 8: Sills and bricks that loosened during jacking and packing reinstated

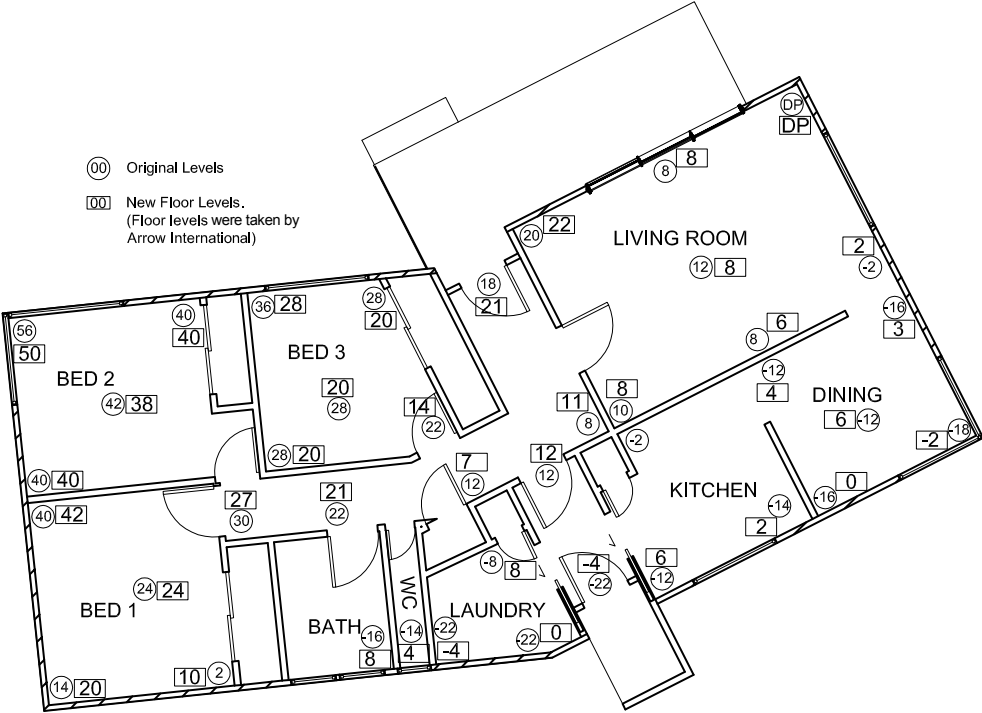
## 18 Four Elms Place, Parklands

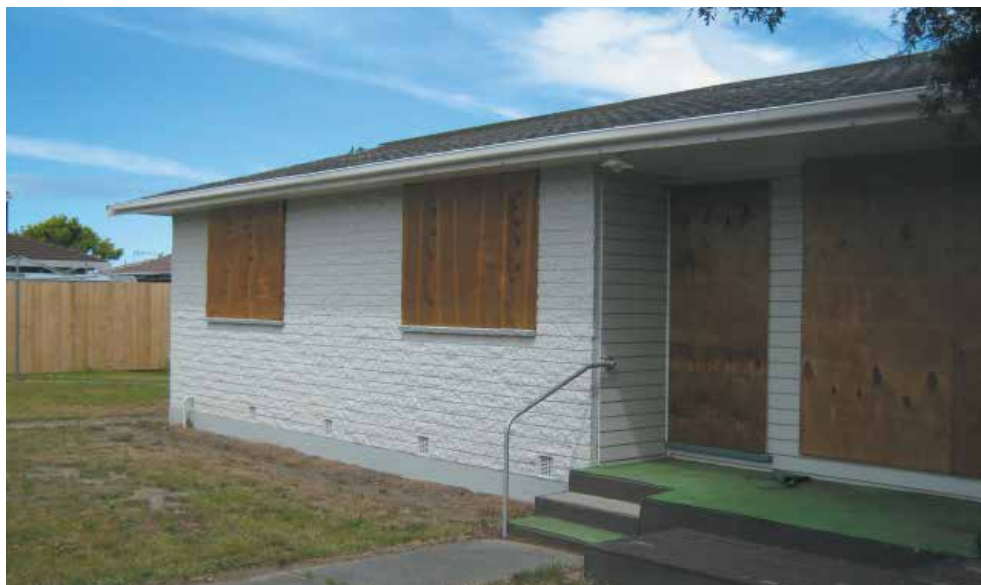
### Property Details

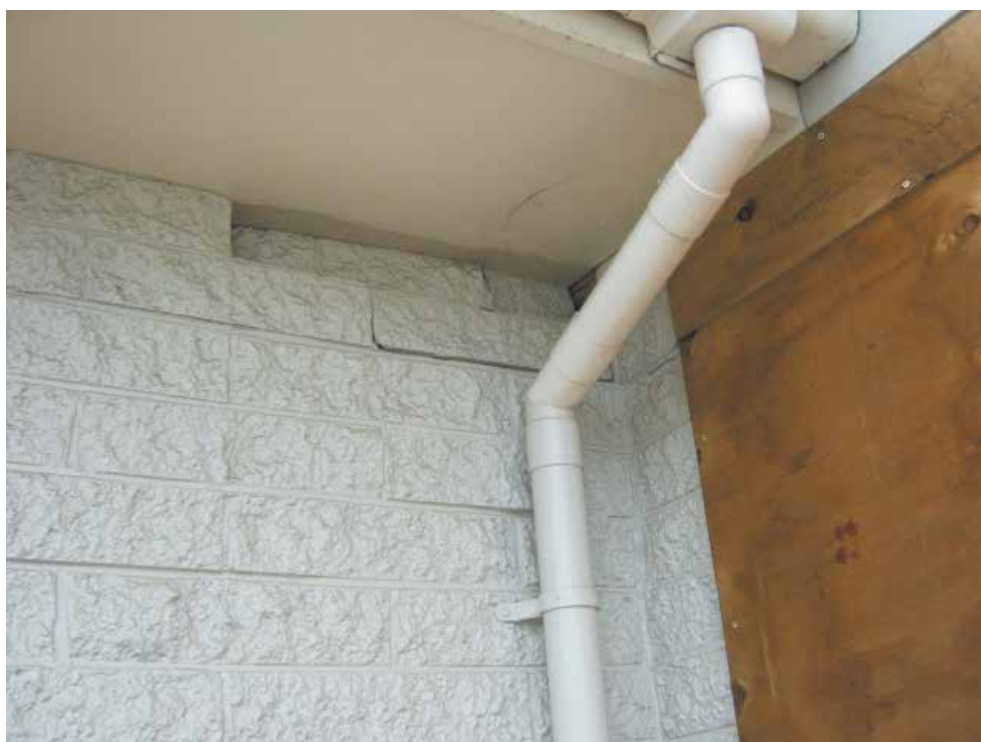
Image 1: Moderate damage to Summerhill Stone cladding
