# Housing New Zealand

Technical Report on the Results of Foundation Repair Trials  
Conducted following the Canterbury Earthquakes

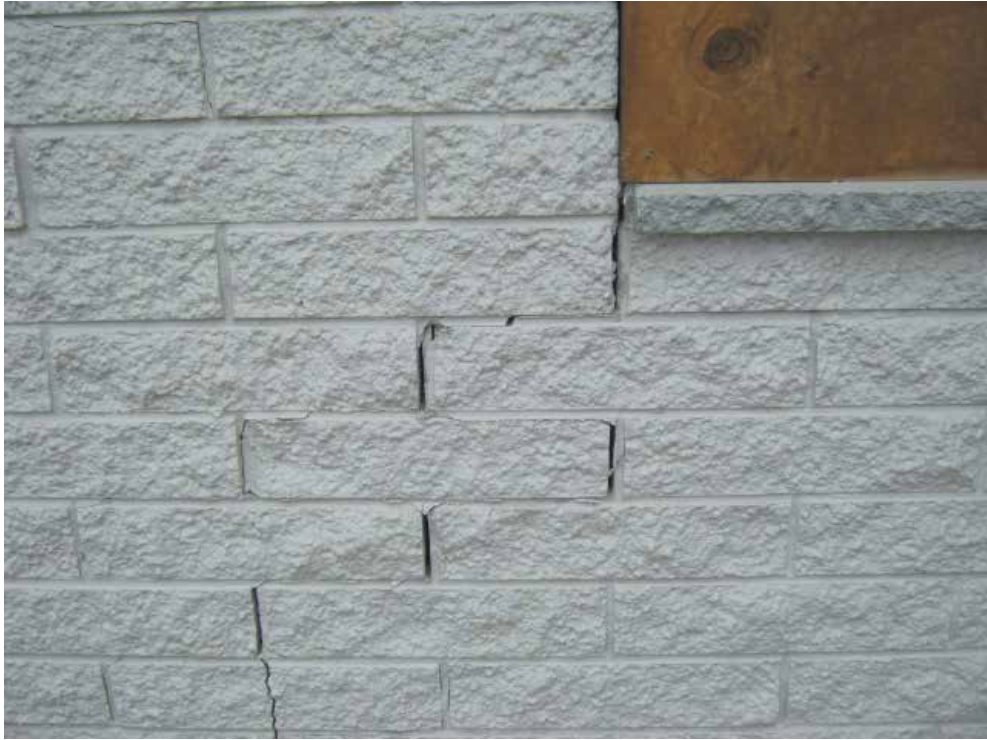
Image 2: Step cracking in mortar

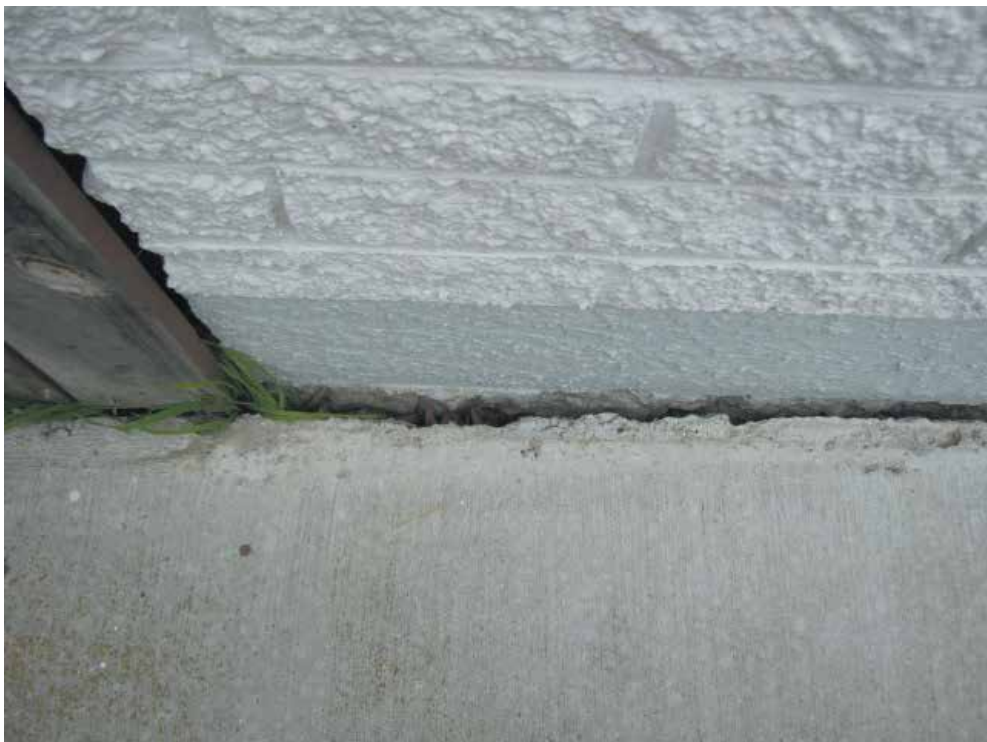
Image 3: Lateral spreading of hard surfaces

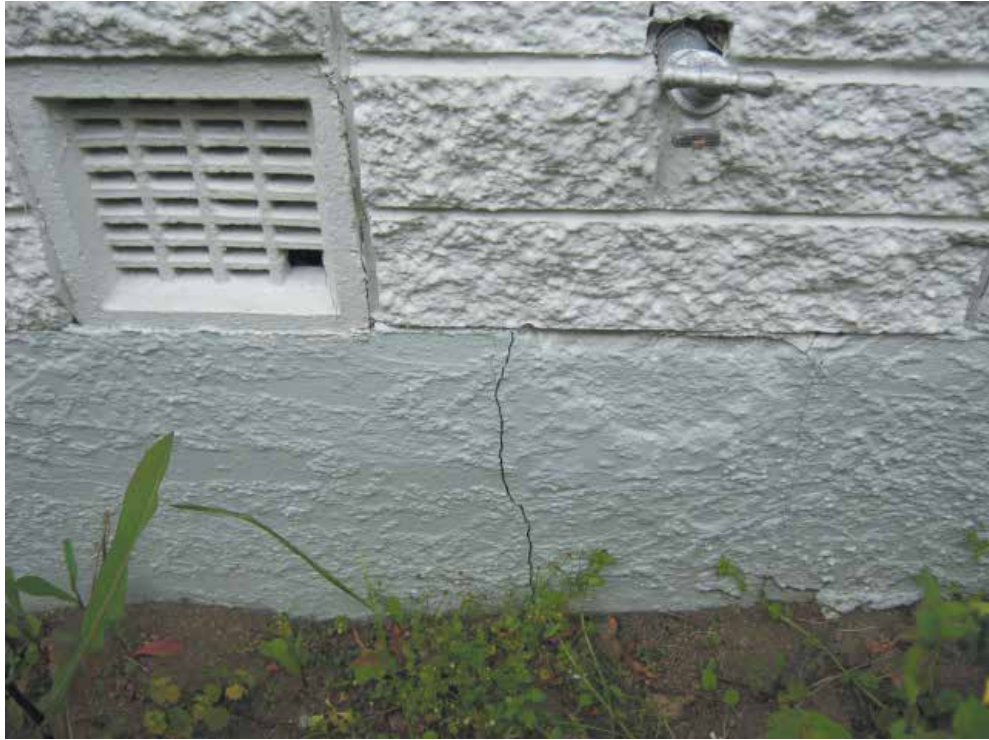
Image 4: Minor cracking to concrete perimeter foundation

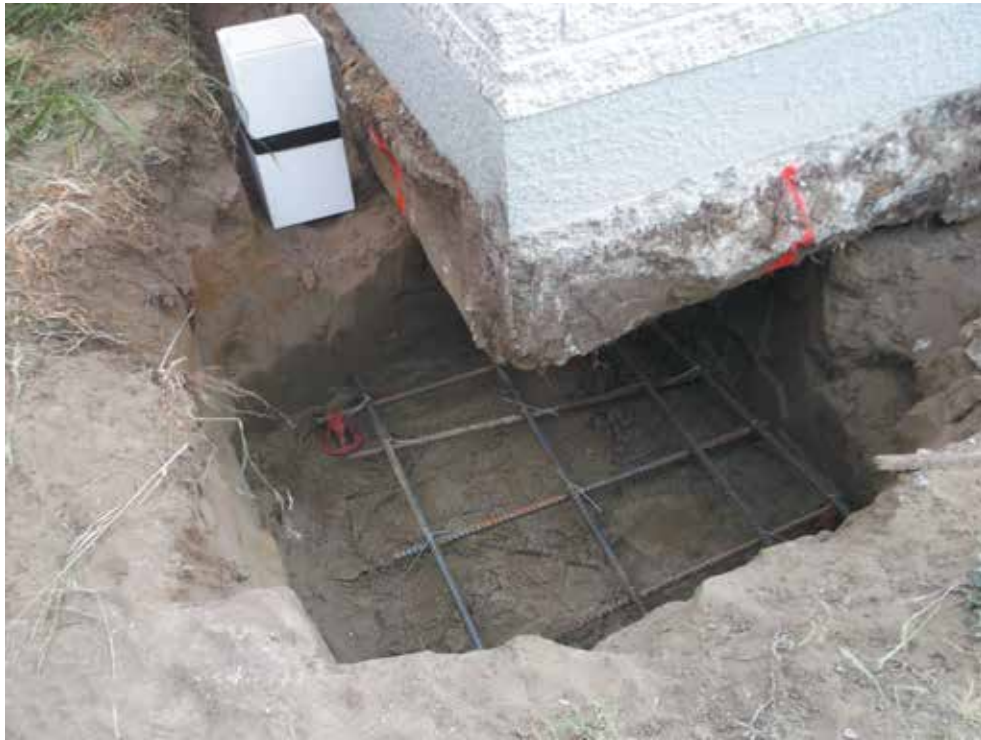
Image 5: Jacking points excavated and reinforcing installed

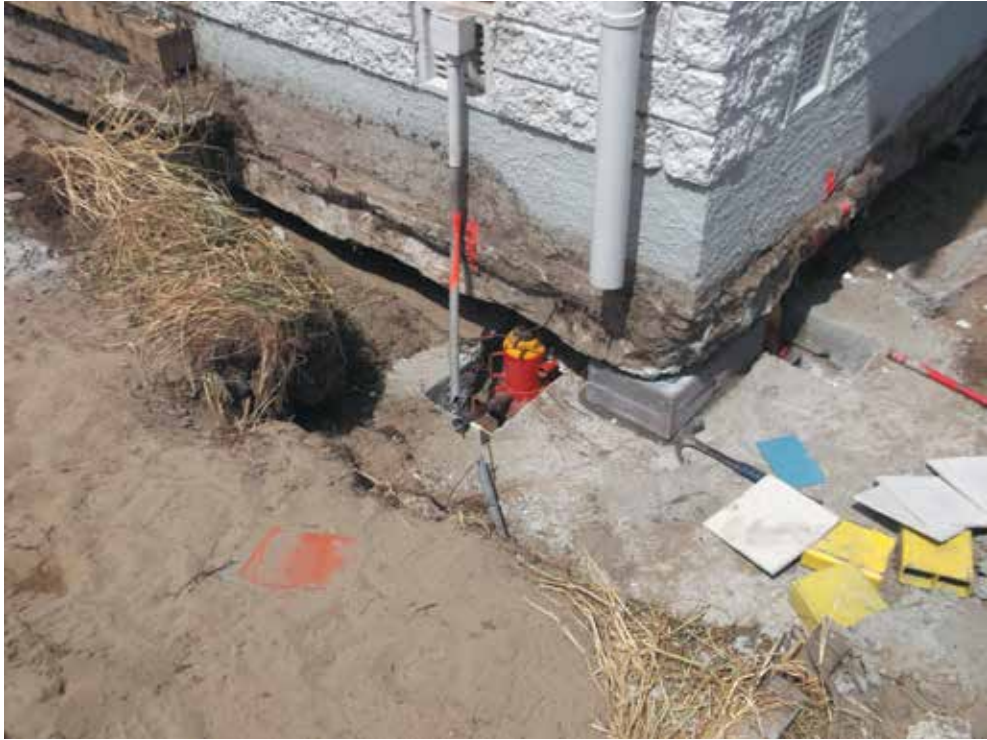
Image 7: Perimeter ring foundation jacked and packed

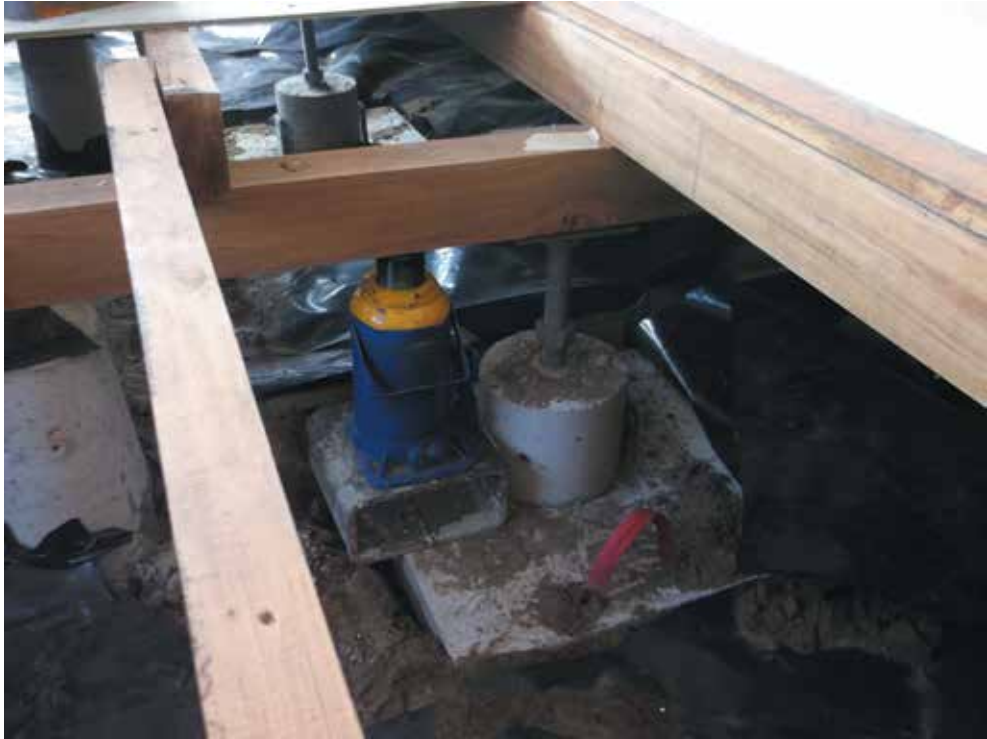
Image 8: Bearers jacked and packed

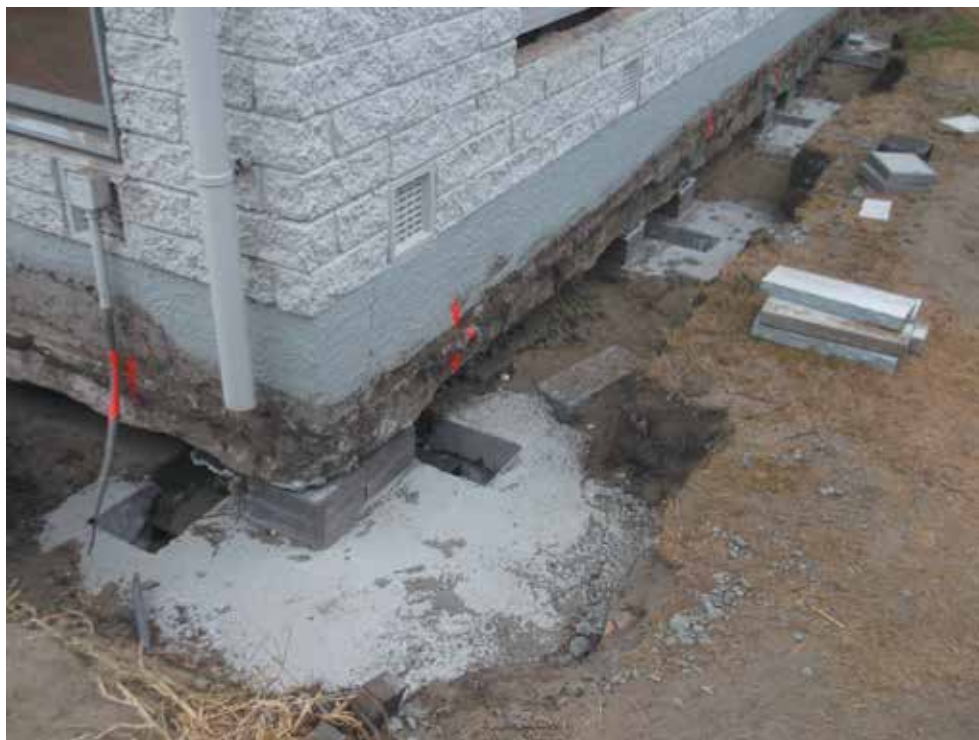
Image 9: Entire foundation packed and jacks removed ready for void fill

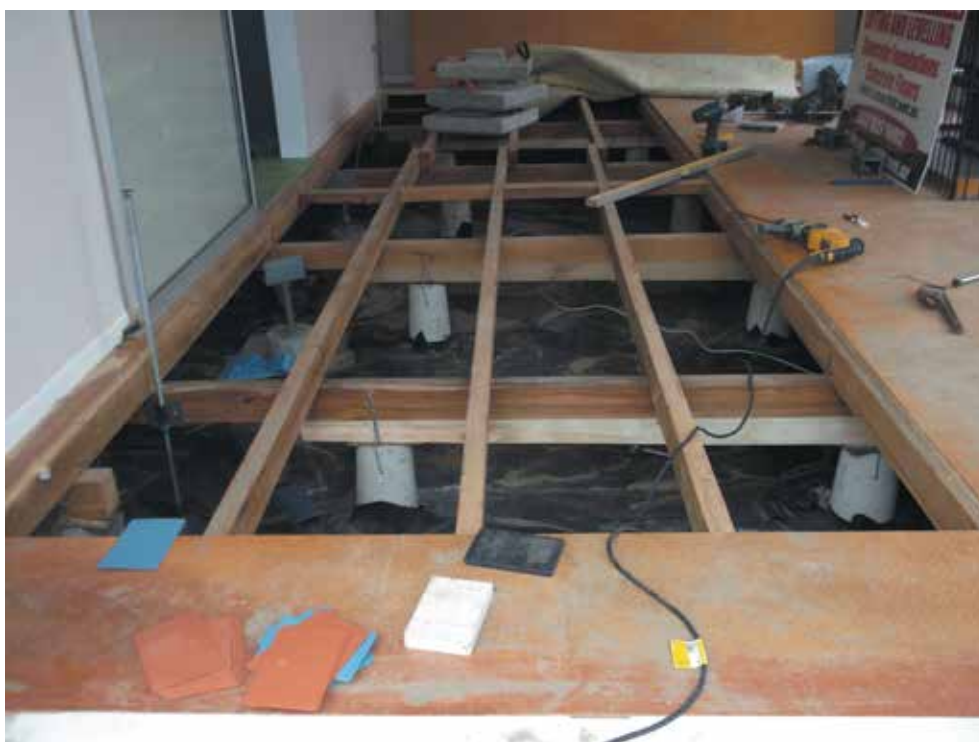
Image 10: Where lift was over 100 mm, piles were packed with an extra bearer spanning at least two piles

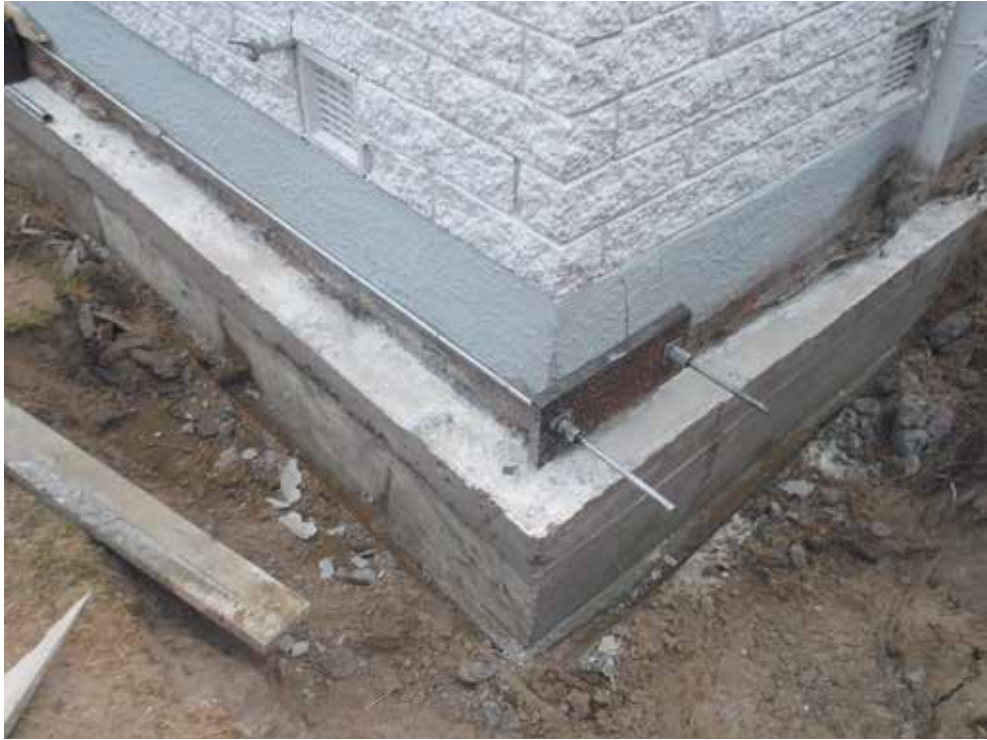
Image 11: Tension bars pulled foundation together closing up cracks

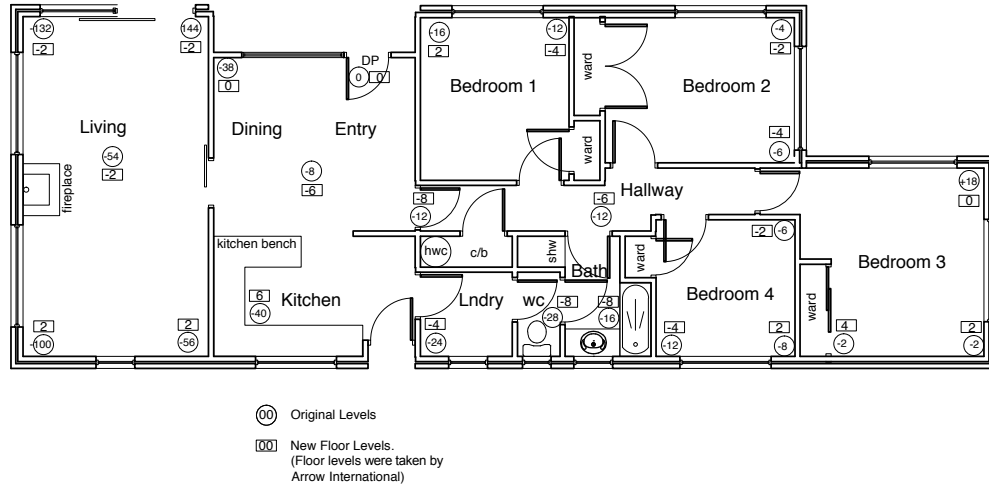
## 37 Charnwood Crescent, Bishopdale

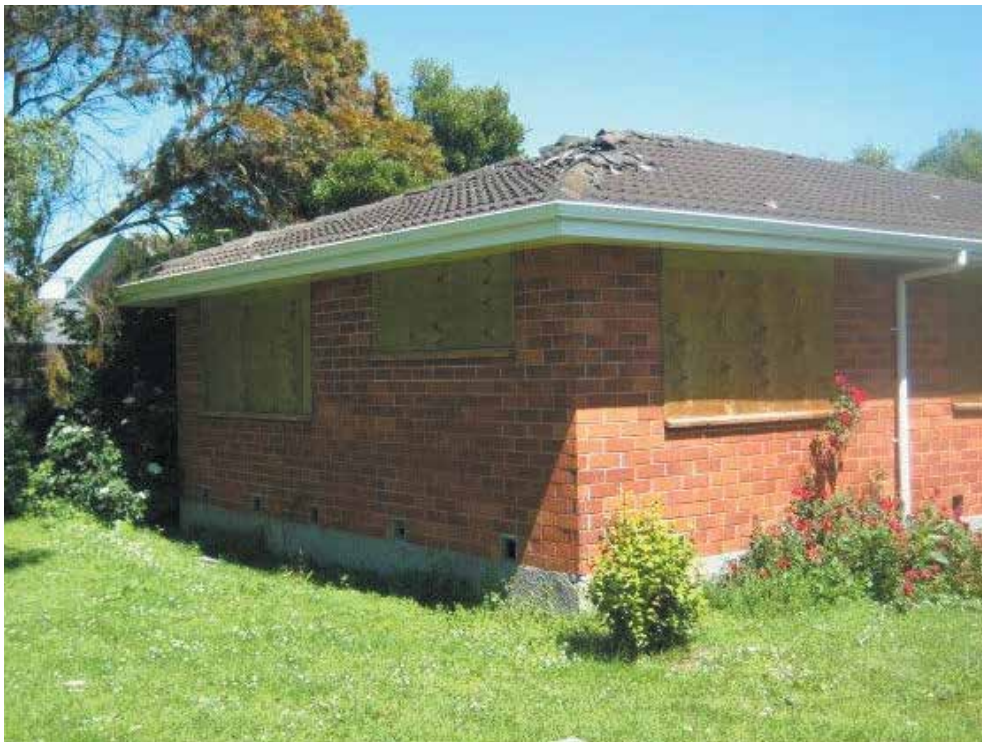
Image 1: Moderate damage to heavy weight roof

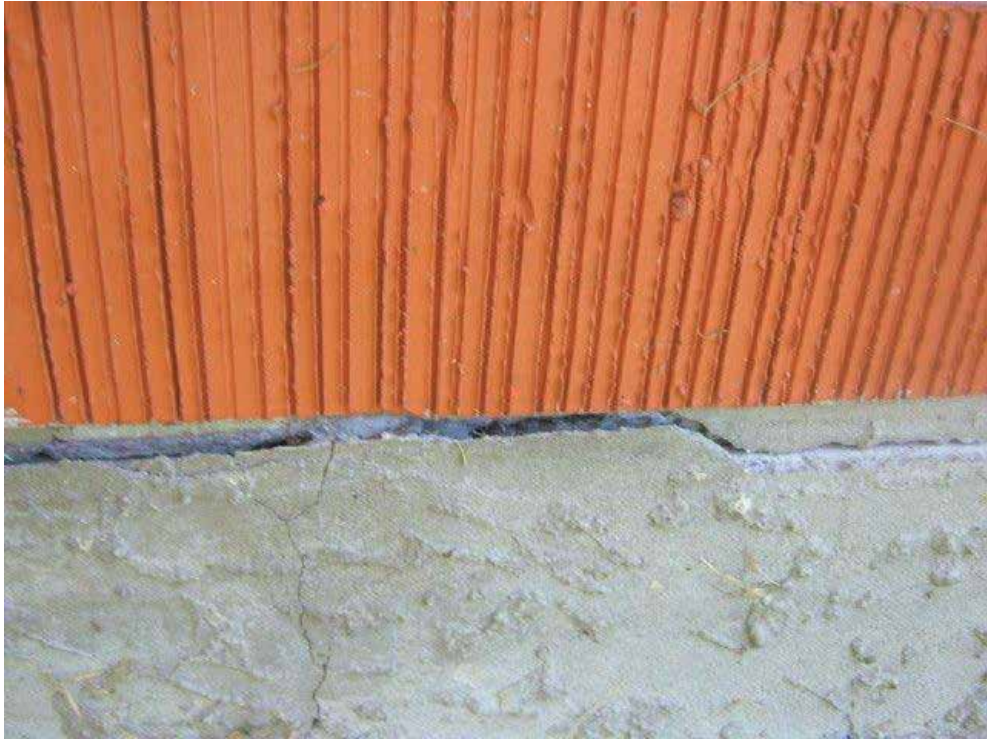
Image 2: Minor damage to perimeter foundation

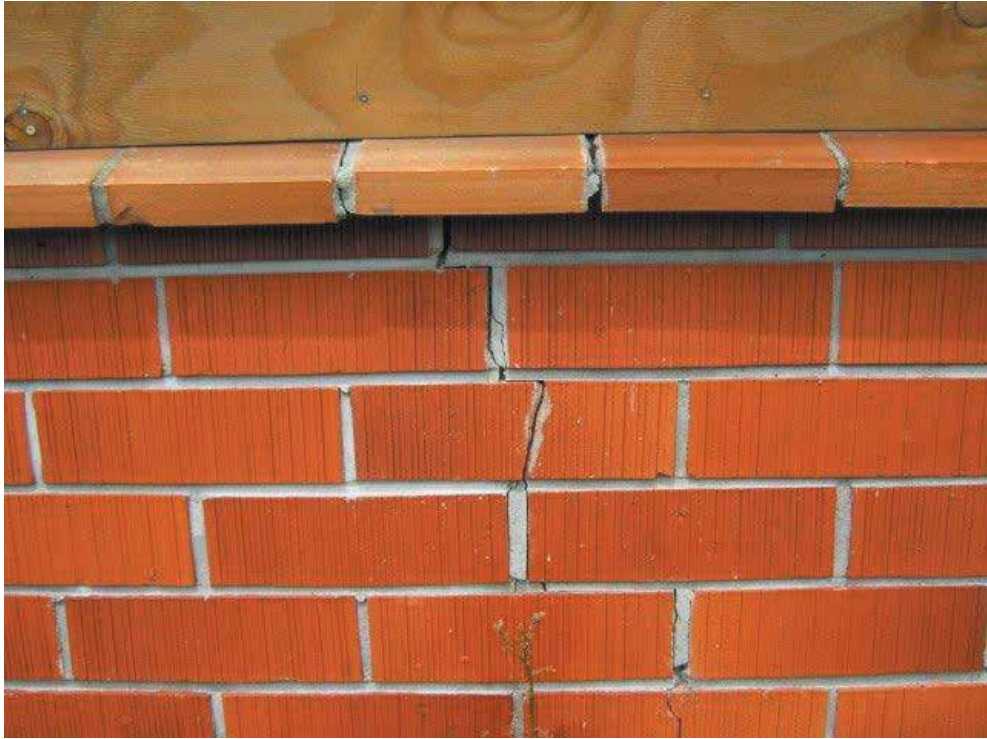
Image 3: Vertical split bricks and mortar

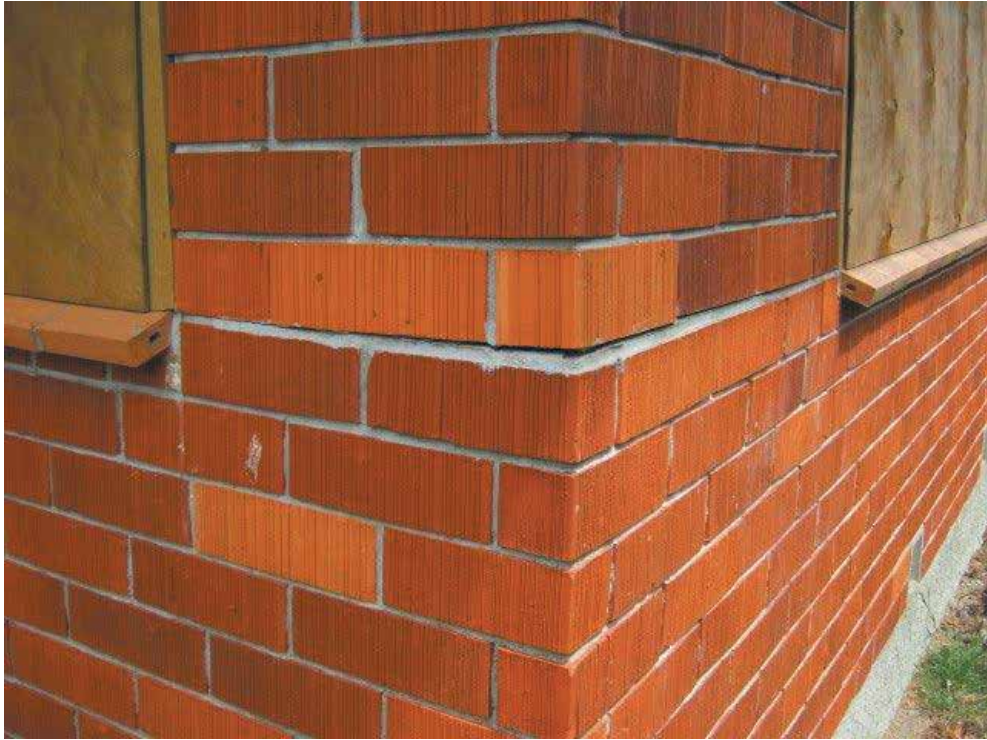
Image 4: Foundation has settled at corners causing damage to veneer

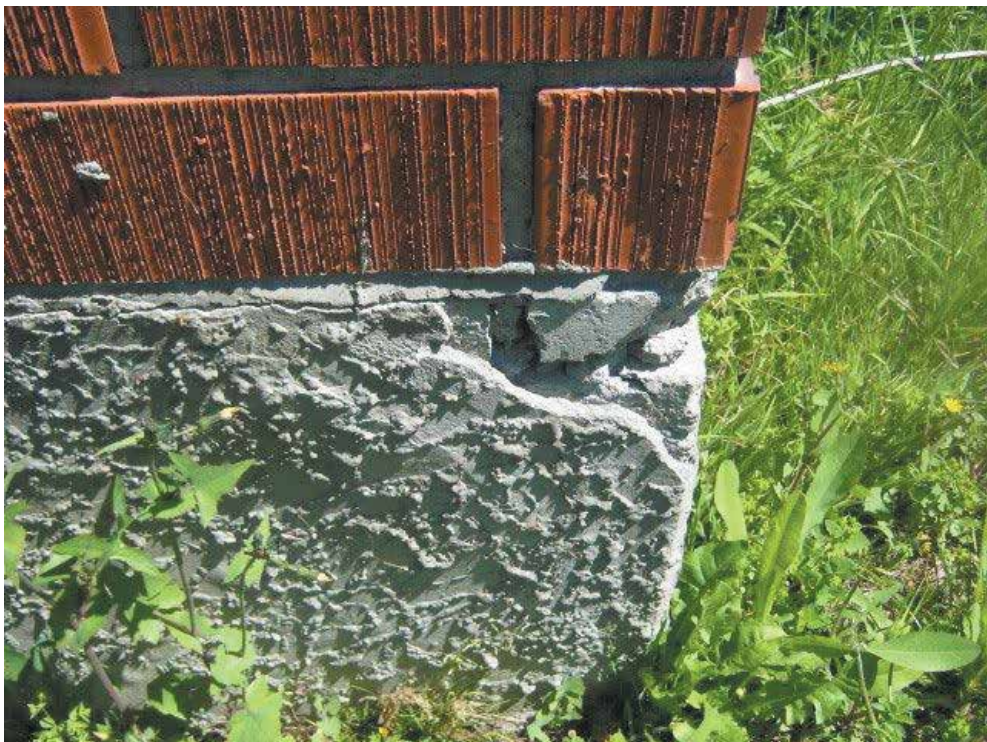
Image 5: Minor foundation damage

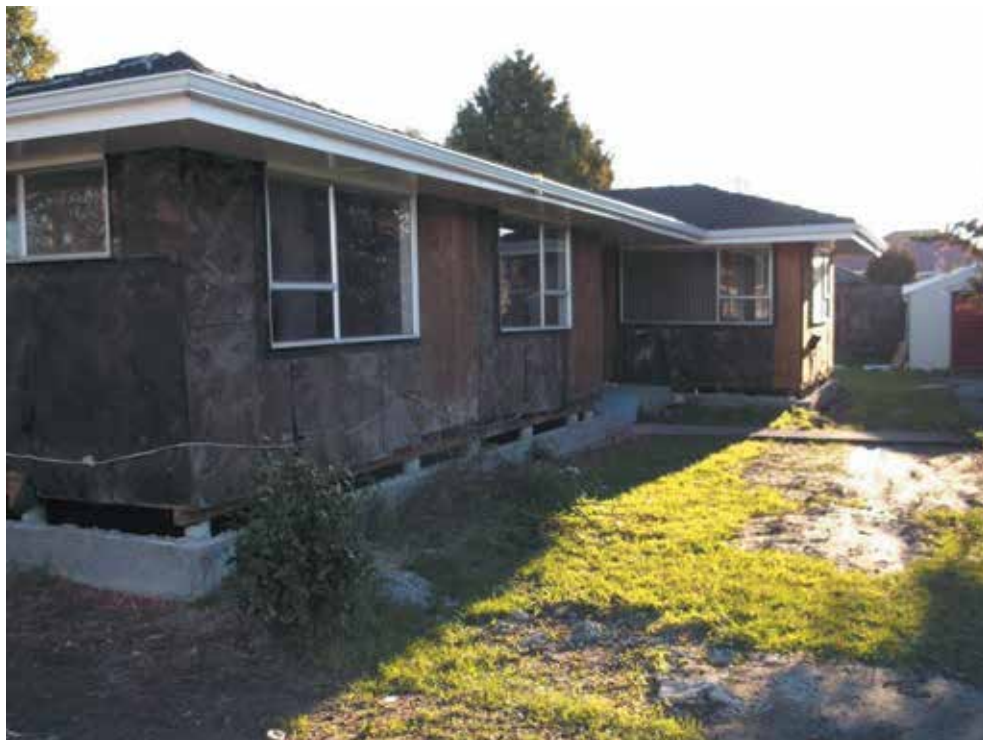
Image 6: Cladding removed. Opportunity taken to replace any worn insulation and new wrap installed

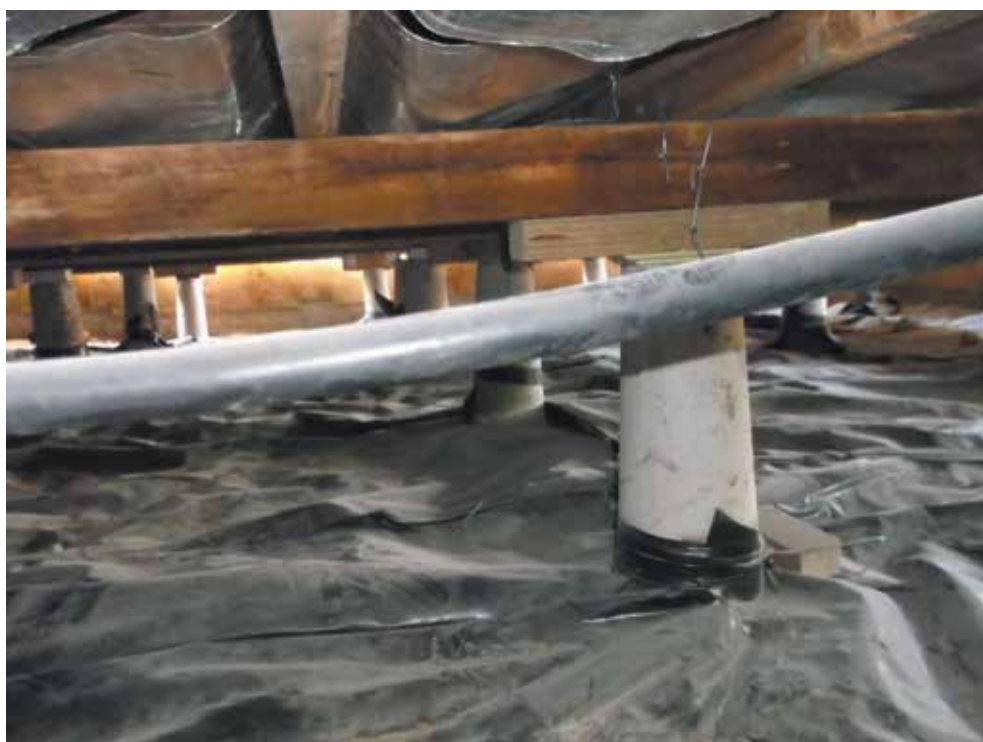
Image 7: Subfloor jacked and packed

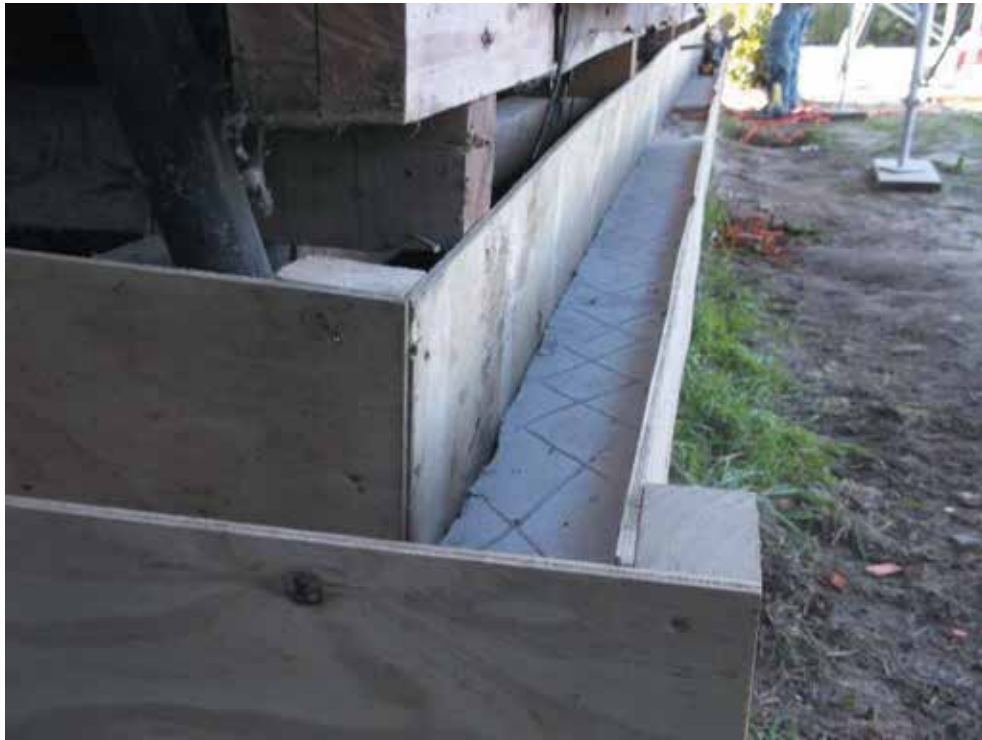
Image 8: Foundation cleaned and scabbled. Formwork installed for pouring of foundation topping

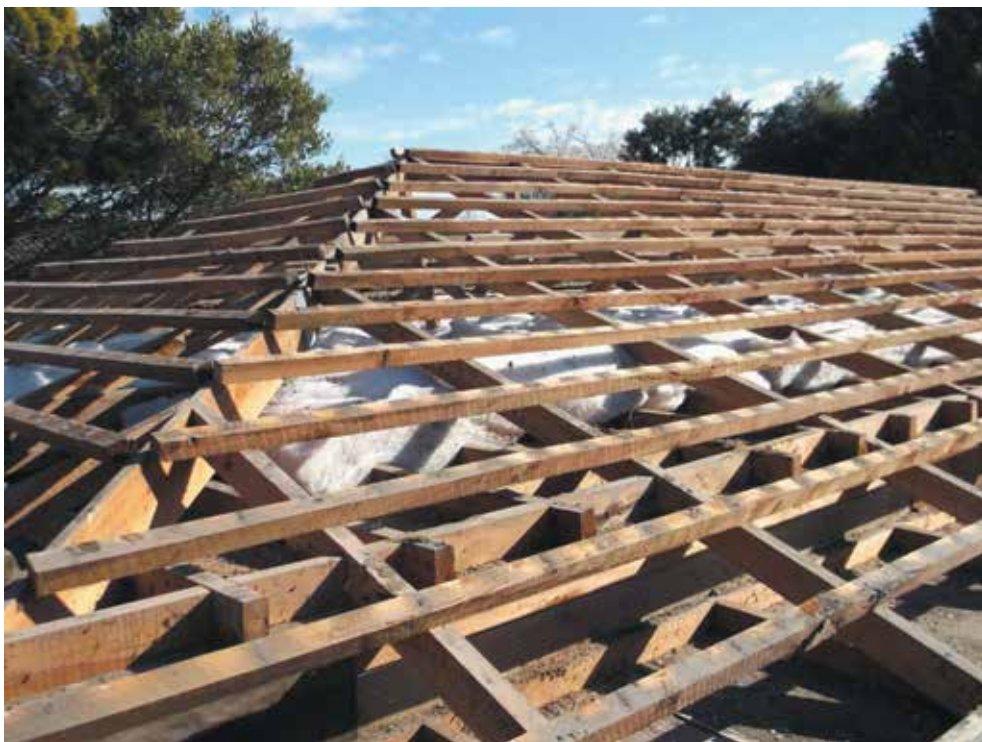
Image 9: Roofing removed. Opportunity taken to insulate areas not accessible from roof space

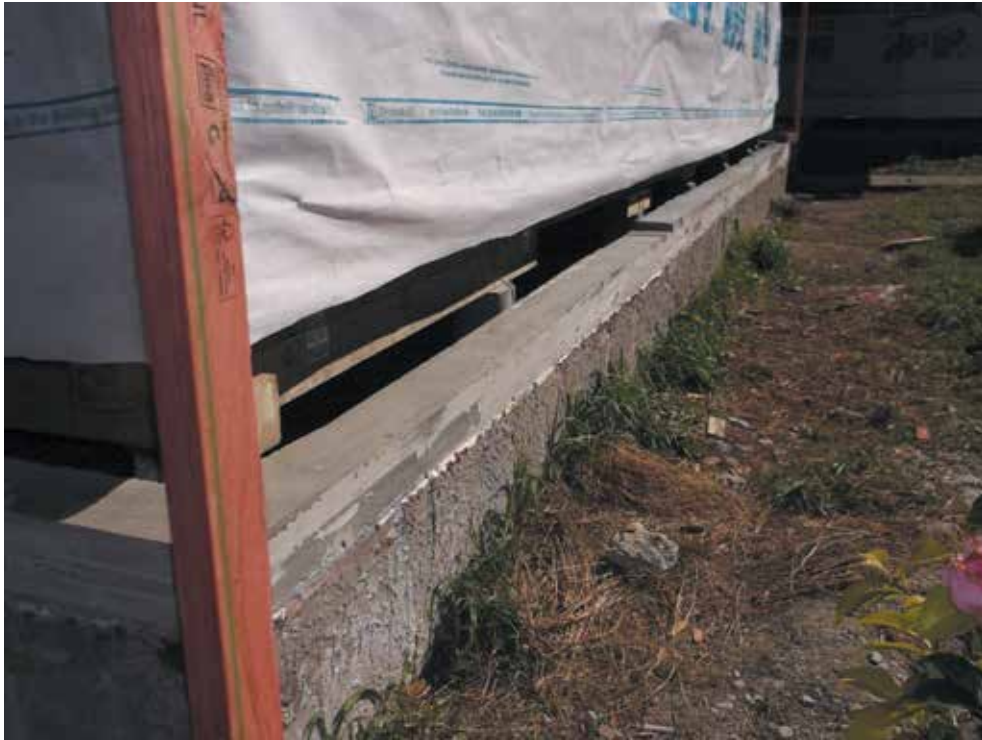
Image 10: Foundation topping poured and formwork removed

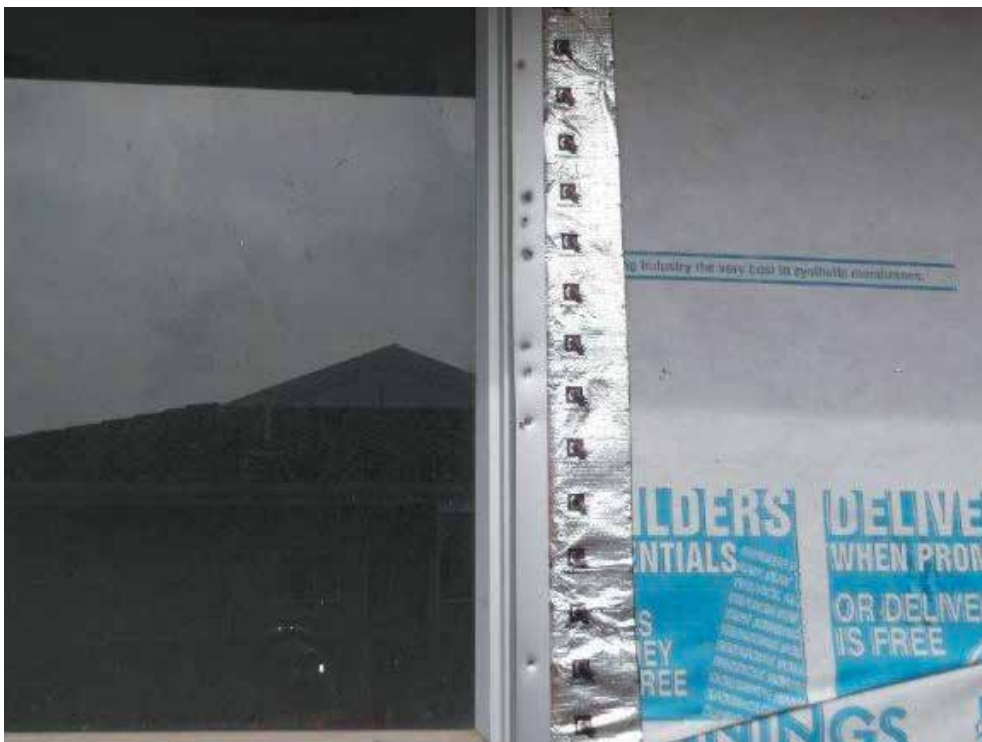
Image 11: New building wrap installed. 50x50mm flashings to windows to provide cover at window brick junction

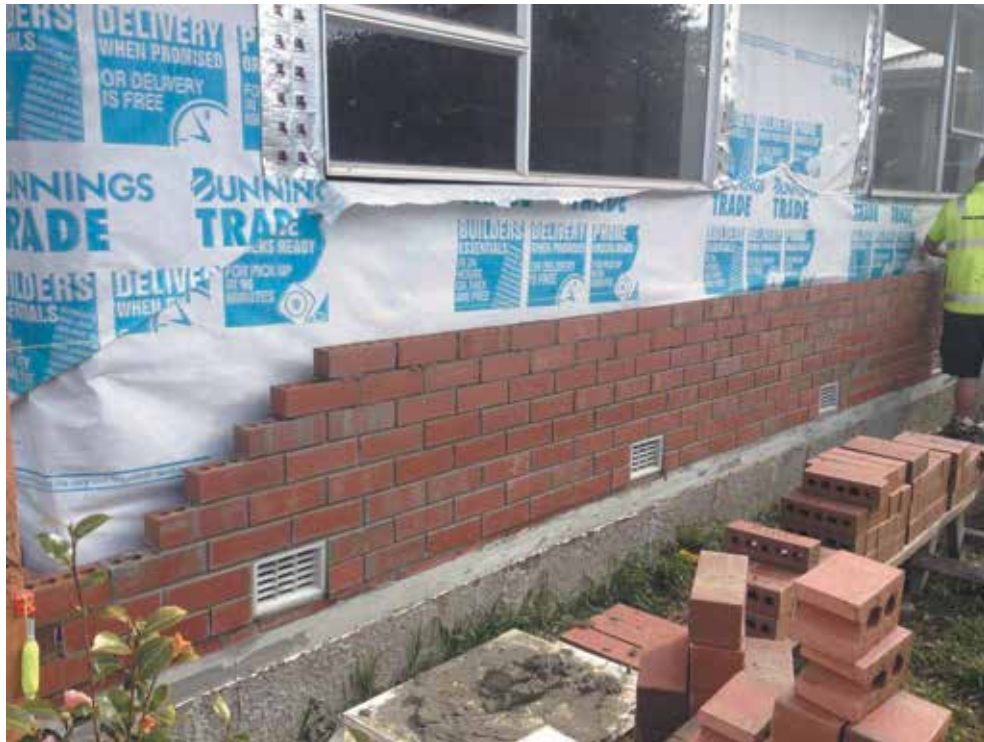
Image 12: Brick slithers laid to bring foundation level where a topping of more than 1:1 ratio required

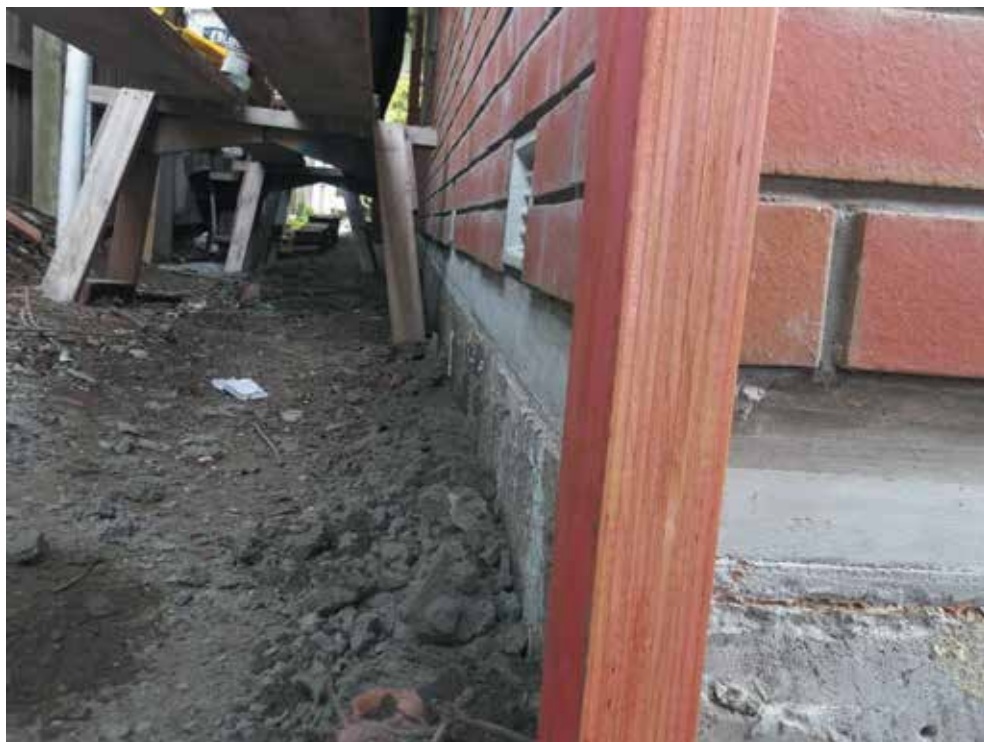
Image 13: Offset new cladding to allow foundation to be plastered in line with brick veneer

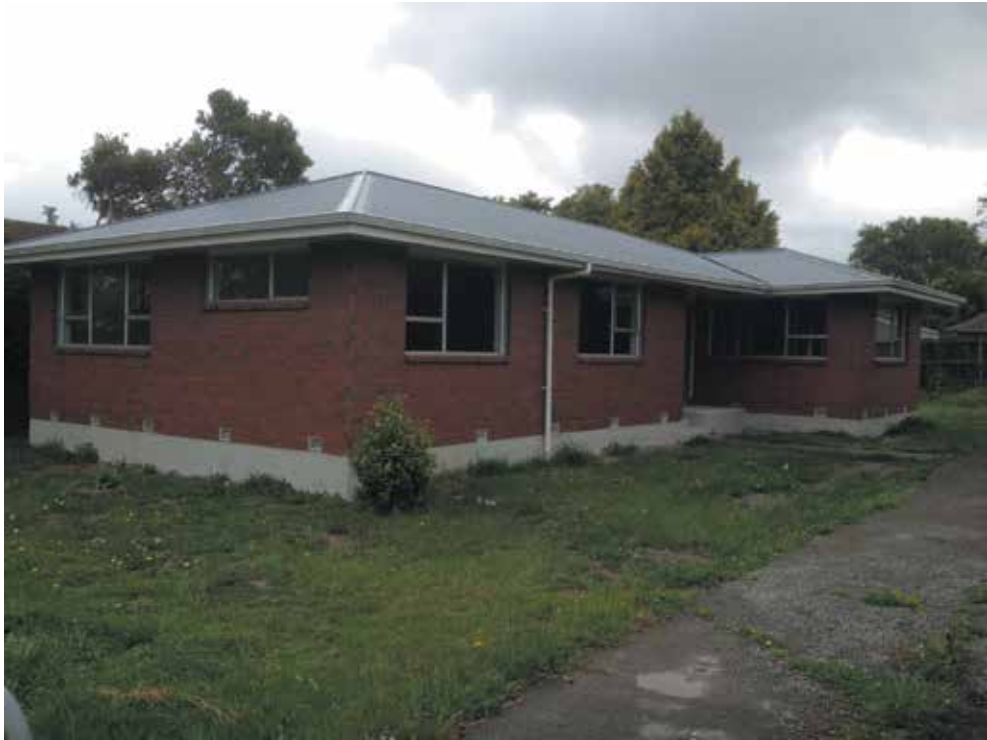
Image 14: Works complete

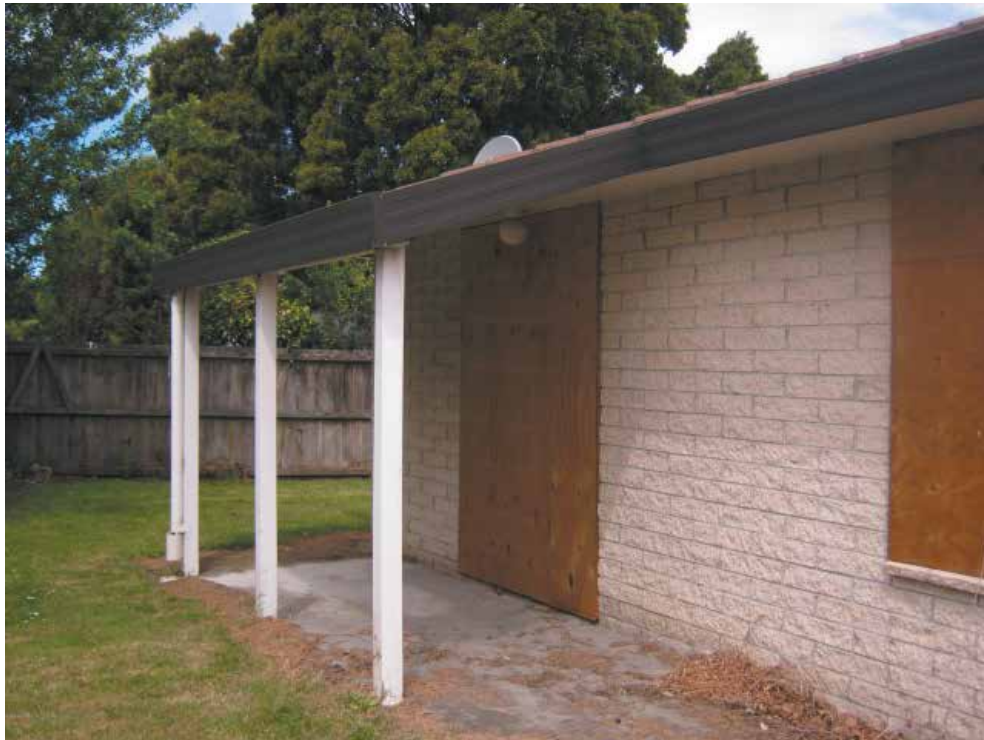
Image 1: Unit settled below ground level

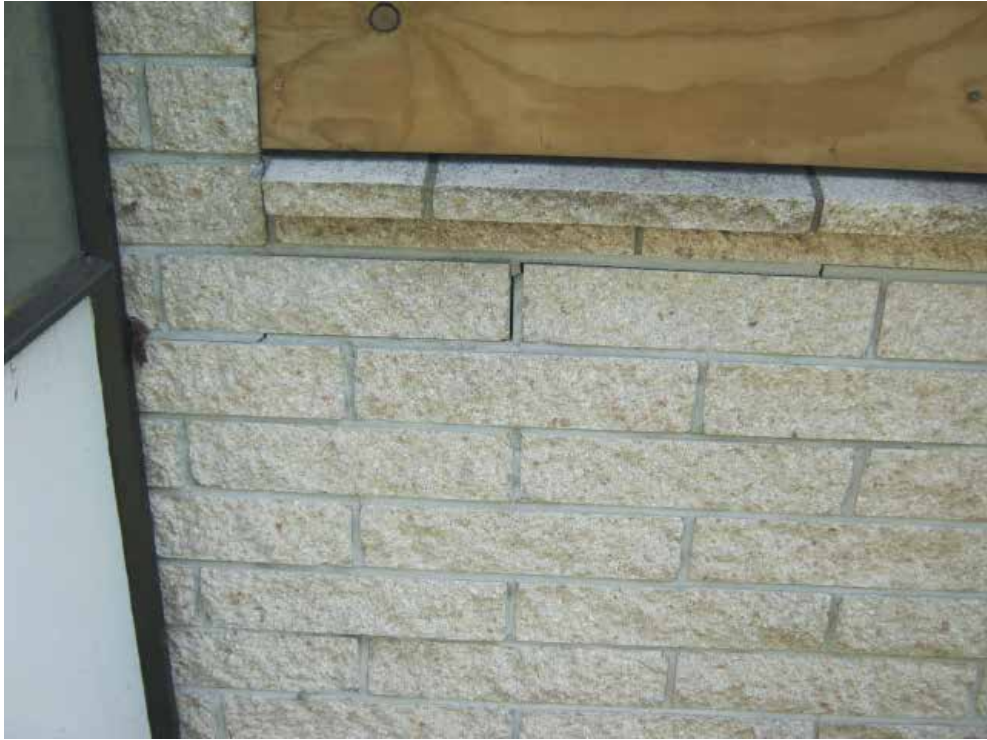
Image 4: Minor masonry veneer cracking

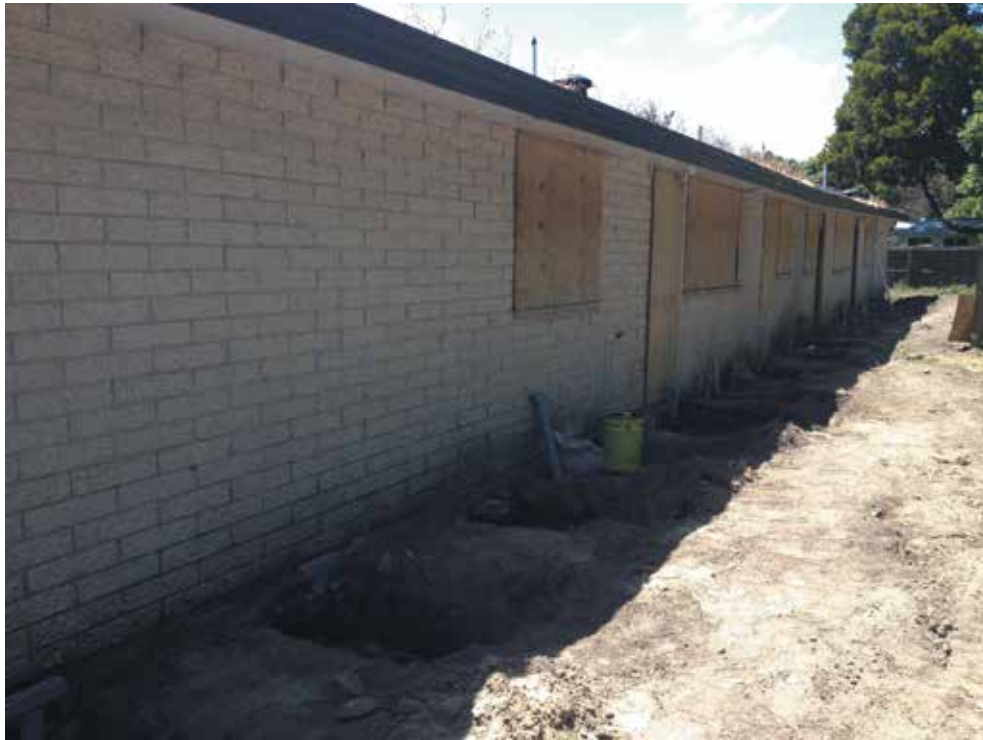
Image 5: Screw piles in place with brackets attached to foundation perimeter beam

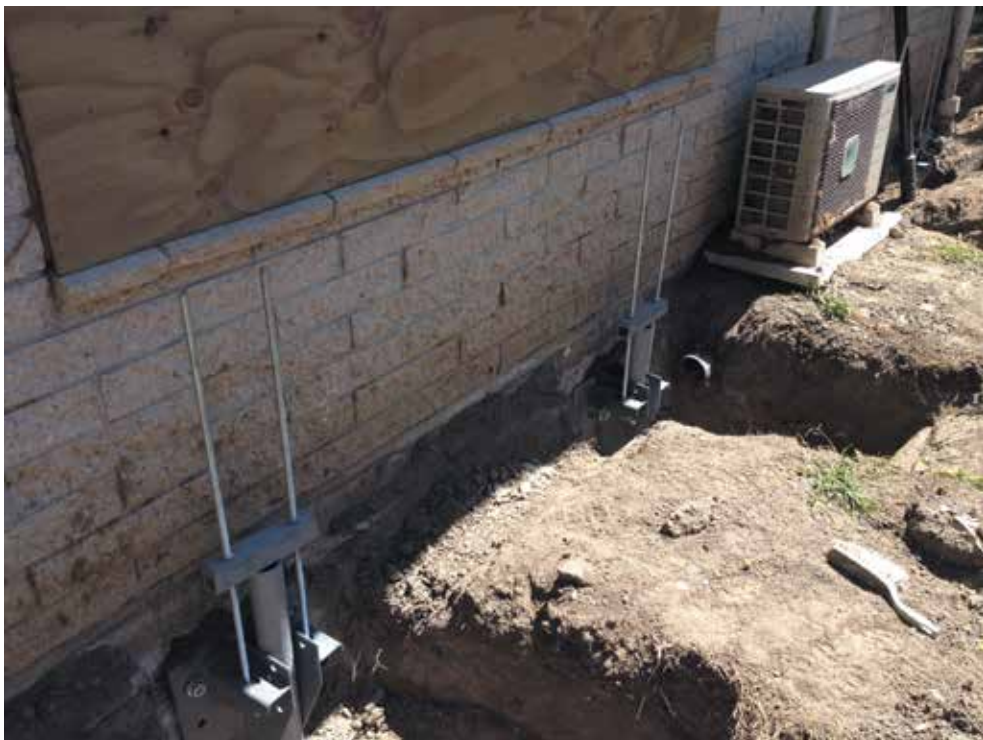
Image 6: Lifting brackets attached to foundation and screw piles

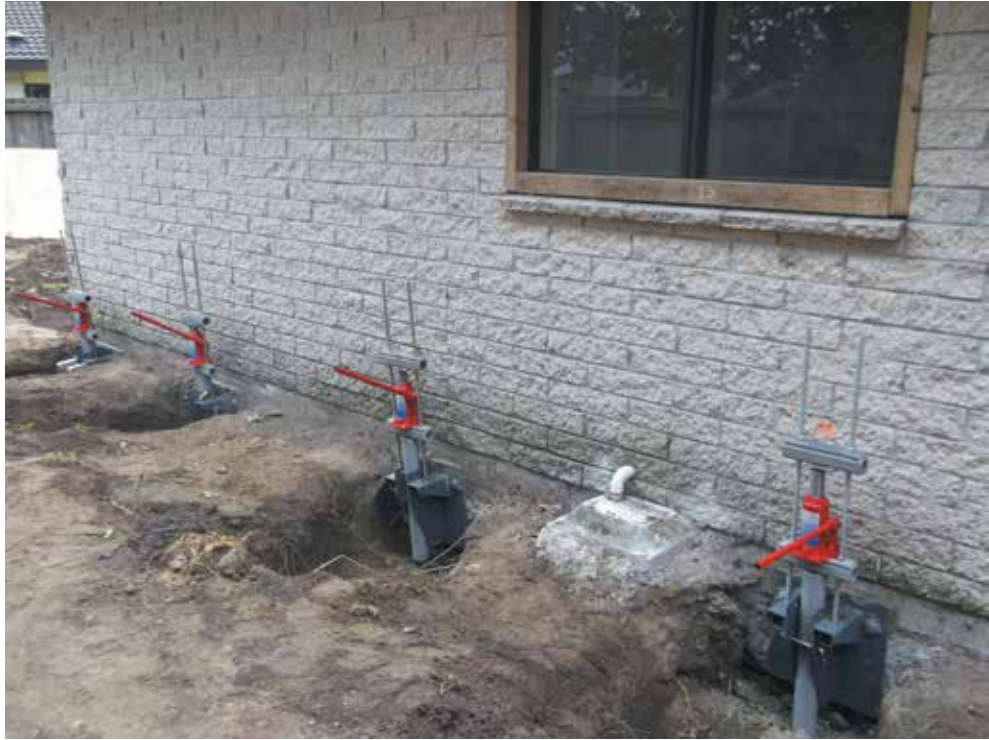
Image 7: Jacks fitted to brackets

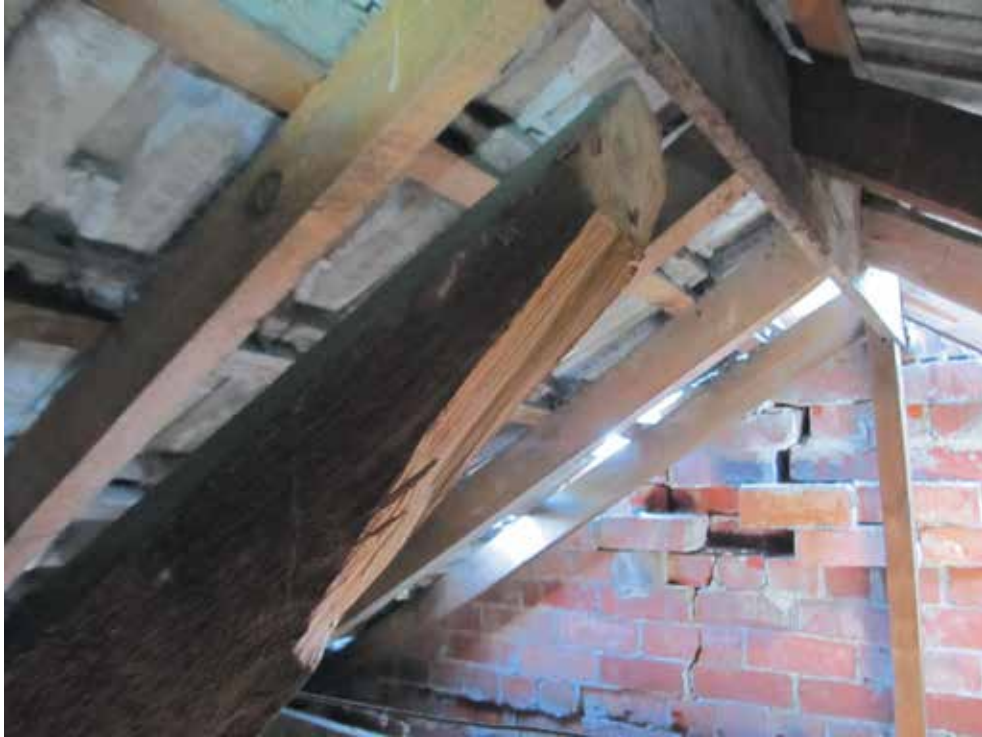
Image 1: Roof lost structural integrity

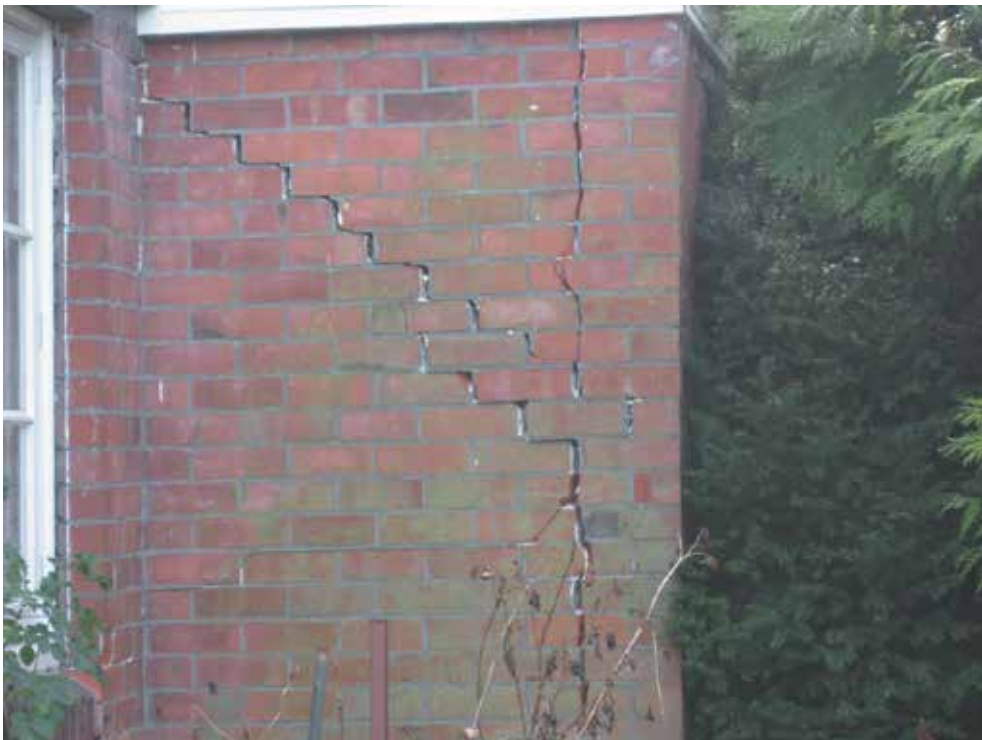
Image 2: Vertical and step cracking of bricks and mortar
