# Housing New Zealand

Technical Report on the Results of Foundation Repair Trials  
Conducted following the Canterbury Earthquakes

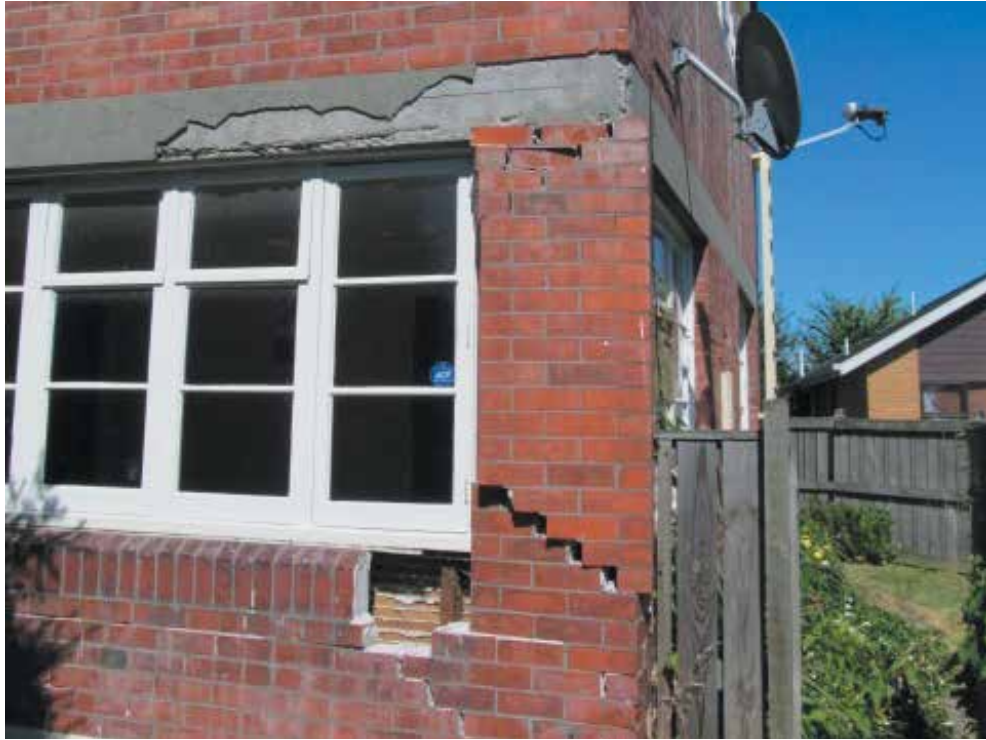
Image 3: Vertical and step cracking of bricks and mortar

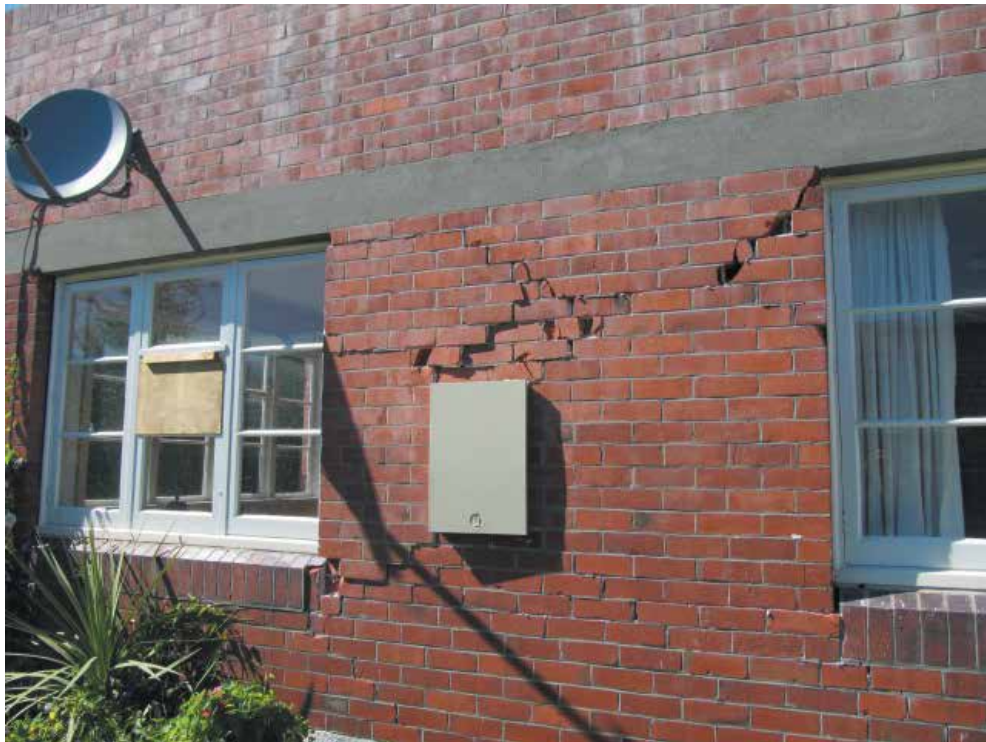
Image 4: Foundation settled at corners causing damage to veneer

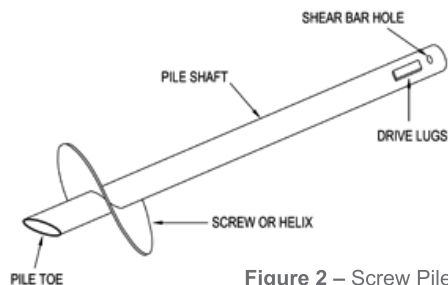
Figure 2 – Screw Pile

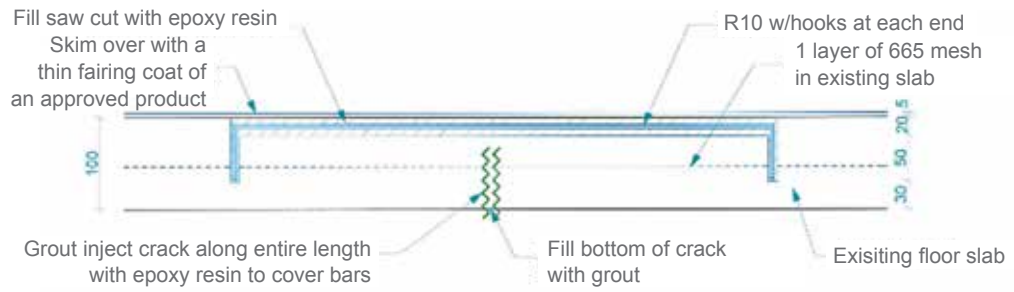
**Figure 1** - Crack repair plan. Not to scale.

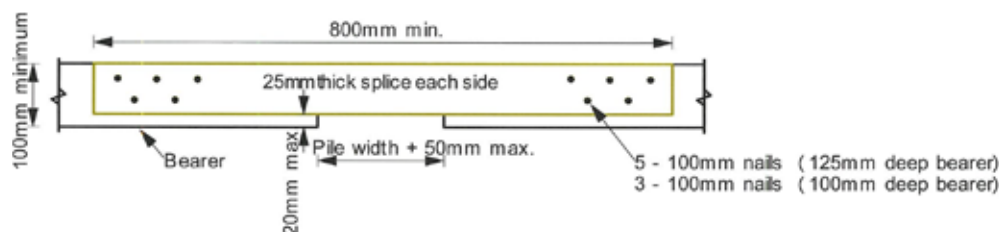
#### Mid-span notches

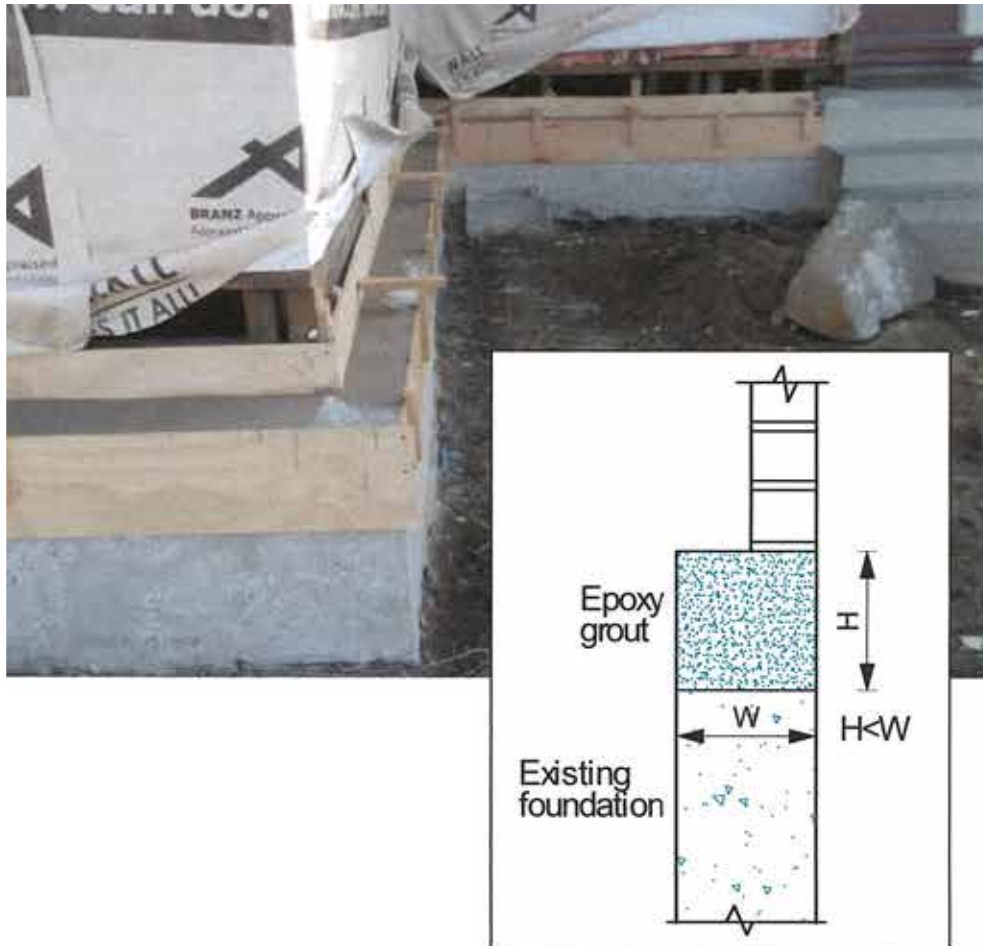
- Veneer replacement provided opportunity to relevel perimeter foundation with epoxy grout to accept new veneer
- Existing roughened
- Maximum grout thickness  $H < W$ .
